ASSESSMENT REPORT OF THE SOASOA DRAINAGE SCHEME
FOLLOWING TC YASA AND TC ANA

FEBRUARY 2021

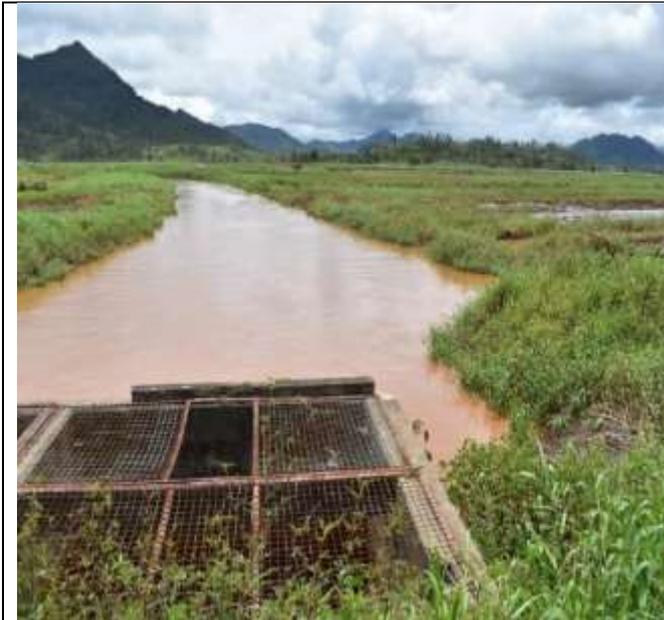
Minor scouring of the banks on both sides of the existing 4-barrel floodgate structure was observed. The minor damages will not affect the construction of the proposed double-barrel flood gate as the section of the levee adjacent to this site is still intact and structurally stable as shown in Figure 4 a-d.

Photo a. Landside of the levee where the existing four-barrel floodgate structure is located.

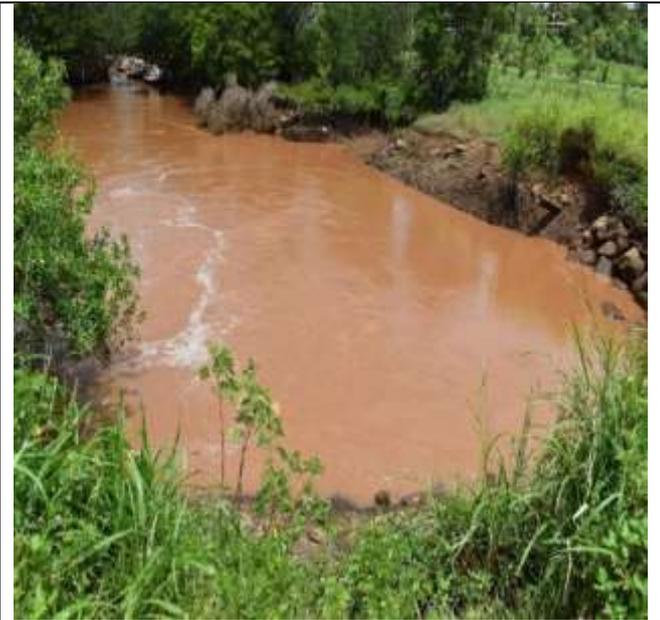
Photo b. Seaside of the levee where the existing four-barrel floodgate structure is located.

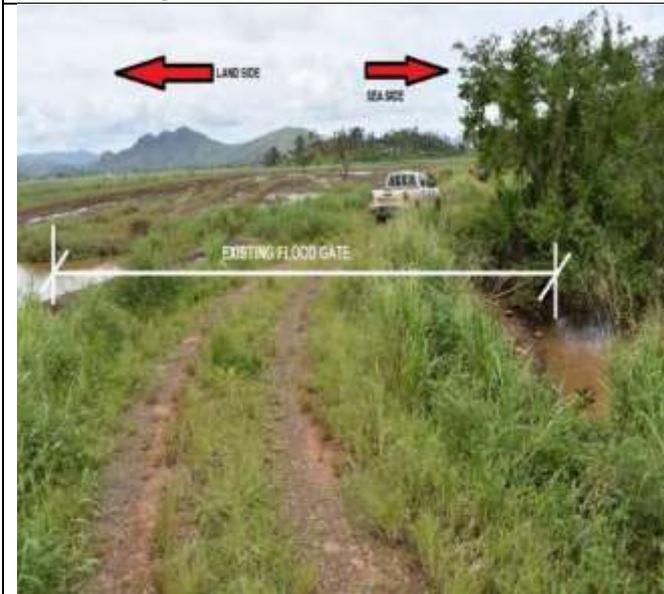
Photo c. Full width of the levee by the existing four-barrel floodgate

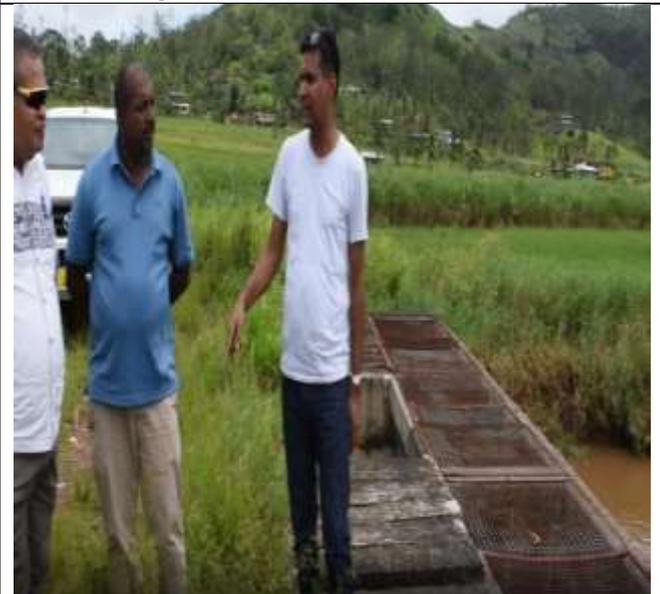
Photo d. Top view of the existing four-barrel floodgate

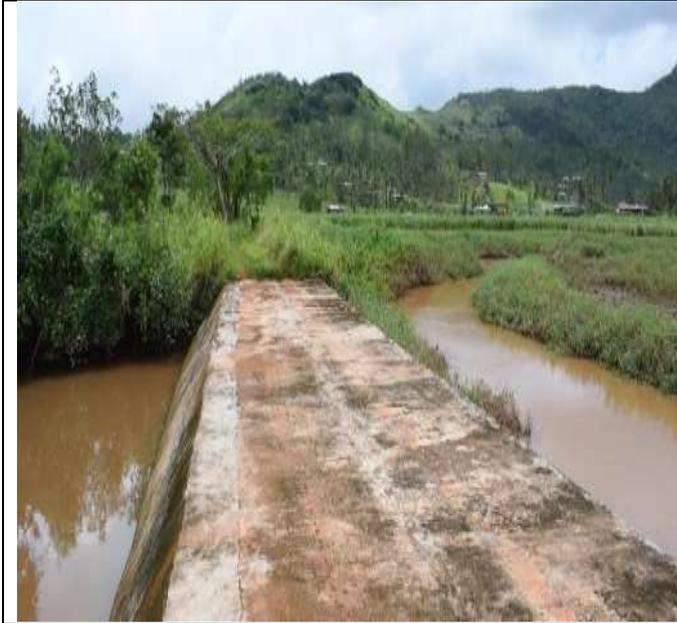
There is a small accumulation of sediment along the landward side of the spillway (Fig. 5b). No signs of damages was observed on the concrete structure including the top, landward side and seaward side of the spillway as seen in figure 5 a, b and c respectively.

Photo a. Spillway structure

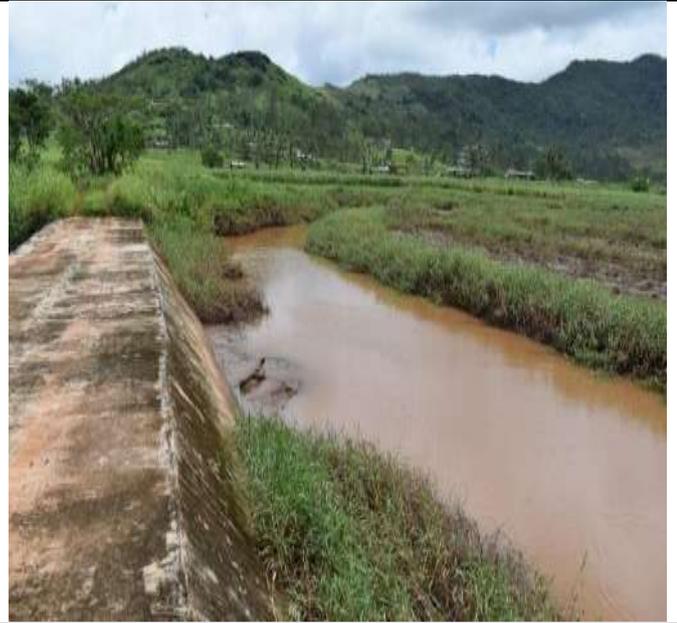
Photo b. Small accumulation of sediment along the landside of the spillway structure

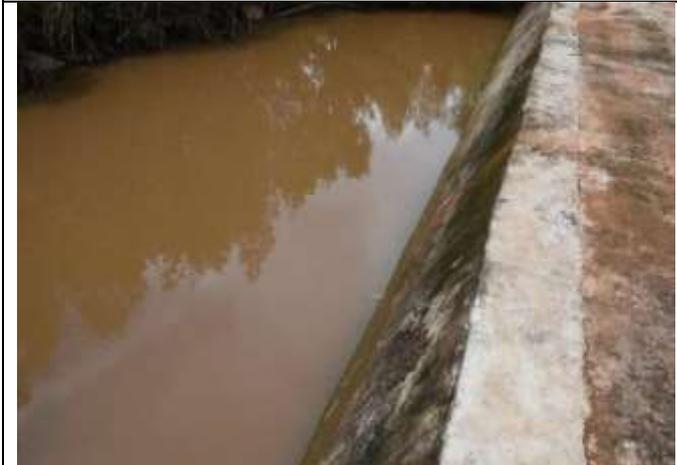
Photo c. Seaside of the spillway structure

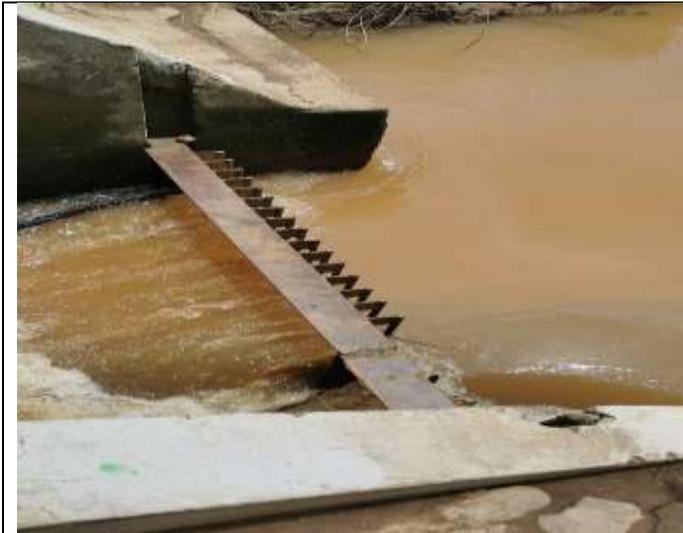
The steel trash rack attached to the flap gate structure did not ascertain any damages and continues to function as normal (Fig.6a), however on the opposite end, the flap gate door has been dislodged and is currently held in place by a rope (Fig. 6b).

Photo a. Steel trash rack landward of the existing flap gate

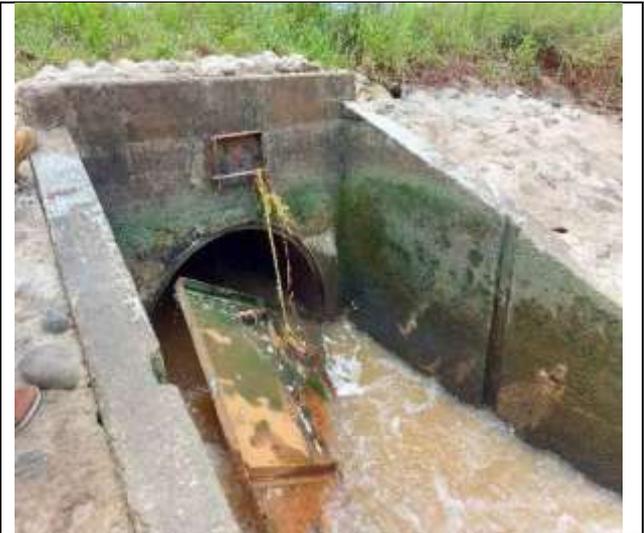
Photo b. Broken flapgate at the exit of the culvert and on the seaward side of the levee.

The MoW team is currently fabricating a new flap gate for this site as well as another site further down the Qawa levee. MoW plan to install the new flap gates as soon as possible and will provide confirmation to the SPC team. Figure 6c shows the man-made channel on the landward side of the flap gate structure, while Figure 6d shows the man-made channel on the seaward side of the existing flap gate. The seaward channel connects to the main Qawa river. The proposed location along the levee for the double-barrel flood gate has not been disturbed.

MoW have advised they are in the process of replacing the dislodged flap gate. Furthermore, that the scouring and erosion along the banks of the Qawa River will be addressed by installing boulders, and the scouring along the landward and seaward sides of the levee will be remedied by earth filling as part of MoW's routine maintenance works.

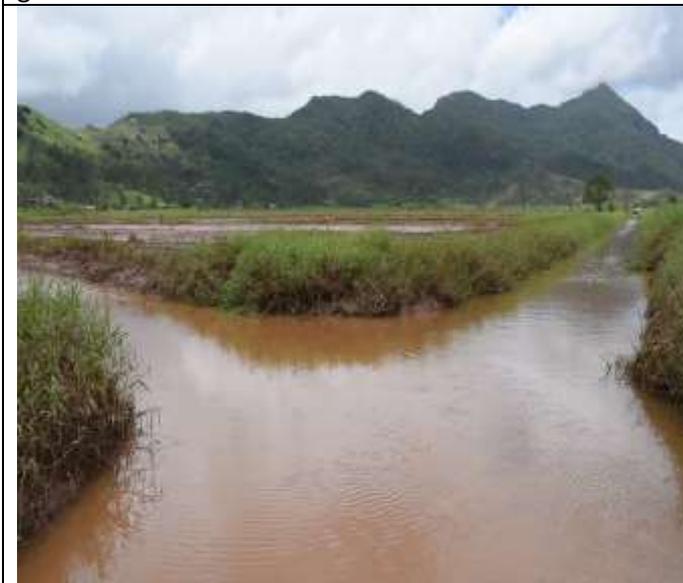
Photo c. Manmade channel at landward side of the existing levee and the culvert flap gate

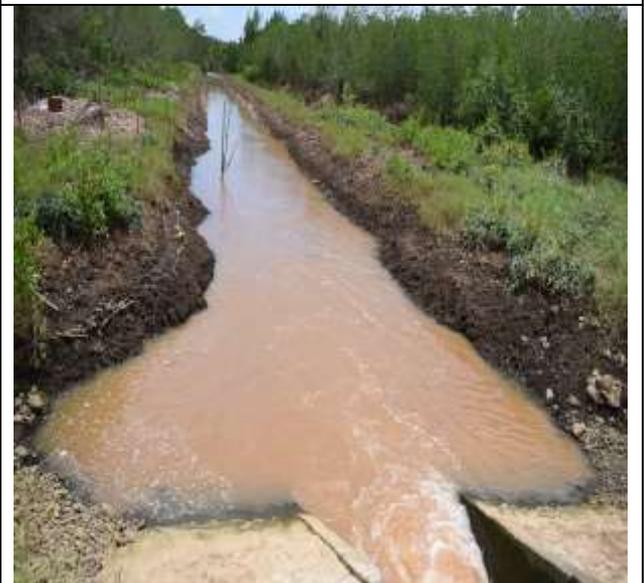
Photo d. Manmade channel at the seaward side of the existing levee and culvert flap gate

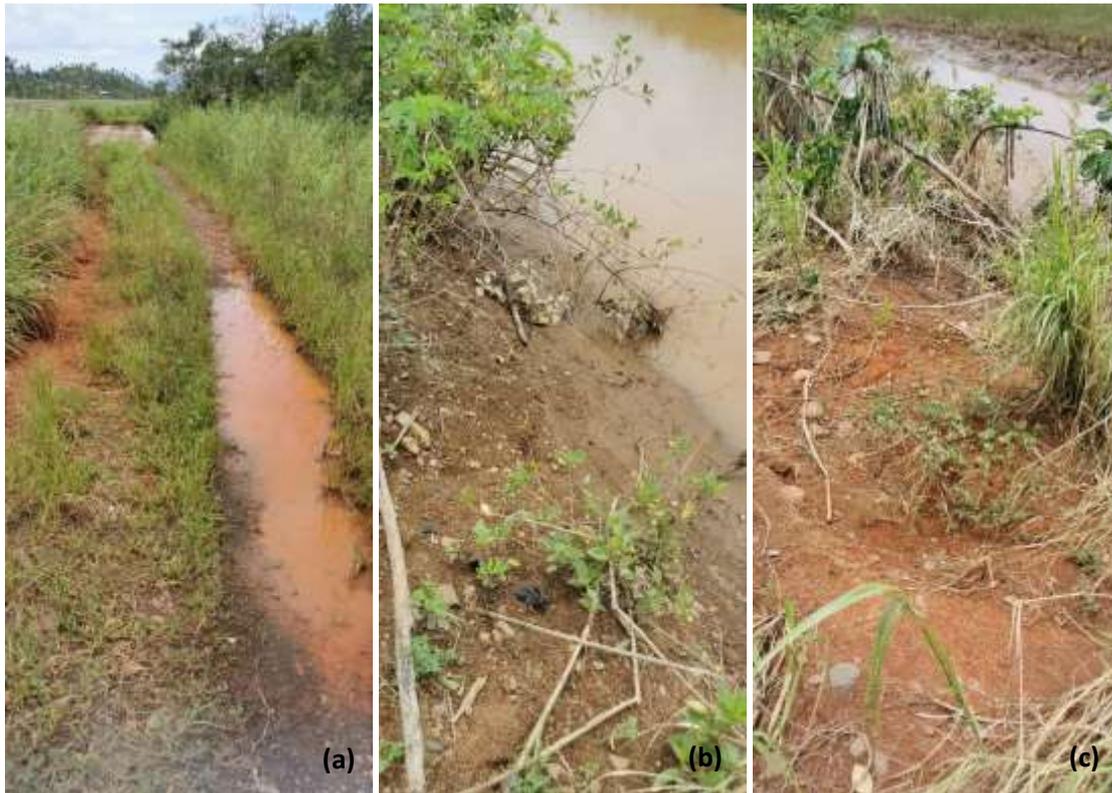
There was no major physical damage to this first segment. Small depressions containing water were observed on the crest as shown in Fig. 6a. Minor scouring extending for a distance of 10m and a lowering of 0.6m was observed on the seaward side (Fig 6b) and the landward side (Fig. 6c) of the levee.

Figure 6: Photographs of damages observed along levee along segment 1 of levee, with (a) showing depressions on the crest of levee, (b) minor erosion scars on the seaward side of levee and (c) minor erosion scars on the landward side of levee

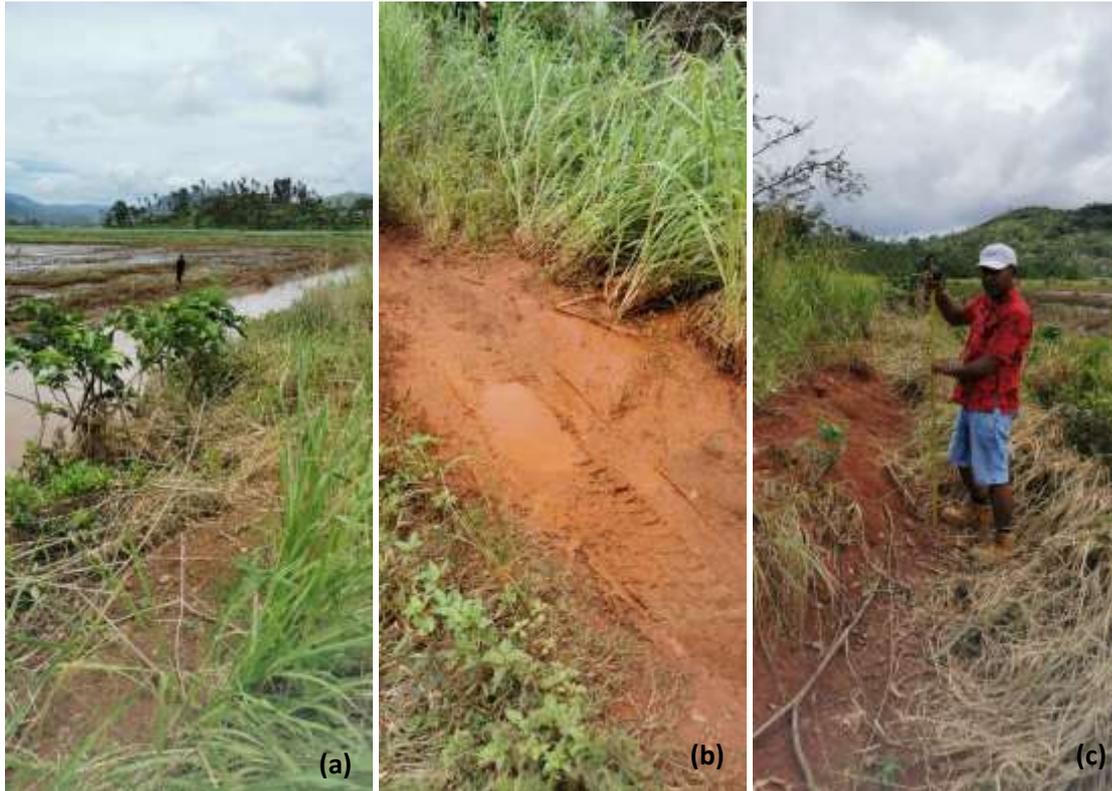
Small, waterlogged depressions were observed at certain sections along the crest of the levee as seen in figure 7b. In addition, certain areas along the landward side of levee had visible erosions (Fig. 7a). a notable erosion was encountered along segment 2 with dimensions of approximately 1.2m in depth and 50m in length as seen in figure 7c.

Figure 7: Photographs of damages observed along segment 2 of levee, with (a) showing minor erosion scars on the landward side of levee, (b) minor depressions on the crest and (c) intermediate level of erosion on the landward side of levee

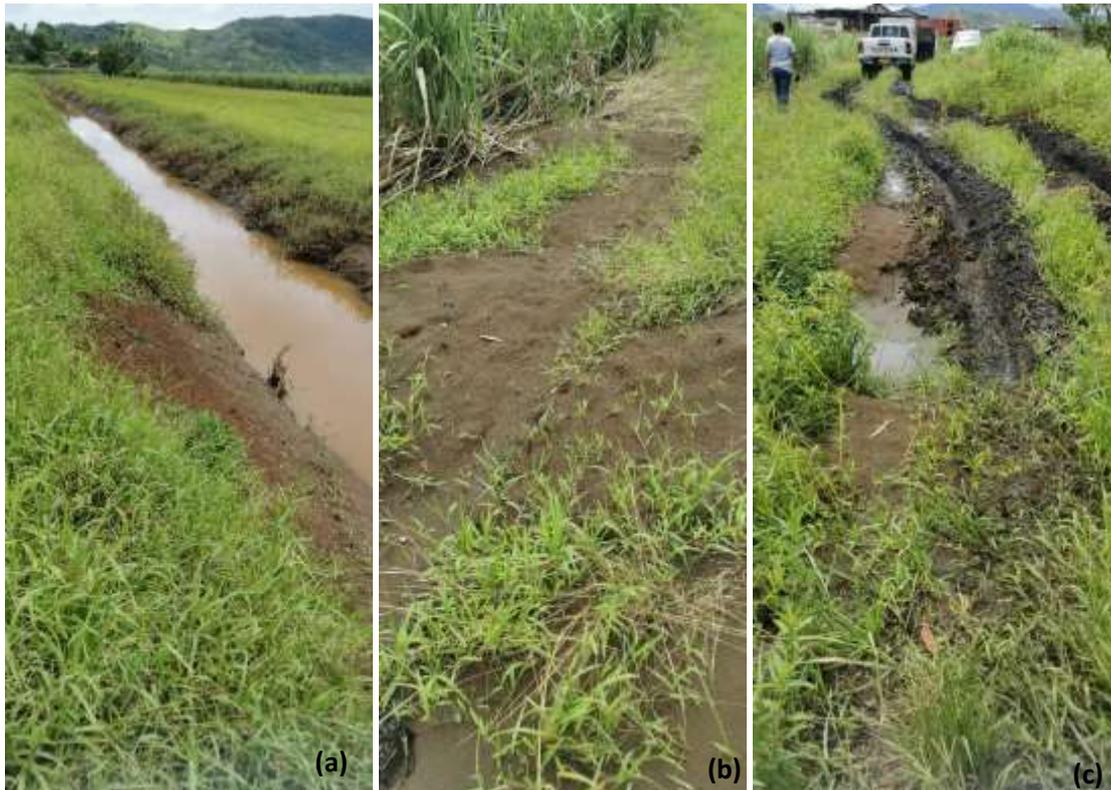
The last segment of the levee was mainly intact with only minor depressions along the crest (Fig. 8c) and superficial scouring on levee banks (Fig 8a). this segment had also several areas of accumulated or deposited sediments along the crest as seen in figure 8b that may have been brought in by moving flood waters during TC Yasa and TC Ana.

Figure 8: Photographs of damages observed along segment 3 of levee, with (a) showing minor erosion scars on the landward side of levee, (b) minor sediment deposits on the crest and (c) depressions on the crest of levee.

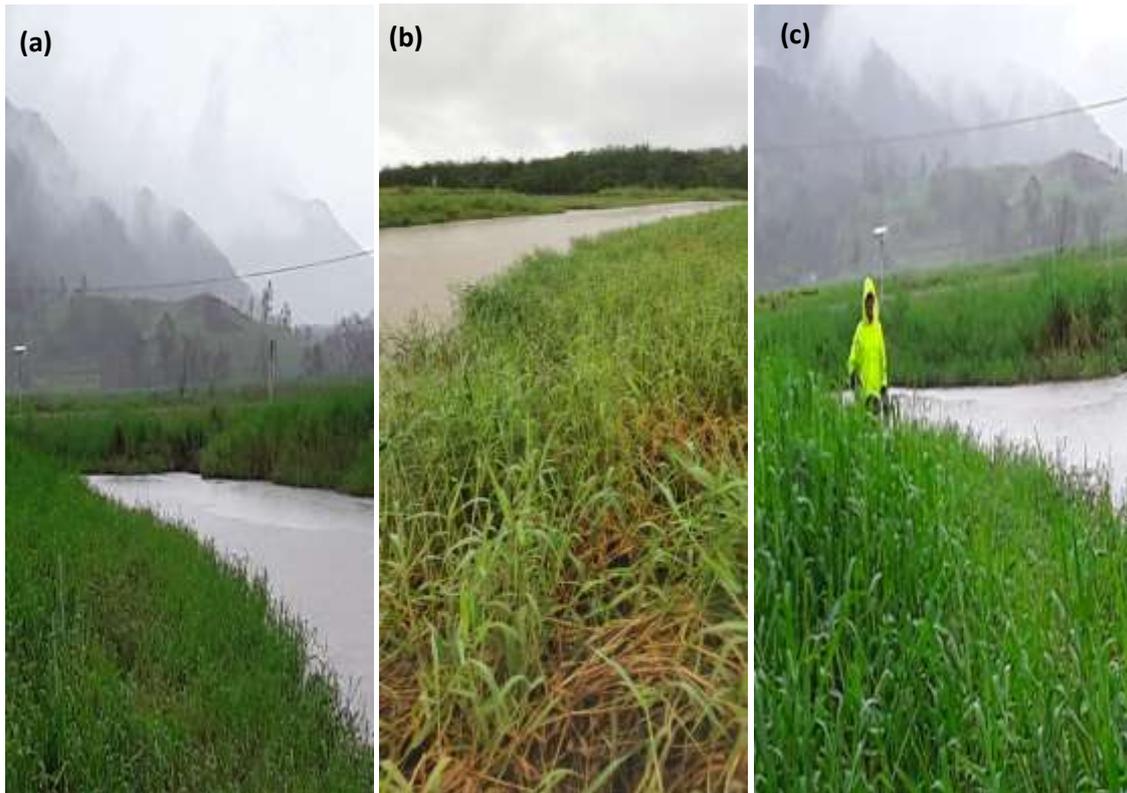
The location of the proposed trash rack structure along the banks of the Nasuva Creek is intact and stable enough for the trash rack (Fig. 9a, b & c).

Figure 9: Photographs trash rack site with (a) & (c) showing actual location of proposed trash rack and (b) showing the access area to the trash rack site.
