ASSESSMENT REPORT OF THE SOASOA DRAINAGE SCHEME
FOLLOWING TC YASA AND TC ANA

FEBRUARY 2021

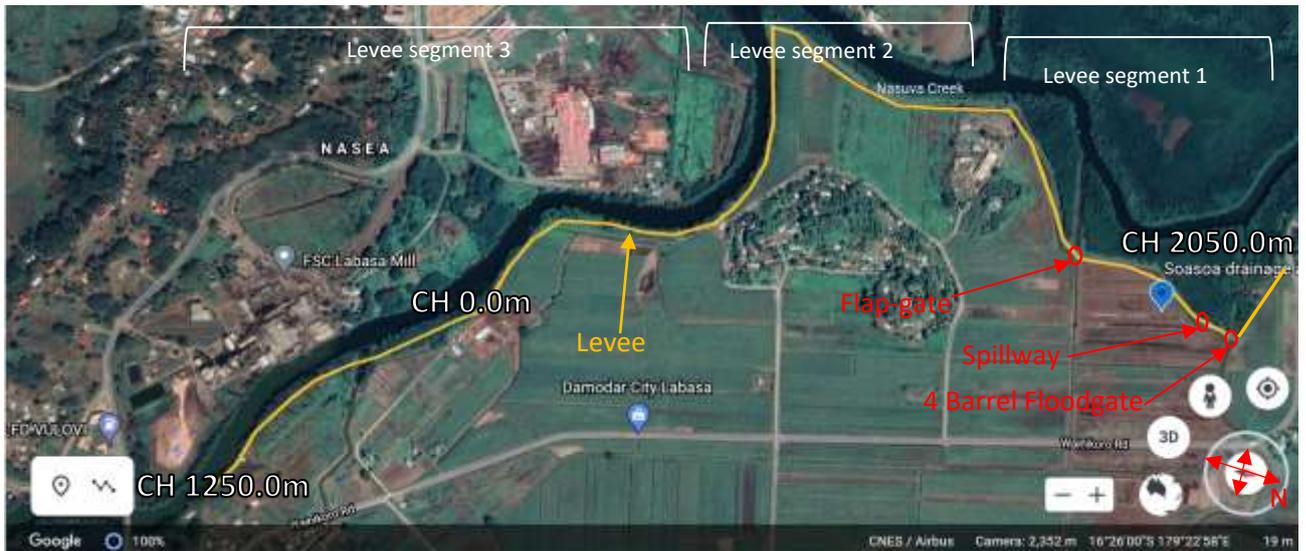
Figure 2: Soosoa drainage scheme satellite view from Google Earth. showing damage assessment locations including levee (yellow line), flap-gate, floodgate and spillway (red circle). Top white lines delineate segments of the levee into 3 segments

Inspection of the seawall commenced along the Soasoa levee, from chainage 2,050m to chainage 0, then continued along the Qawa levee, from chainage 0 to chainage 1,250m. The full length of the levee to be raised is $(1,250 + 2,050)$ 3,300m. The Soasoa levee was divided into three segments as shown in figure 2. For each segment, the observed damages are shown in figure 6, 7 and 8 in the subsequent pages.

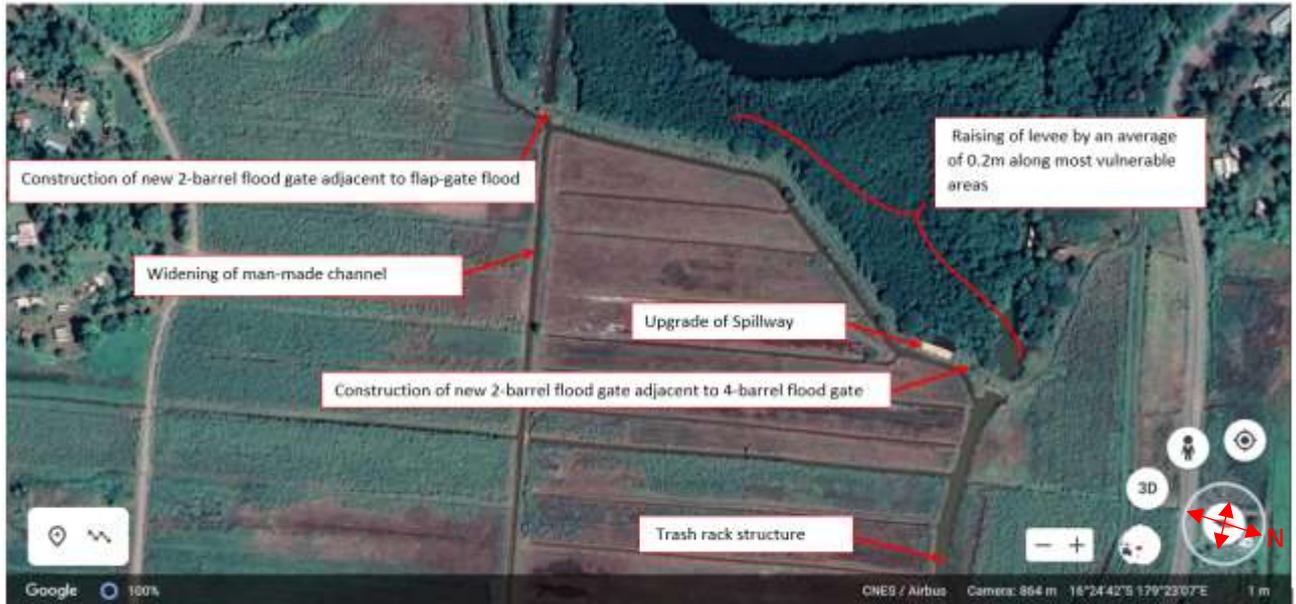
Figure 3: Soasoa drainage scheme, zoomed in view from Google Earth, showing proposed sites for scaling up of drainage systems. (Note the widening of the man-made channel will be completed by MoW as part of their maintenance work).

An assessment was also carried out of the proposed sites for new drainage structures, namely the trash rack structure and the two double-barrel flood gate structures as shown in Fig. 3 above.
