Groundwater Resources Assessment: Gagil-Tomil, Yap State, Federated States of Micronesia

Aminisitai Loco, Andreas Antoniou, Anesh Kumar, Nicholas Metherall,
Peter Sinclair

North Pacific – Readiness for El Niño (RENI) project

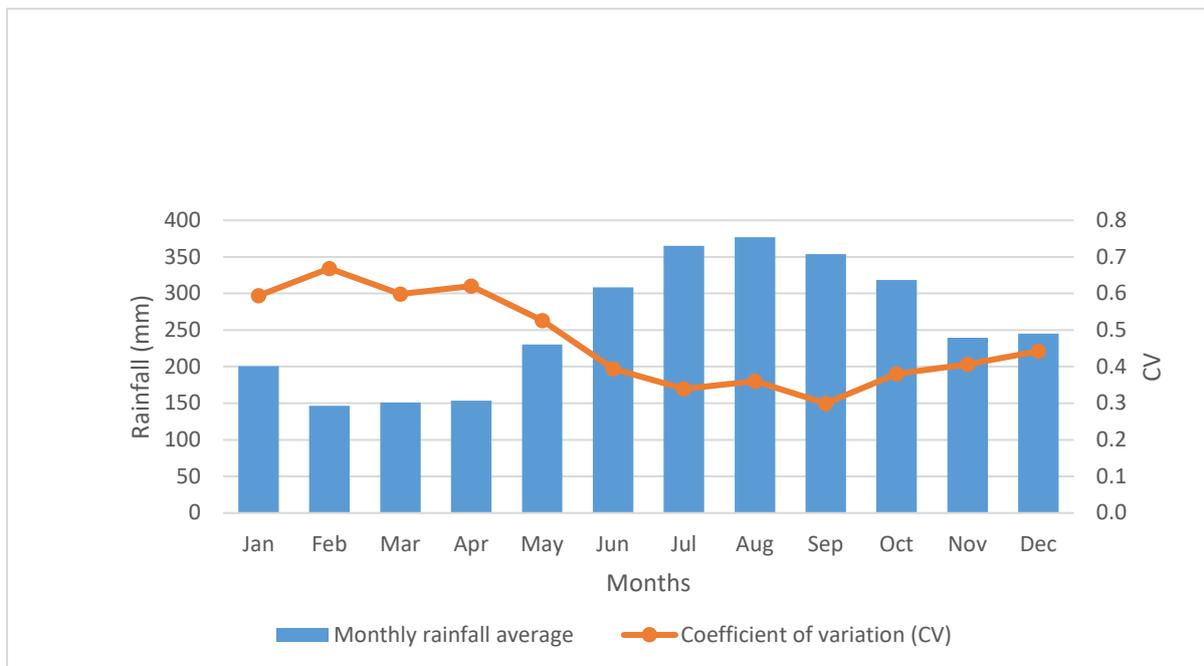
Figure 4. Mean monthly rainfall and coefficient of variation (CV) for Yap State from January 1949 to May 2019, Yap Weather Service Office – Airport.

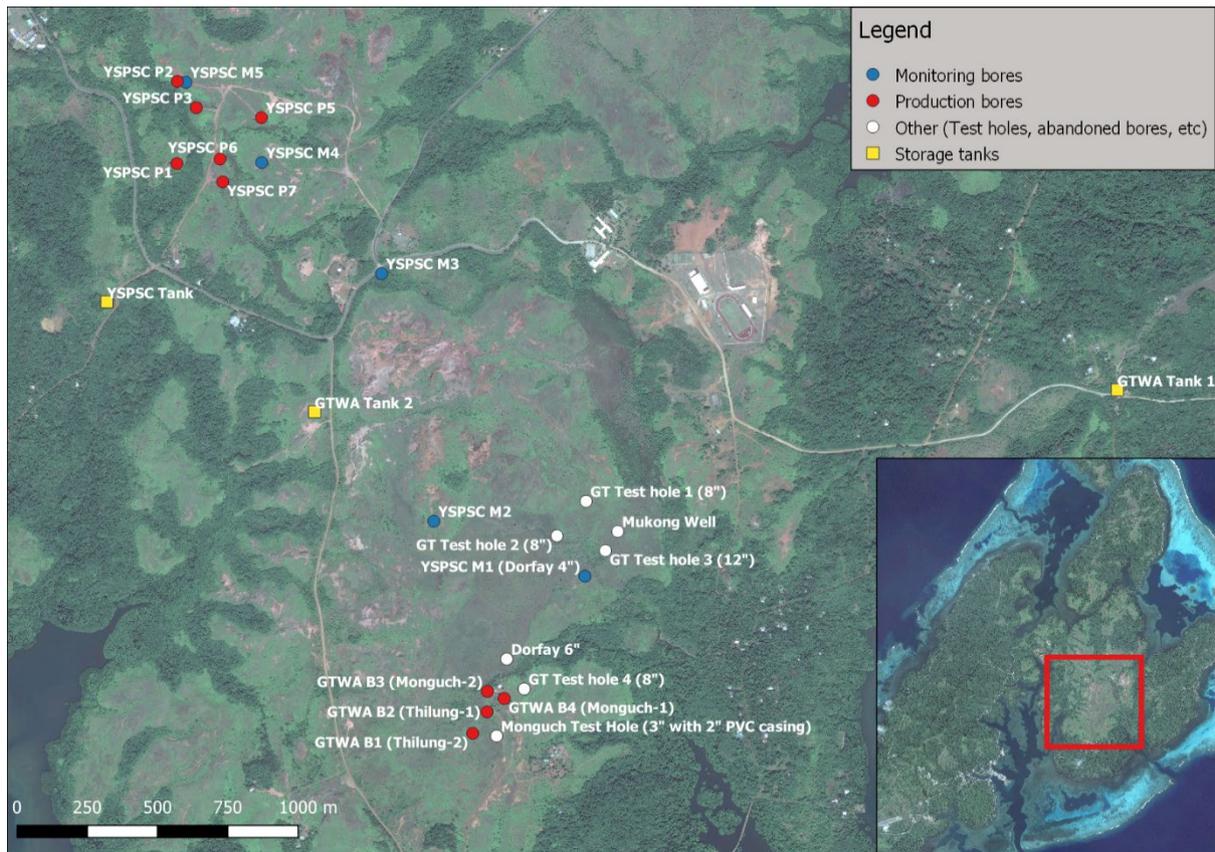
Figure 8. Location of groundwater bores, monitoring wells and tanks within the Gagil-Tomil aquifer area. Source: Bing maps

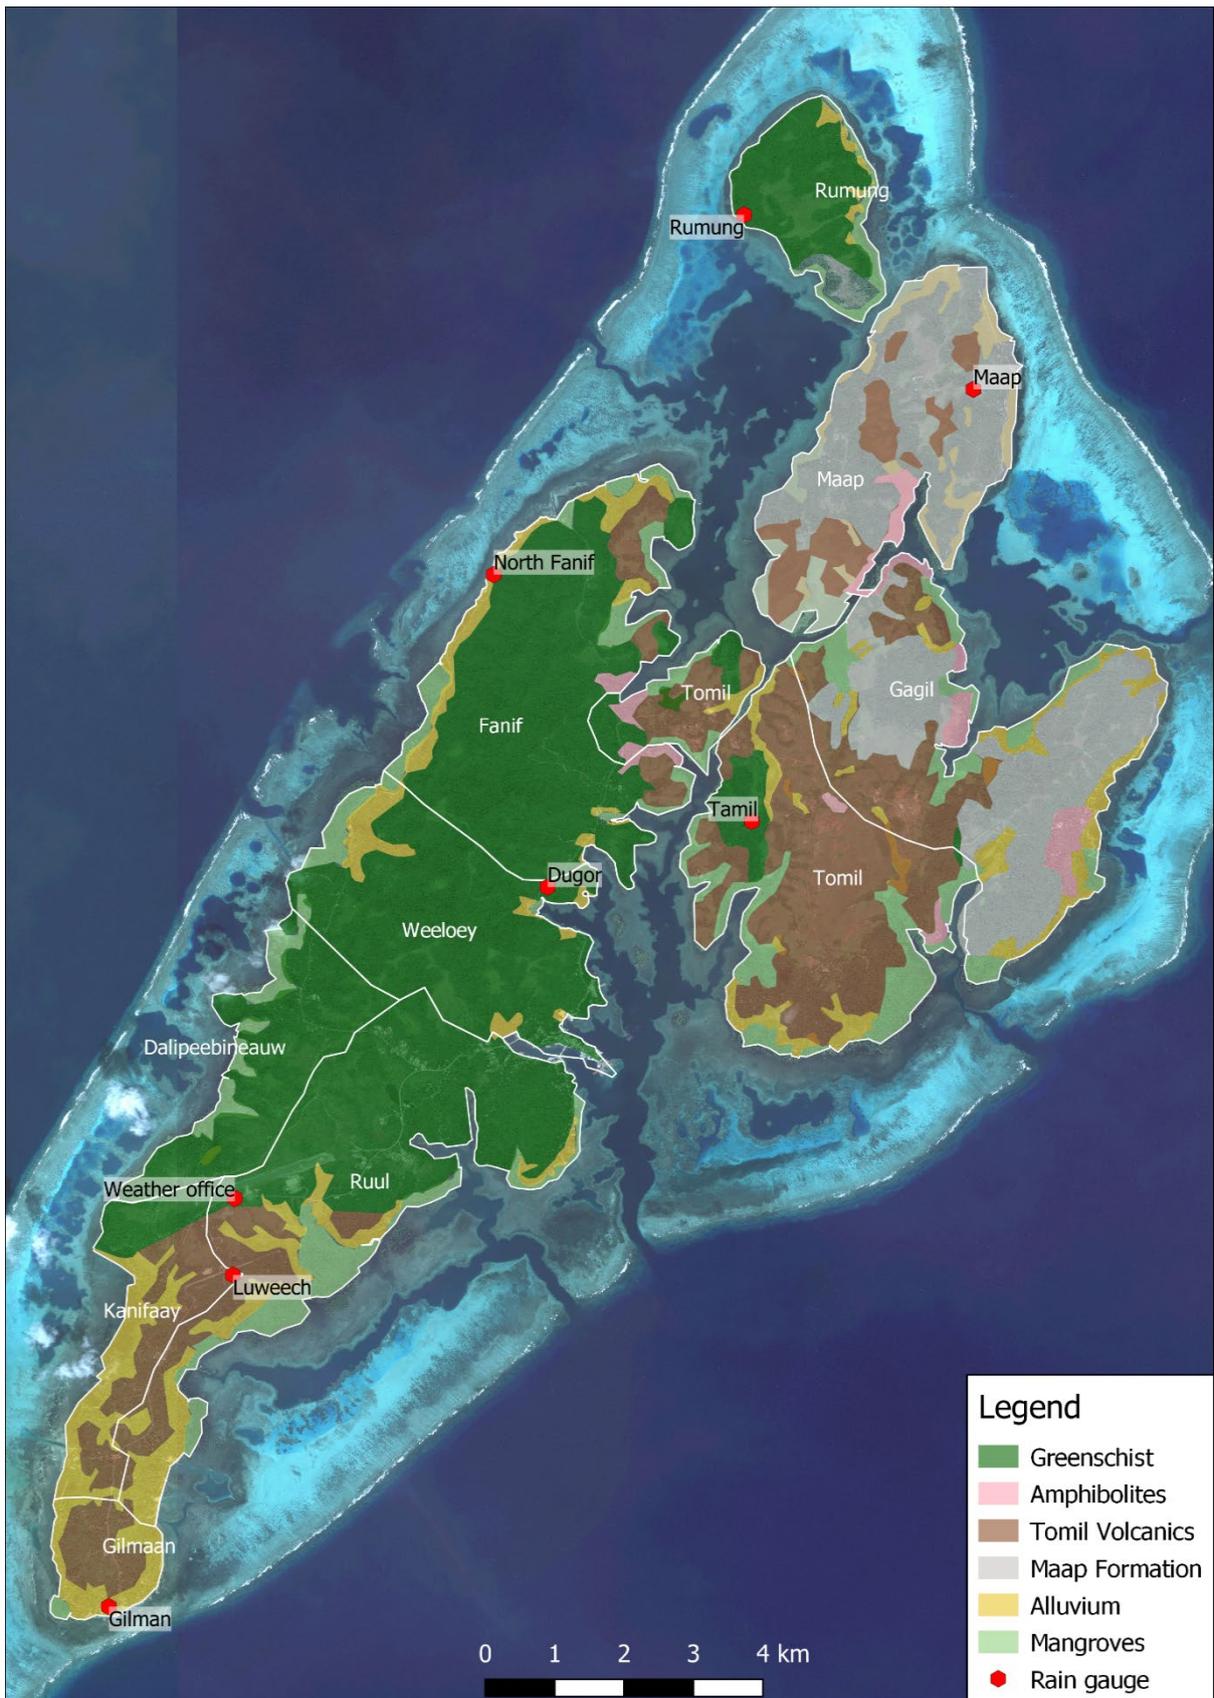
Figure 9. Geological map of Yap Proper, including municipality boundaries and Yap Weather Service Office rain gauge locations. Source: Bing maps

- The alluvial deposits are a mixture of stream-alluvium deposits and are observed around the south and northwest of Yap Island, and the eastern side of Gagil-Tomil.

- Mangrove swamps cover the coastal areas.

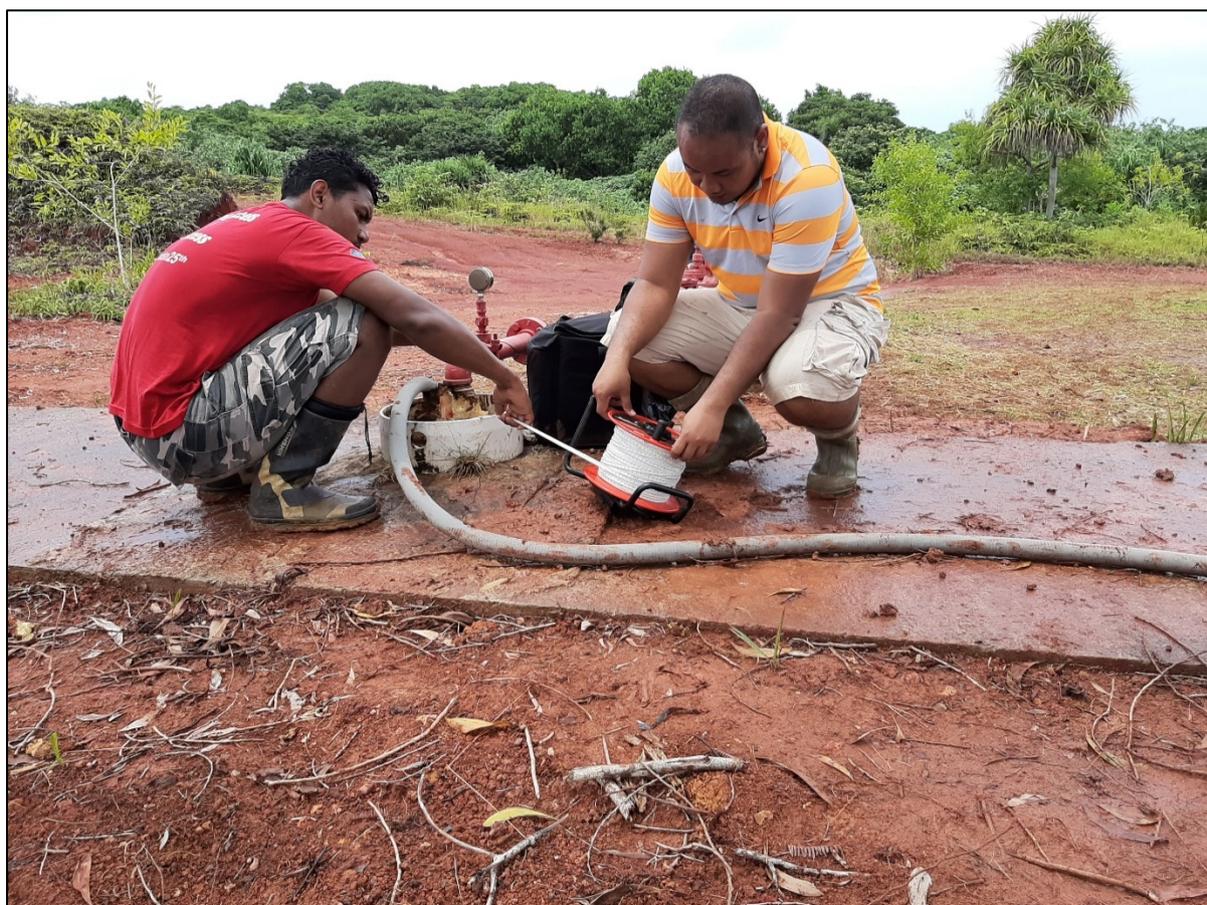
Figure 10. Measuring drawdown and conductivity at YSPSC pump 6 using a digital water level meter.

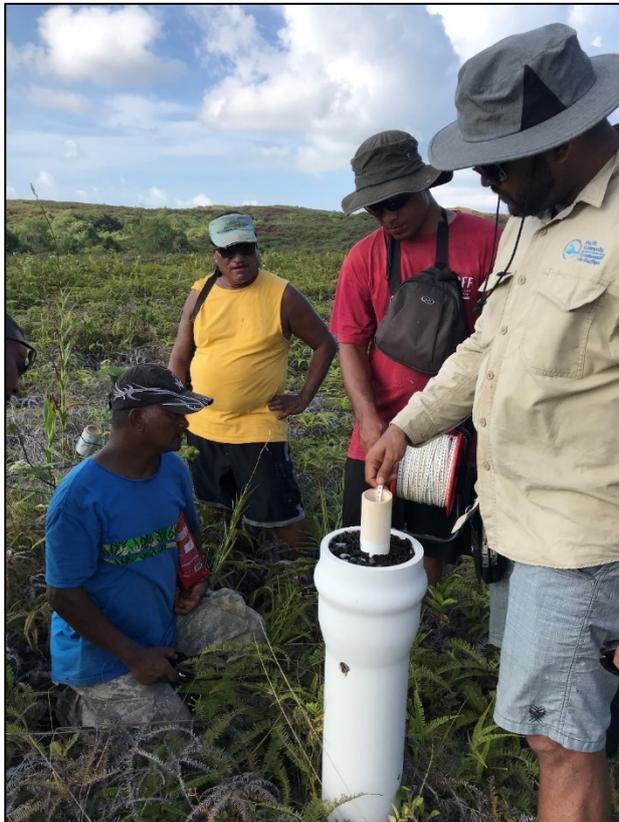
Figure 11. Piezometer water level and conductivity readings taken at YSPSC monitoring bore 4 (M4) prior to the pumping test.

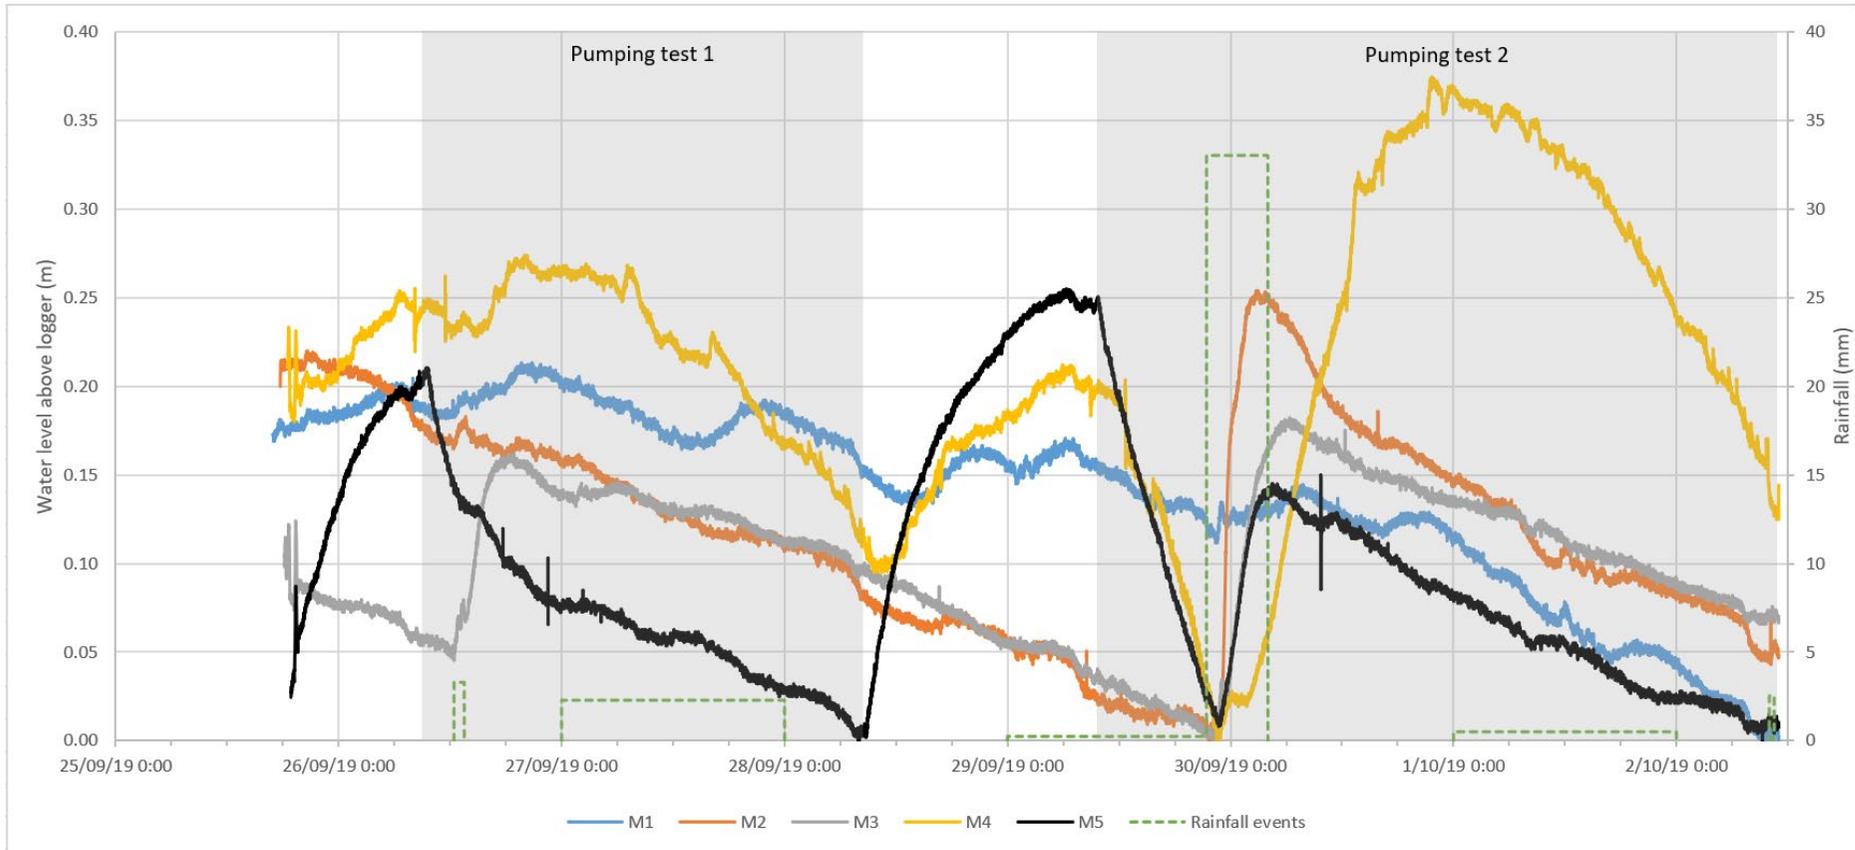
Figure 12. Groundwater level response in the monitoring bores during the two pumping tests (rainfall presented as rainfall events).

The loggers installed in the GTWA bores did not indicate any impact from the pumping of the YSPSC bores. The drawdown effects observed in the GTWA wells is the result of the GTWA pumps being switched on by the GTWA water manager for 6 hours each night during the YSPSC 48-hour pumping test to ensure minimal water disruption to the Gagil-Tomil communities (Annex 3).

The logger data also reflect the impact of rainfall on the pumping test, whereby a significant rainfall event of 1.3 in (33 mm) of rain was experienced overnight and in the early morning of the 30 September 2019, for an estimated total of six hours. During this period, all bores showed a rapid and connected response to rainfall, with water level responses reaching their maximum generally within an average of six hours from the commencement of rainfall, which is similar to the period of rainfall. This closely connected behaviour of rainfall and water level response was observed in all bores, except for M4 which demonstrated continued recharge for another 16 hours, or a total of over 23 hours, for the same 6-hour rainfall event. The average groundwater level increase due to this rainfall event in M2, M3, M4 and M5 was 0.23 m, with M4 showing a water level response of 0.36 m over approximately 23 hours.

The behaviour observed in M4 suggests that groundwater in this area receives prolonged recharge from groundwater flow higher in the catchment, resulting in a larger and more sustained water level response to recharge than observed in other monitoring bores. Similarly, the decline in water level in M4, representing discharge, over the following approximately 10 days after a rainfall event is also larger and more sustained than observed in other bores. This water level behaviour observed in the monitoring bores is a strongly connected response to rainfall, and indicates a rapid groundwater system that is most likely to be fracture controlled.

- M4's rapid and larger water level response to rainfall, followed by a rapid and large decline, is likely a result of its location and the geology it intercepts. It is suggested that M4 receives prolonged recharge in response to the connectivity to fractures higher in the catchment, which is observed by the duration of the water level response to rainfall. Equally, it is observed that the water level decline indicates prolonged discharge over a 10-day period following a significant rainfall event (Fig. 12 and Fig. 14).

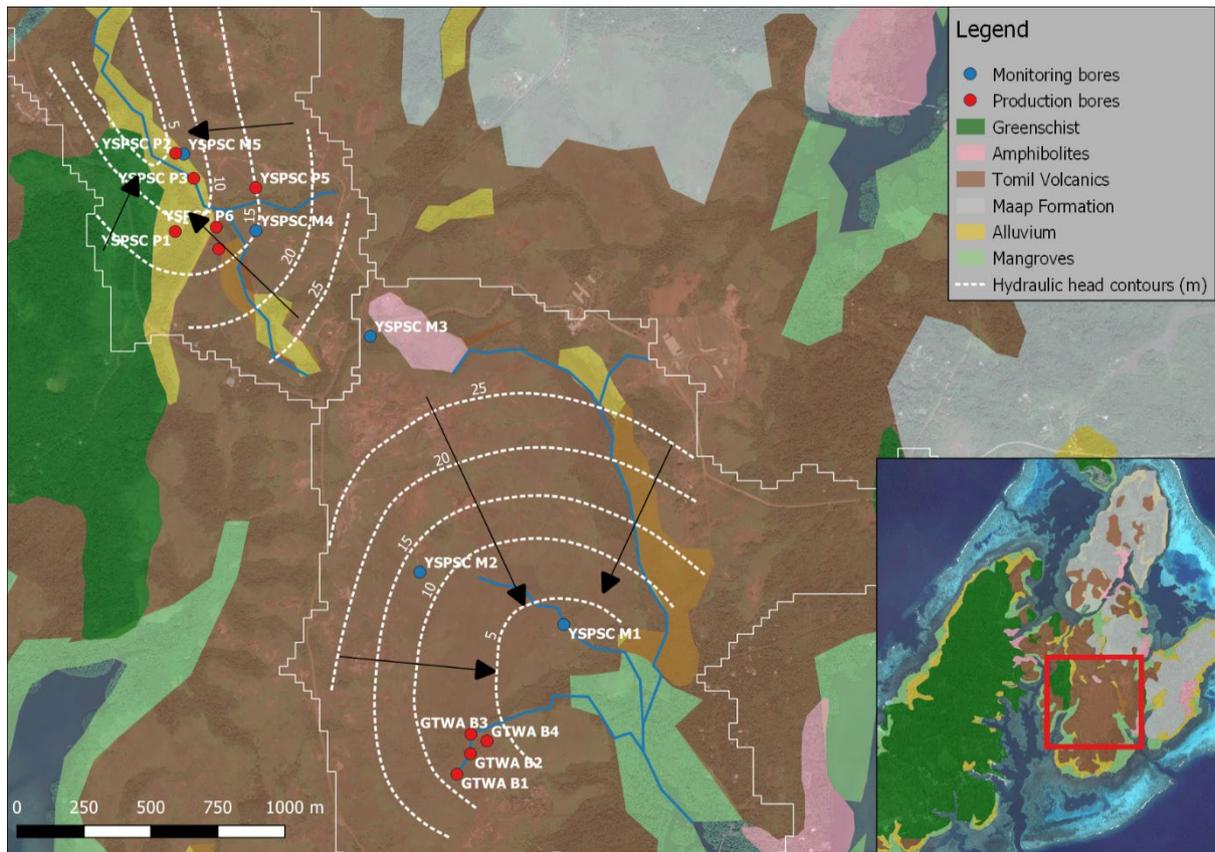
Figure 13. Groundwater head contour map under natural conditions, not pumping induced (September 2019). Black arrows indicate the flow direction of groundwater (perpendicular to the hydraulic head contours).

If indeed the geological formation from which abstraction occurs in the Eyeb Valley is different from the one in Monguch Valley (weathered Tomil Volcanics), this could account for the differences in observed hydraulic conductivities. Drilling logs are unavailable for the YSPSC bores, so it is difficult to provide any certainty for the above explanation. Nevertheless, the aquifers in both valleys demonstrate similar hydraulic characteristics, with similar groundwater chemistry (see Section 3.3) and water level response, albeit they seem to be separated by a groundwater divide located along the highest elevation and crossing monitoring bore M3 (see Fig. 13).

Figure 13 illustrates the calculated hydraulic head contours, as approximated by groundwater level measurements in the monitoring bores in September 2019, governing the general groundwater flow direction. The groundwater appears to flow from the topographically higher areas towards the streams and associated estuaries. Analysis of the Mukong stream flow data (16 September 1980 to 21 March 1984, elevation 20') operated by the United States Geological Service (https://waterdata.usgs.gov/nwis/inventory/?site_no=16893200) indicates that the groundwater supports the perennial streams, except during dry periods when the streams run dry, where it is expected that discharge is out towards the ocean through the underlying rocks of greenschist (Annex 4, Fig. 41). The potentiometric contours in Figure 13 represent the measured depth to groundwater for recovered static water levels under a "full" groundwater system (as measured on 29 September 2019). Figure 13 indicates that groundwater flow is towards the streams from higher in the catchment. A groundwater divide is observed between the two catchments, broadly mimicking the catchment topography, with discharge towards the base of the catchment.

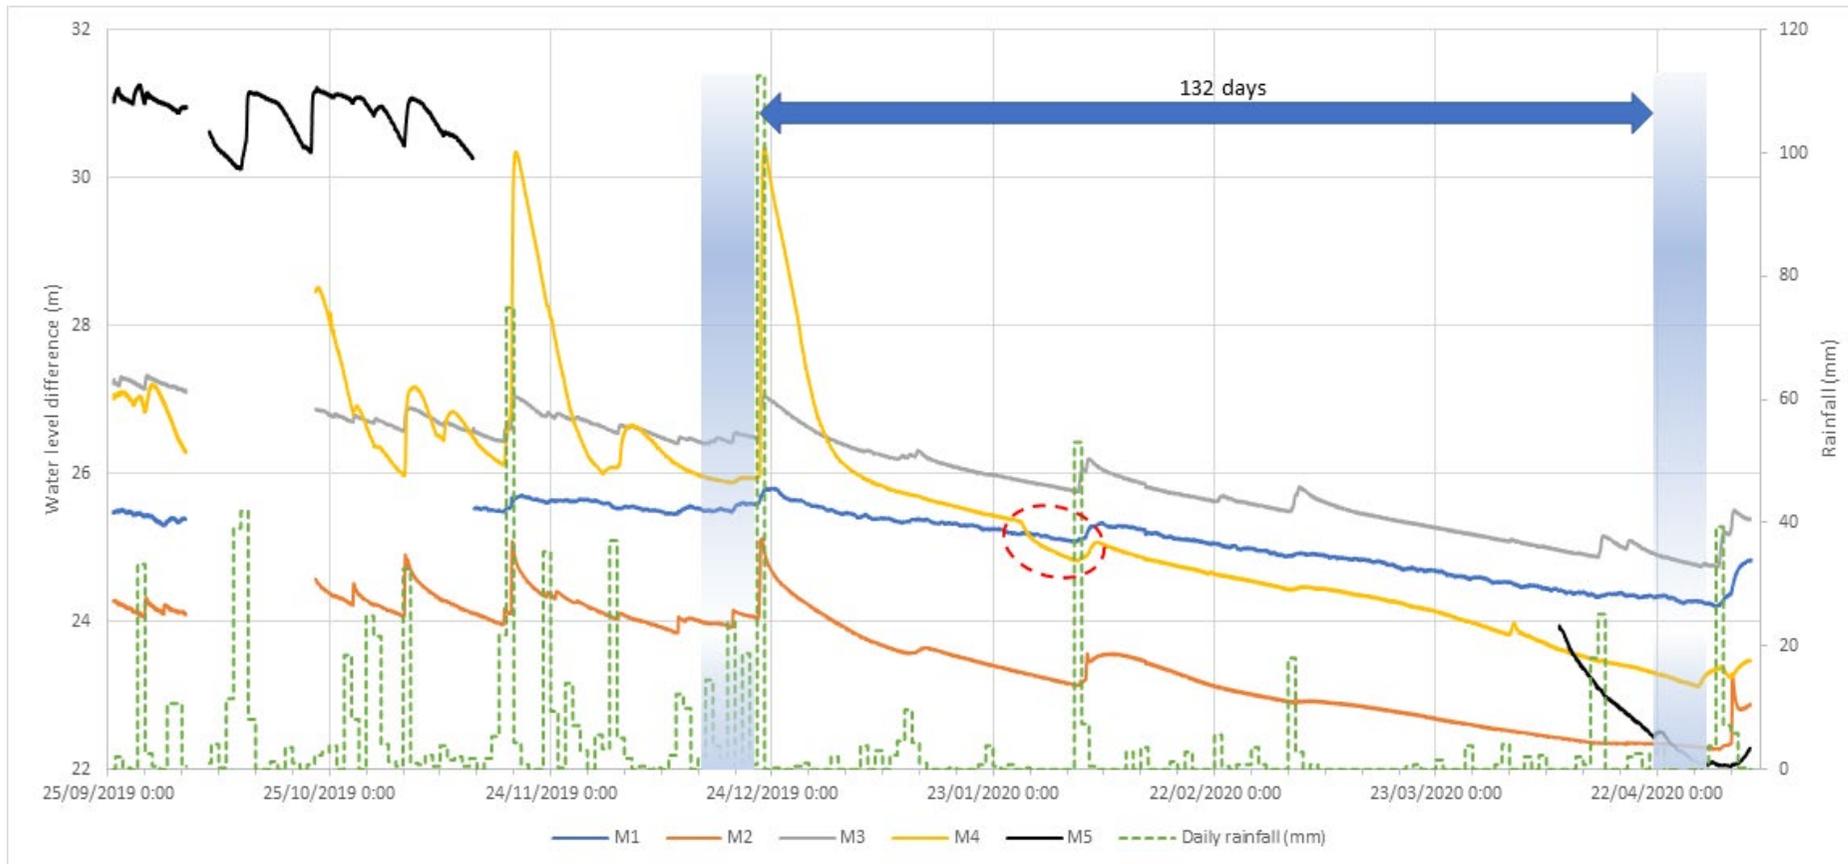
Figure 14. Estimation of rate of decline in water levels over 4.5 months, in response to drought and pumping impacts. Tamil station rainfall included. The dashed red circle for M4 indicates a sudden decline in water level response due to additional stress from increased pumping, or more likely the effect from a boundary impact.

An analysis of the water-level data collected by the loggers from September 2019 until May 2020 (Fig. 14) provides insight into the aquifer's behaviour over an extended seven-month dry period, with continuous pumping from the YSPSC bores in Eyeb Valley. The GTWA pumping schedule during this period is unknown, and assumed to be 8–12 hours nightly, as per normal scheduling during this period. Notable features observed in the groundwater and rainfall data collected include the following:

- A sudden groundwater level decline was recorded on 27 January 2020 until 4 February 2020 (dashed circle in Fig. 14). Two explanations for this observed phenomenon are:

- Abstraction impacts from the production wells have resulted in the flow to the monitoring bore being temporarily interrupted, possibly where the flow within the assumed fracture-dominated system is exhausted, or a boundary is reached. This may have resulted in the release of groundwater from within the aquifer matrix, indicating a secondary porosity effect. The system's recovery is in response to the recharge from a rainfall event, albeit the water level response observed in M4 is more subdued than what would be expected from similar rainfall events observed in a less stressed system. This subdued response to rainfall recharge is likely due to the need for the "wetting up" of the unsaturated zone before recharge can begin.

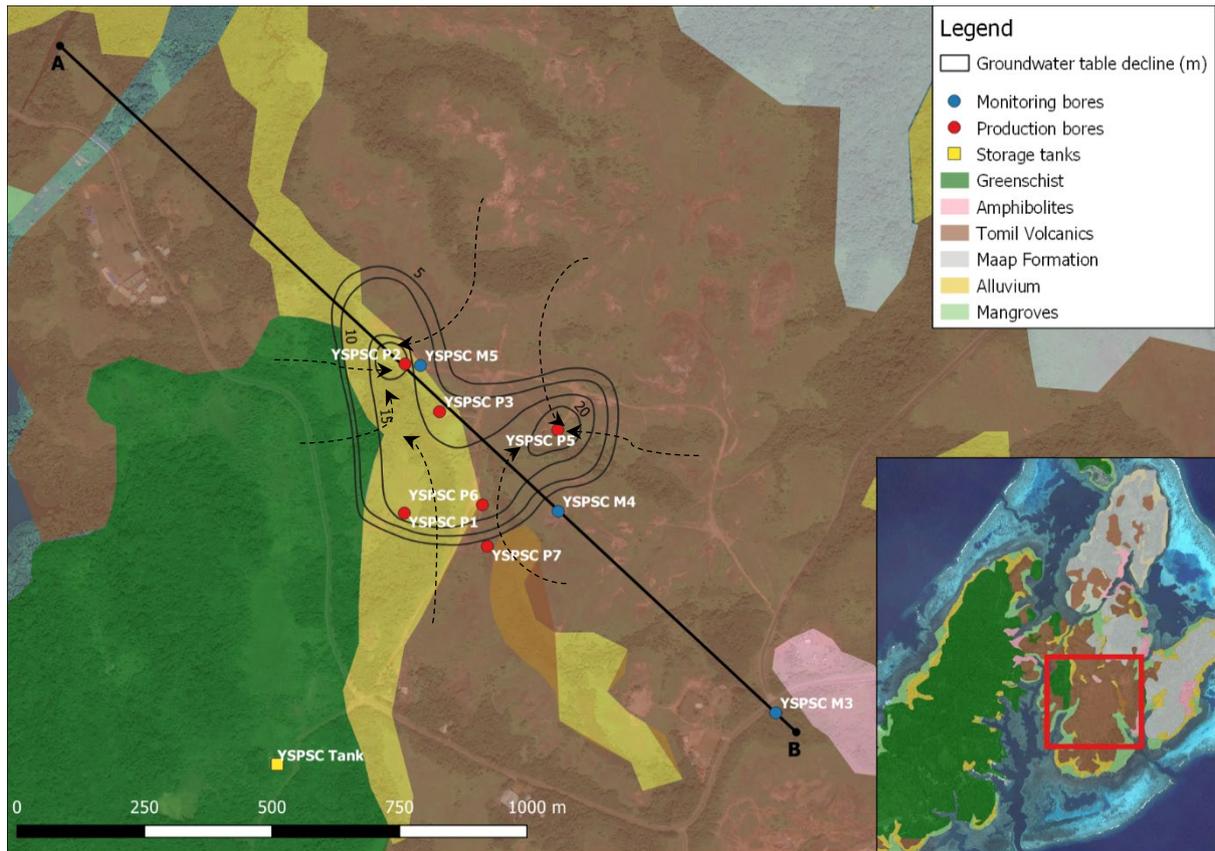
Figure 15. Geological map of Eyeb Valley (YSPSC wellfield), illustrating the groundwater drawdown decline between September 2019 and April 2020. Arrows represent groundwater flow during extended pumping.

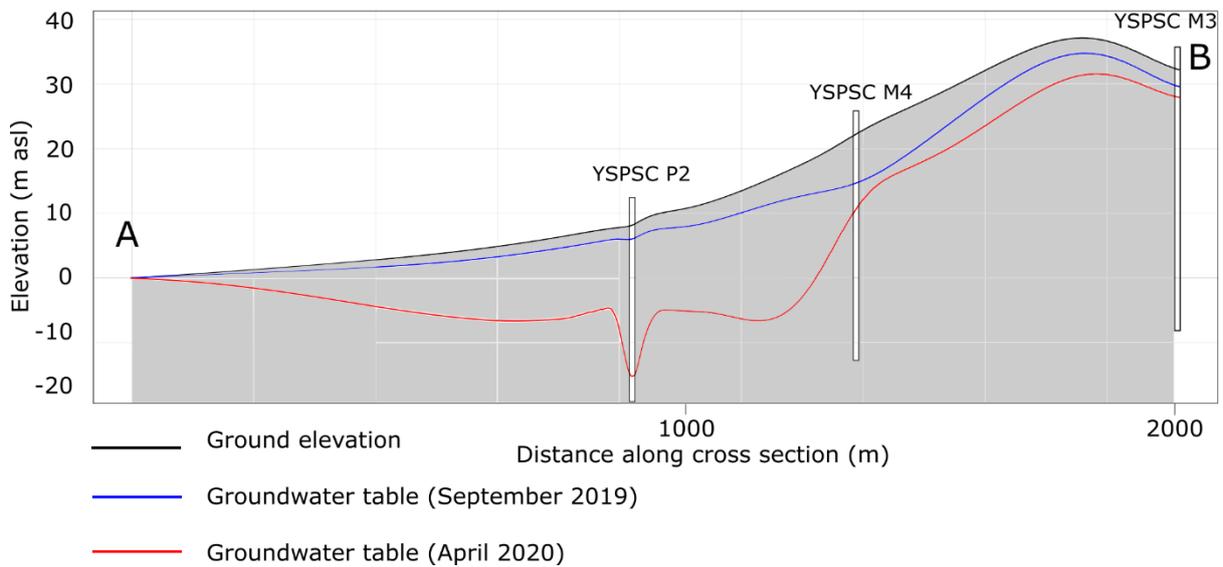
Figure 16. Cross section illustrating groundwater drawdown decline in Eyeb Valley between September 2019 and April 2020 in response to an extended dry period and abstraction. Note: “m asl” refers to meters above sea level.

Figure 16 illustrates a conceptual cross section of Eyeb Valley, demonstrating the impact of pumping on groundwater levels. This conceptual section indicates that drawdown levels are below mean sea level, suggesting that there is potential for sea water to be induced towards the Eyeb production bores. While this impact to water quality was not observed in any of the production or monitoring bores, or for just short periods, may be an acceptable abstraction and management strategy to meet water demands. Given the existing high manganese (Mn) and iron (Fe) within the groundwater, and where the reduced recharge is likely to result in increased reliance of groundwater within storage, there could be the potential for Fe and Mn concentrations to increase. The following, therefore, are recommended:

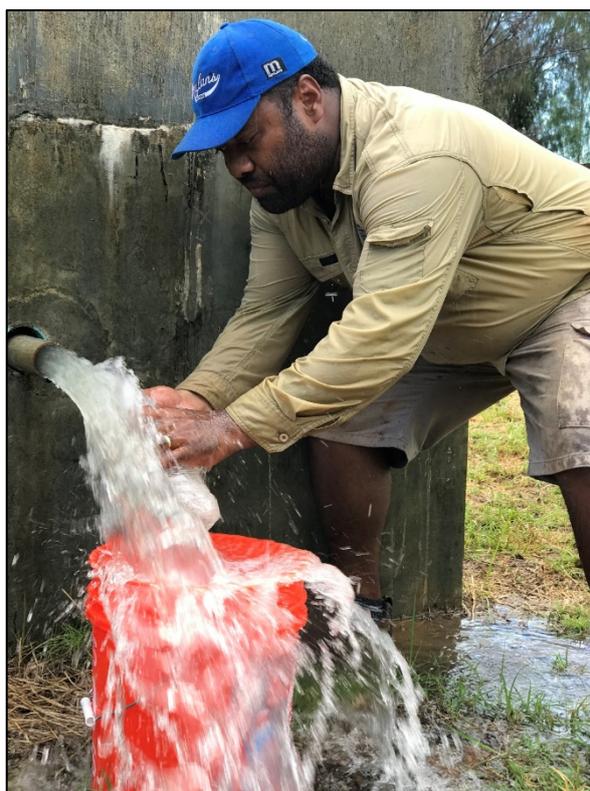
Figure 17. Groundwater chemistry sample collected at GTWA pumping well B3, following purging.

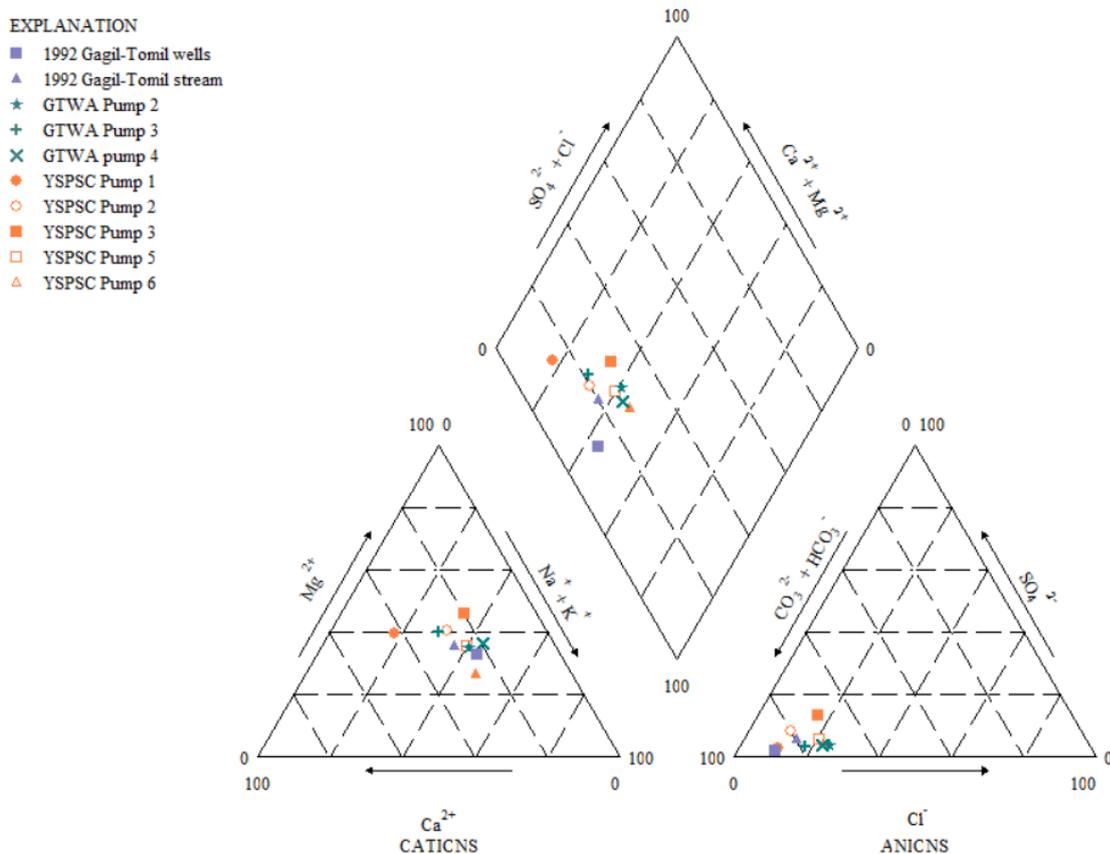
Figure 18. Characterisation of sampled groundwaters from Monguch and Eyeb valleys.

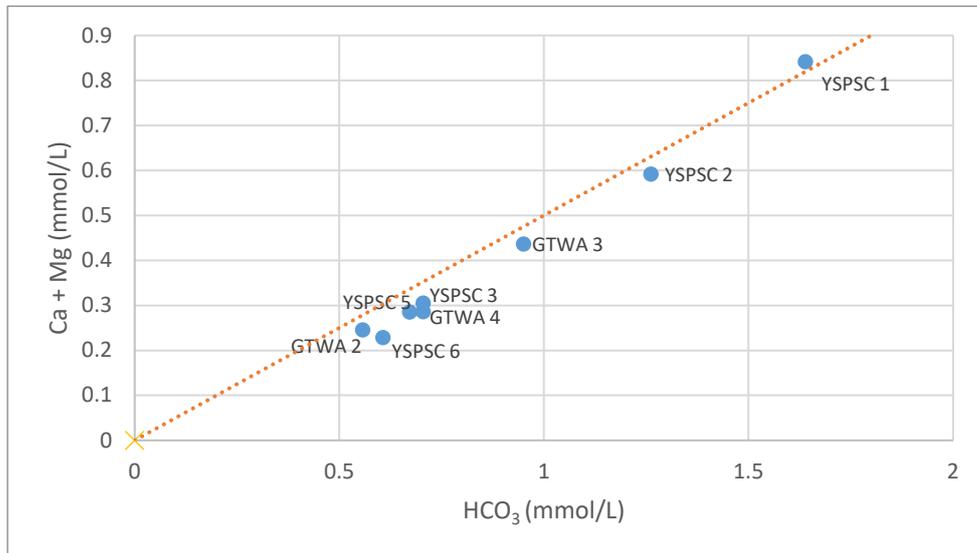
Figure 19. $Ca^{2+} + Mg^{2+}$ versus HCO_3^- concentrations in groundwater samples obtained from the pumping wells. The dashed line represents Ca-Mg-carbonate equilibrium for increasing CO_2 pressure.

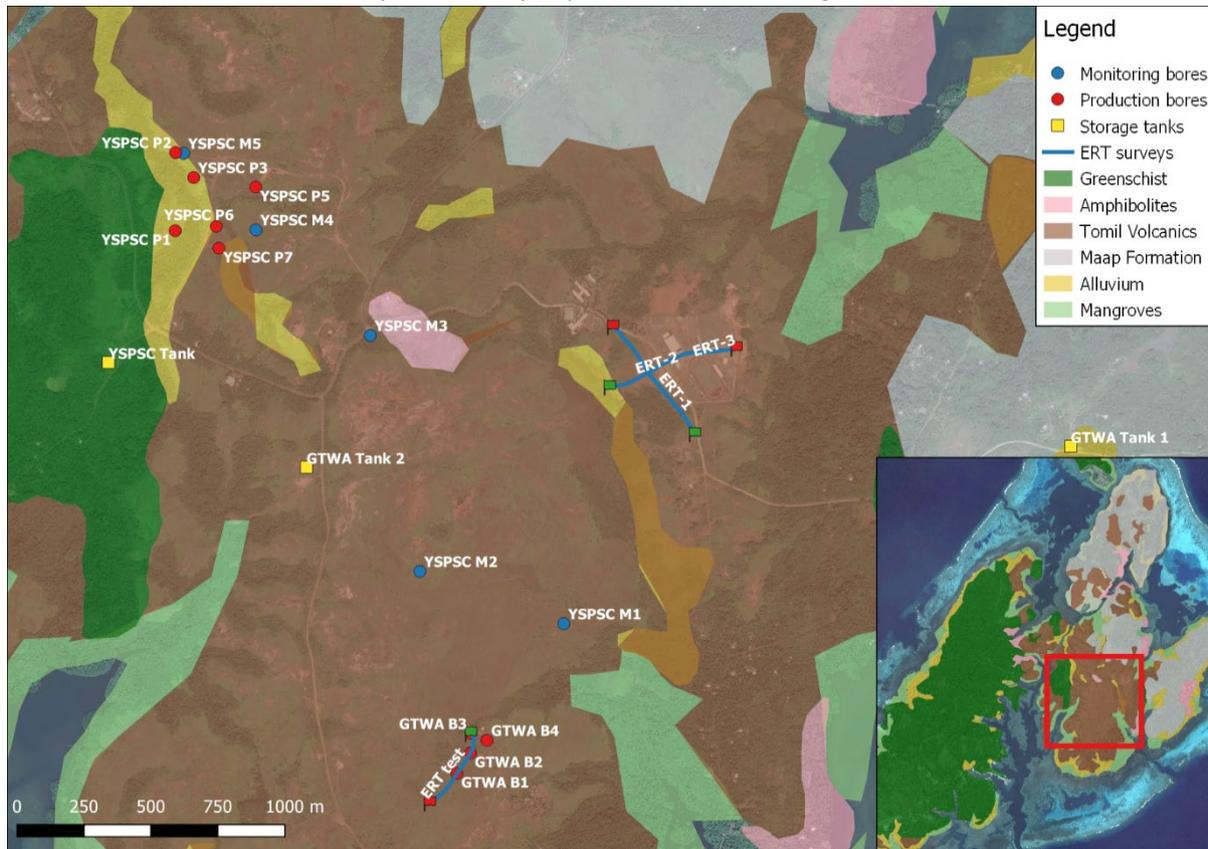
Figure 20. Location of the groundwater infrastructures and the electrical resistivity tomography survey lines superimposed onto the geological framework. Red box indicates the location of the study area.

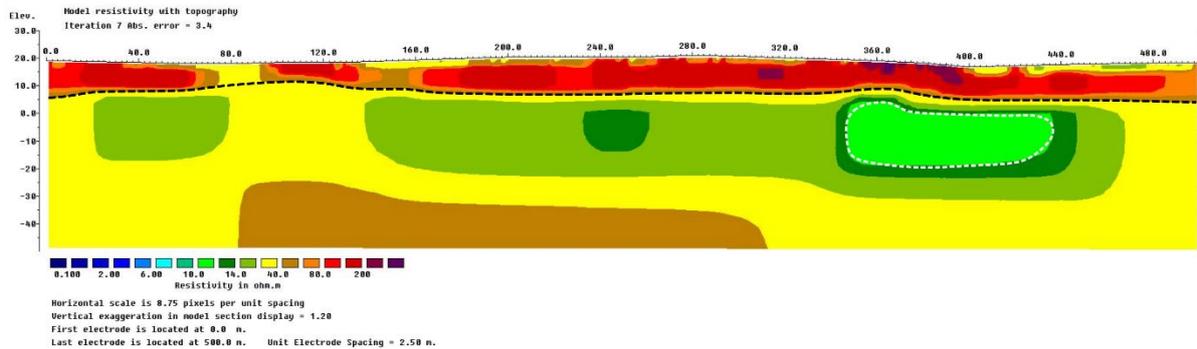
Figure 21. Electrical resistivity tomography survey line 1, illustrating the depth to the top of the Tomil Volcanics (black dashed line) and a potential drilling site for groundwater development (white dashed line).

1. a highly resistive 5–10 m thick zone on top, indicating low permeability laterite soil;
2. a thick zone of low to medium resistivity interpreted as fractured and/or weathered volcanic breccia, and expected to yield groundwater; and
3. a medium resistivity (40–80 Ohm.m) zone at depth, suggesting the presence of less weathered volcanics or of the low permeability Yap Formation (i.e. the greenschist basement).

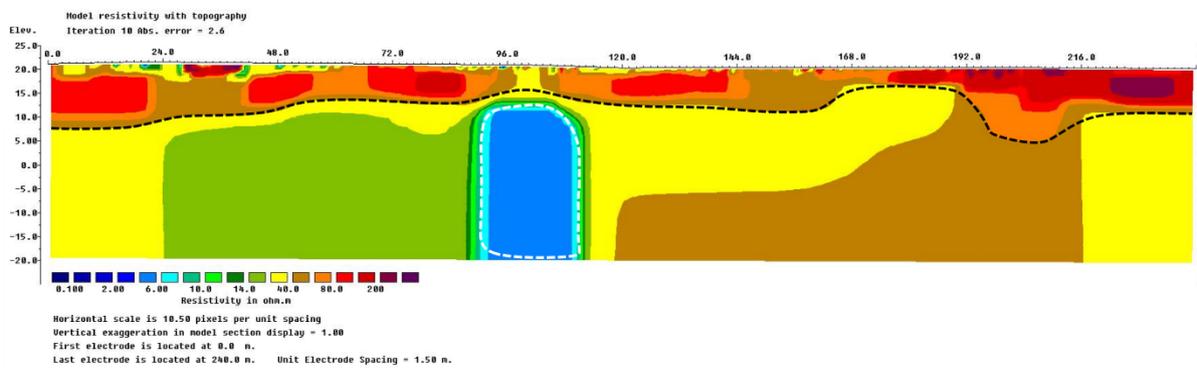
Figure 22. Electrical resistivity tomography survey line 3, illustrating the depth to the top of the Tomil Volcanics (black dashed line) and a potential drilling site for groundwater development (white dashed line).

deposits with moderate groundwater development potential. An interesting low-resistivity vertical feature was identified at 90–115 m distance along survey line 3, possibly suggesting the presence of a highly fractured zone in the volcanic deposits that is likely to be saturated with groundwater. This feature was interpreted as another potential drill target for groundwater development.

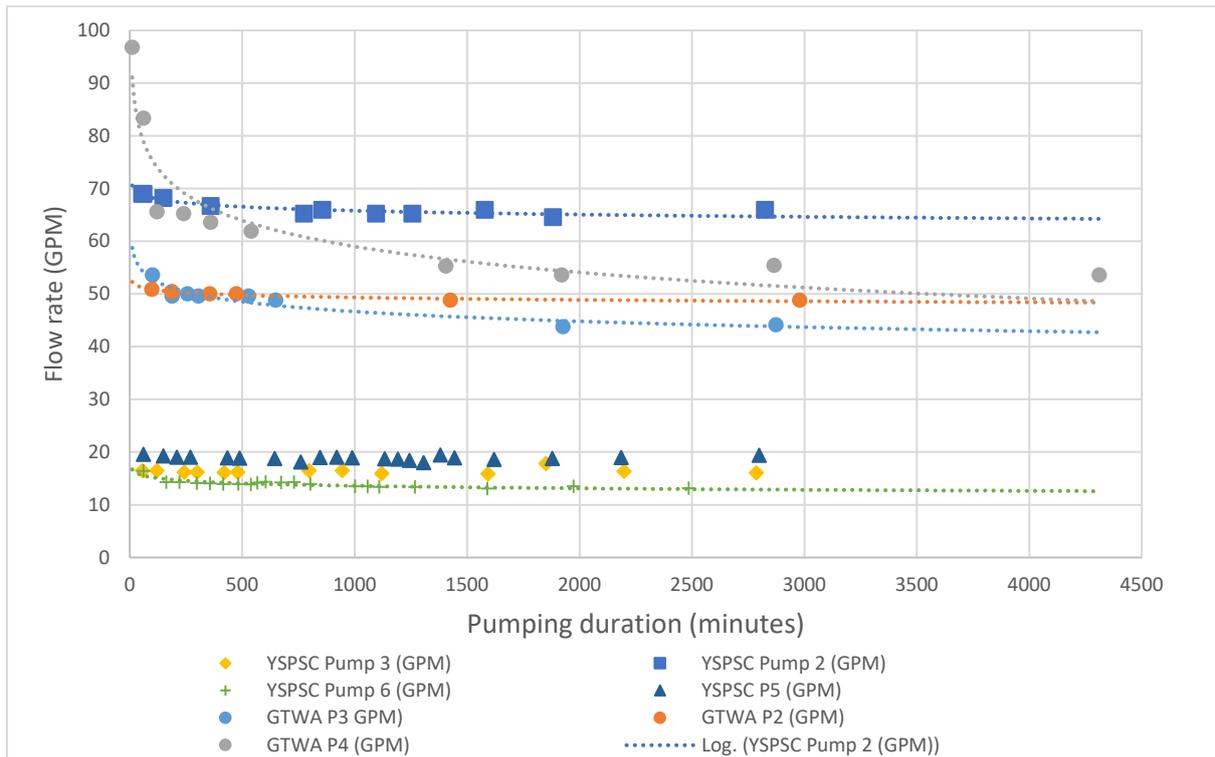
Figure 24. Variability in discharge rates (Q) recorded in pumping wells.

- Variations in pumping rates (Q) were observed in all the wells and in most cases pumps were observed to be decreasing in yield, which does not satisfy the assumption of a constant rate of pumping. This is probably attributed to the discharge from the pumping wells into the distribution pipe network and to storages, rather than to outflow unrestricted from the pump. Discharge (Q) was observed to be the highest during the early pumping stages, when the distribution line and the storage tanks were empty and pressure was low, allowing the pumps to operate at near maximum yield with relatively free water flow. As pumping continues and all wells contribute water into the piping network, pressure builds up in the pipes, resulting in reduced flow and forcing the pump impellers to adjust to the new pressure condition.

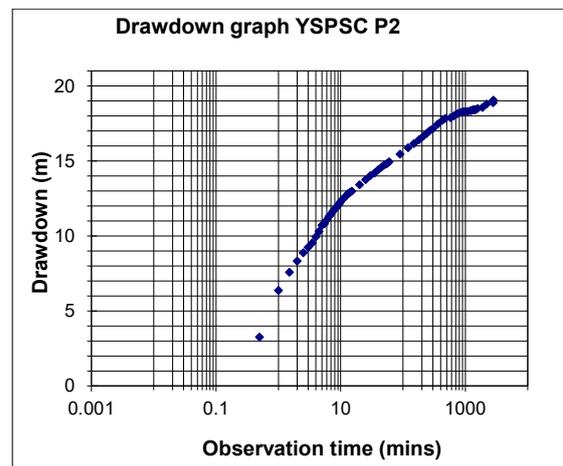
Figure 2. YSPSC well P2 semi-log drawdown graph.

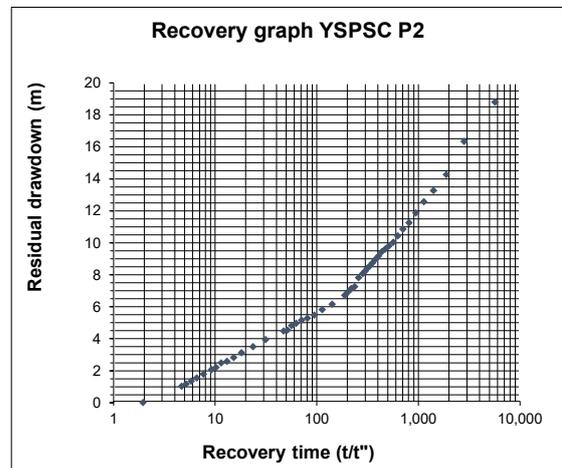
Figure 3. YSPSC pumping well P2 semi-log recovery graph.

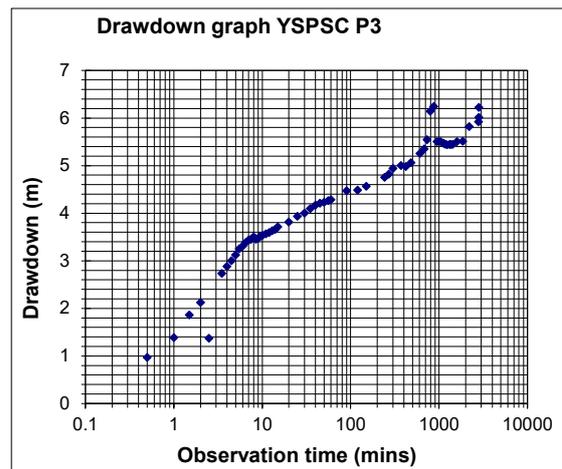
Figure 4. YSPSC pumping well P3 semi-log drawdown graph.

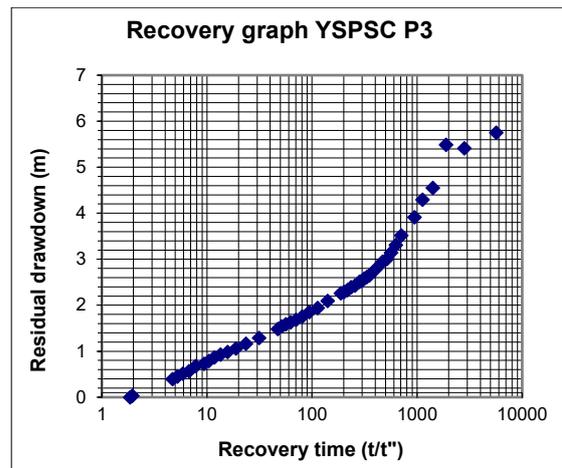
Figure 5. Semi-log recovery graph for YSPSC pumping well P3.

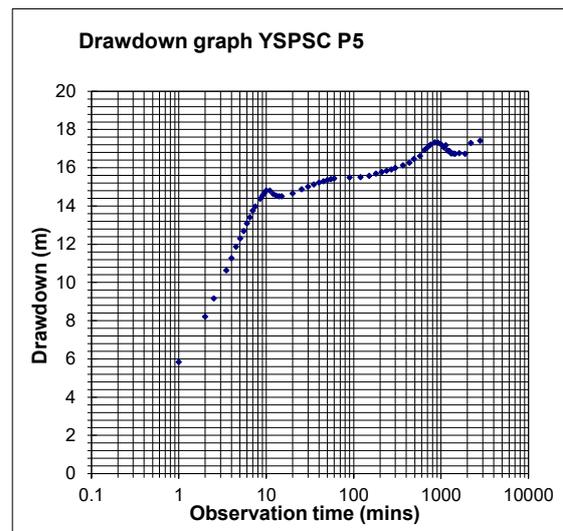
Figure 6. YSPSC pump 5 semi-log drawdown graph.

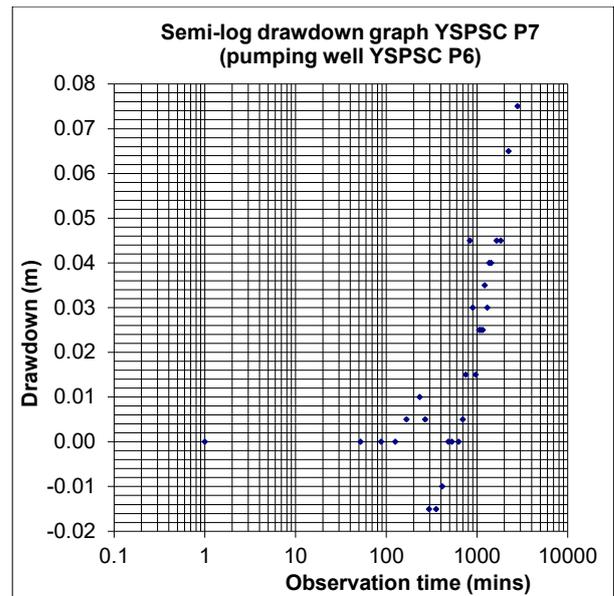
Figure 10. YSPSC pump 7 semi-log drawdown graph, which was used as an additional monitoring bores due to non-operation but data was erroneous.

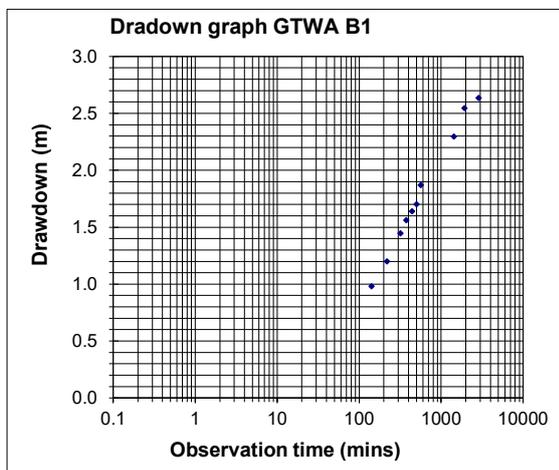
Figure 11. GTWA B1 semi-log drawdown graph.

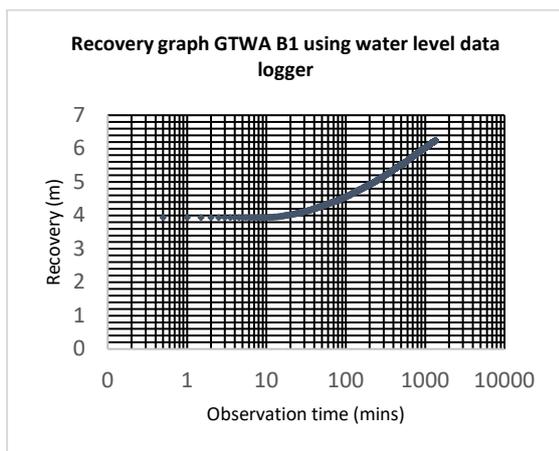
Figure 12. GTWA B1 semi-log recovery graph based on water level logger readings.

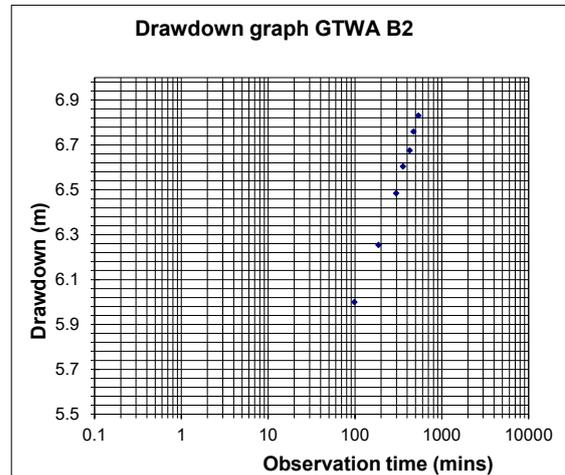
Figure 13. GTWA B2 semi-log graph.

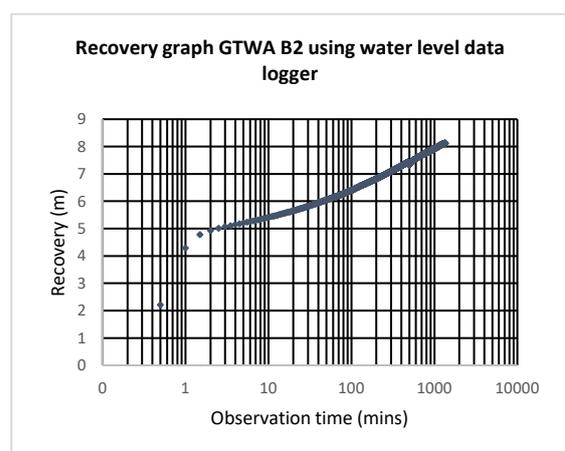
Figure 14. GTWA B2 semi-log recovery graph using water level data loggers.

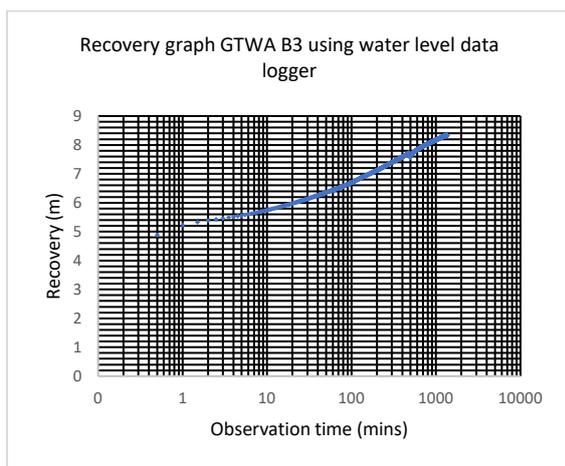
Figure 16. GTWA B3 semi-log recovery graph using water level data loggers.

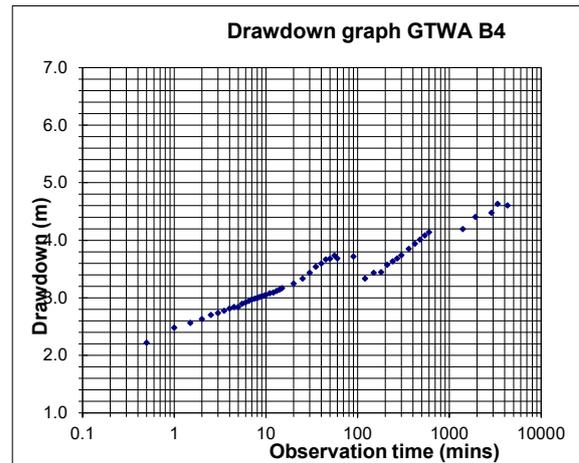
Figure 17. GTWA B4 semi-log drawdown curve.
