Groundwater Resources Assessment: Gagil-Tomil, Yap State, Federated States of Micronesia

Aminisitai Loco, Andreas Antoniou, Anesh Kumar, Nicholas Metherall,
Peter Sinclair

North Pacific – Readiness for El Niño (RENI) project

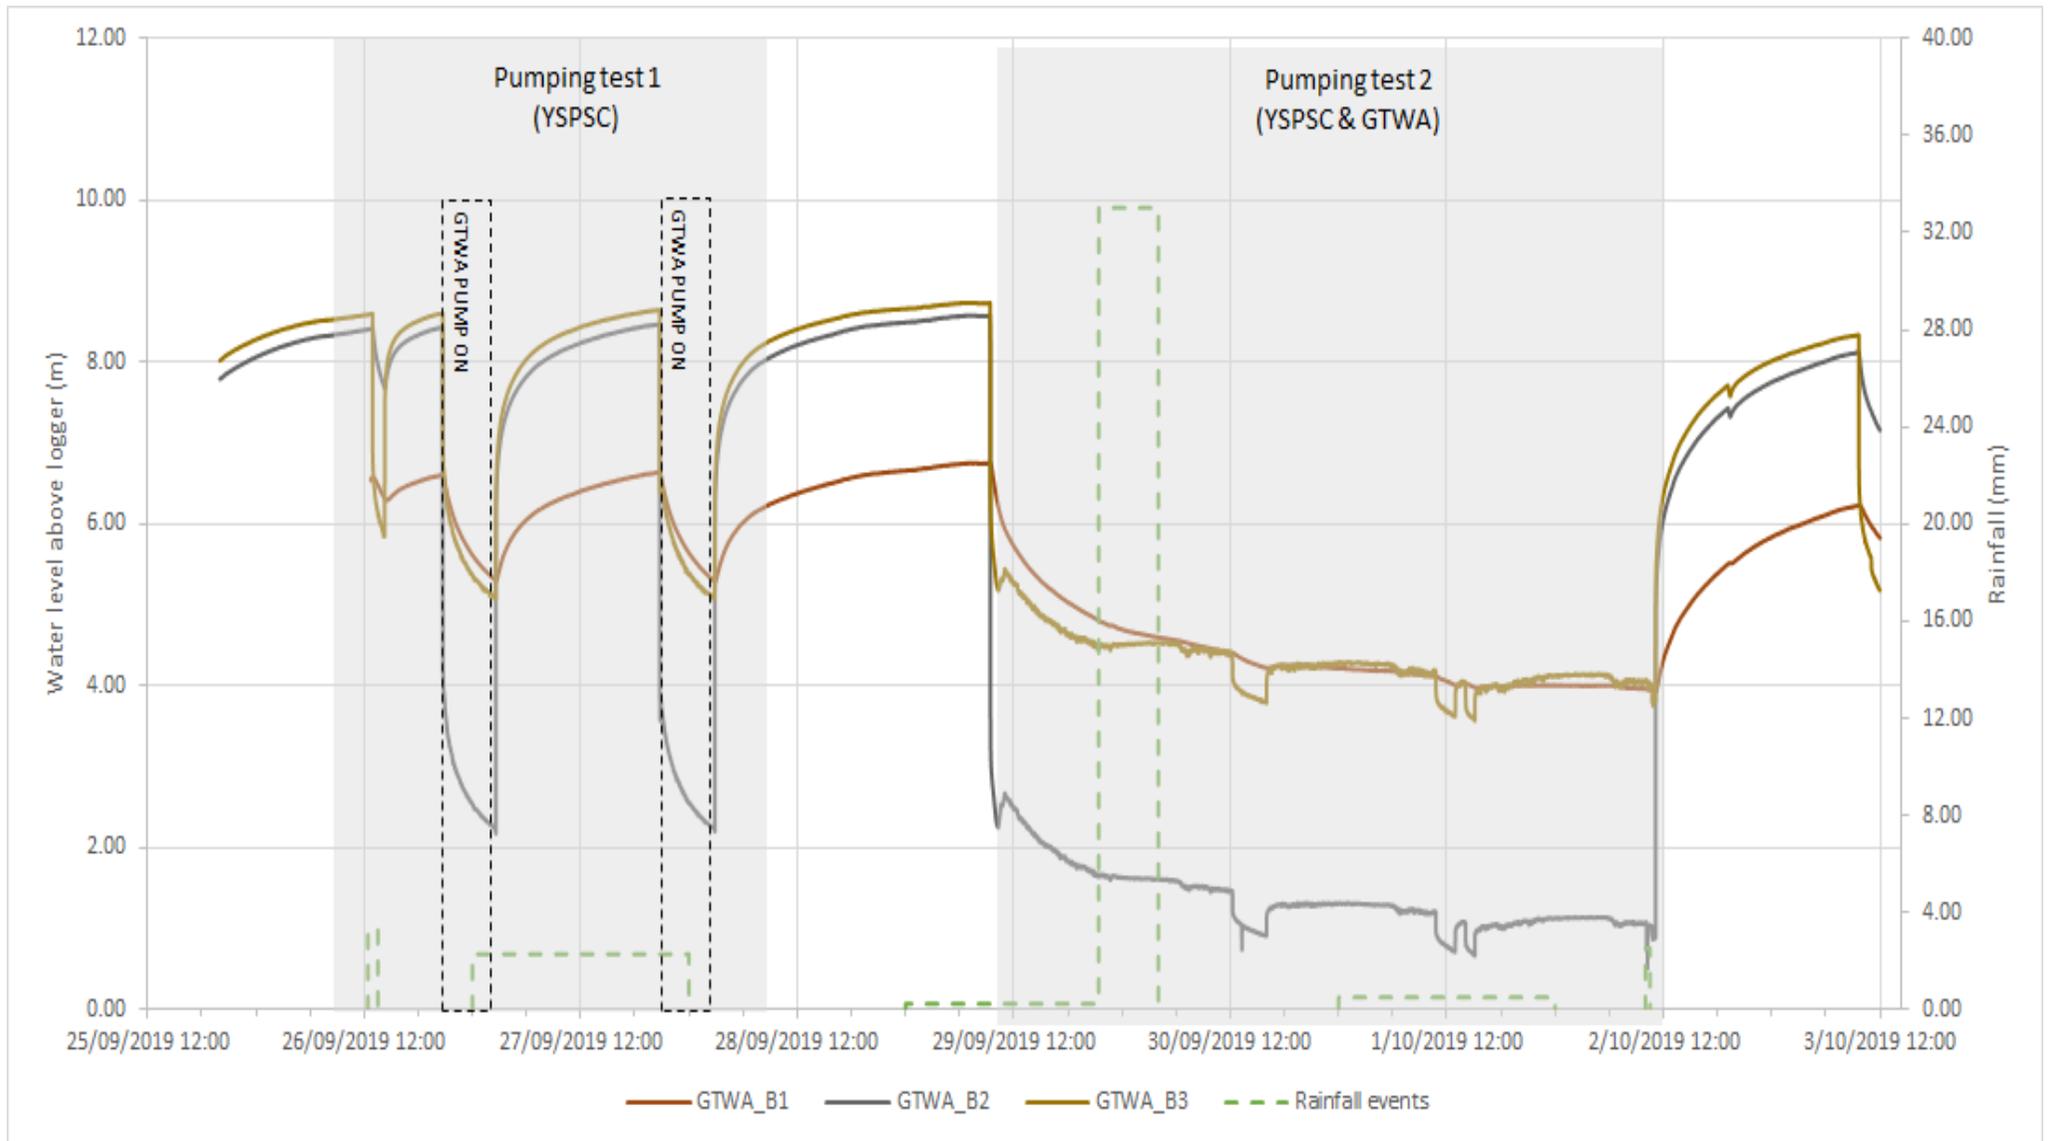
Figure 19. Logger data in GTWA production bores B1, B2, B3, during pumping tests. Note B1 is non-operational, B2, and B3 were pumped for 6 hours per night during the YSPSC 48-hour pumping test.

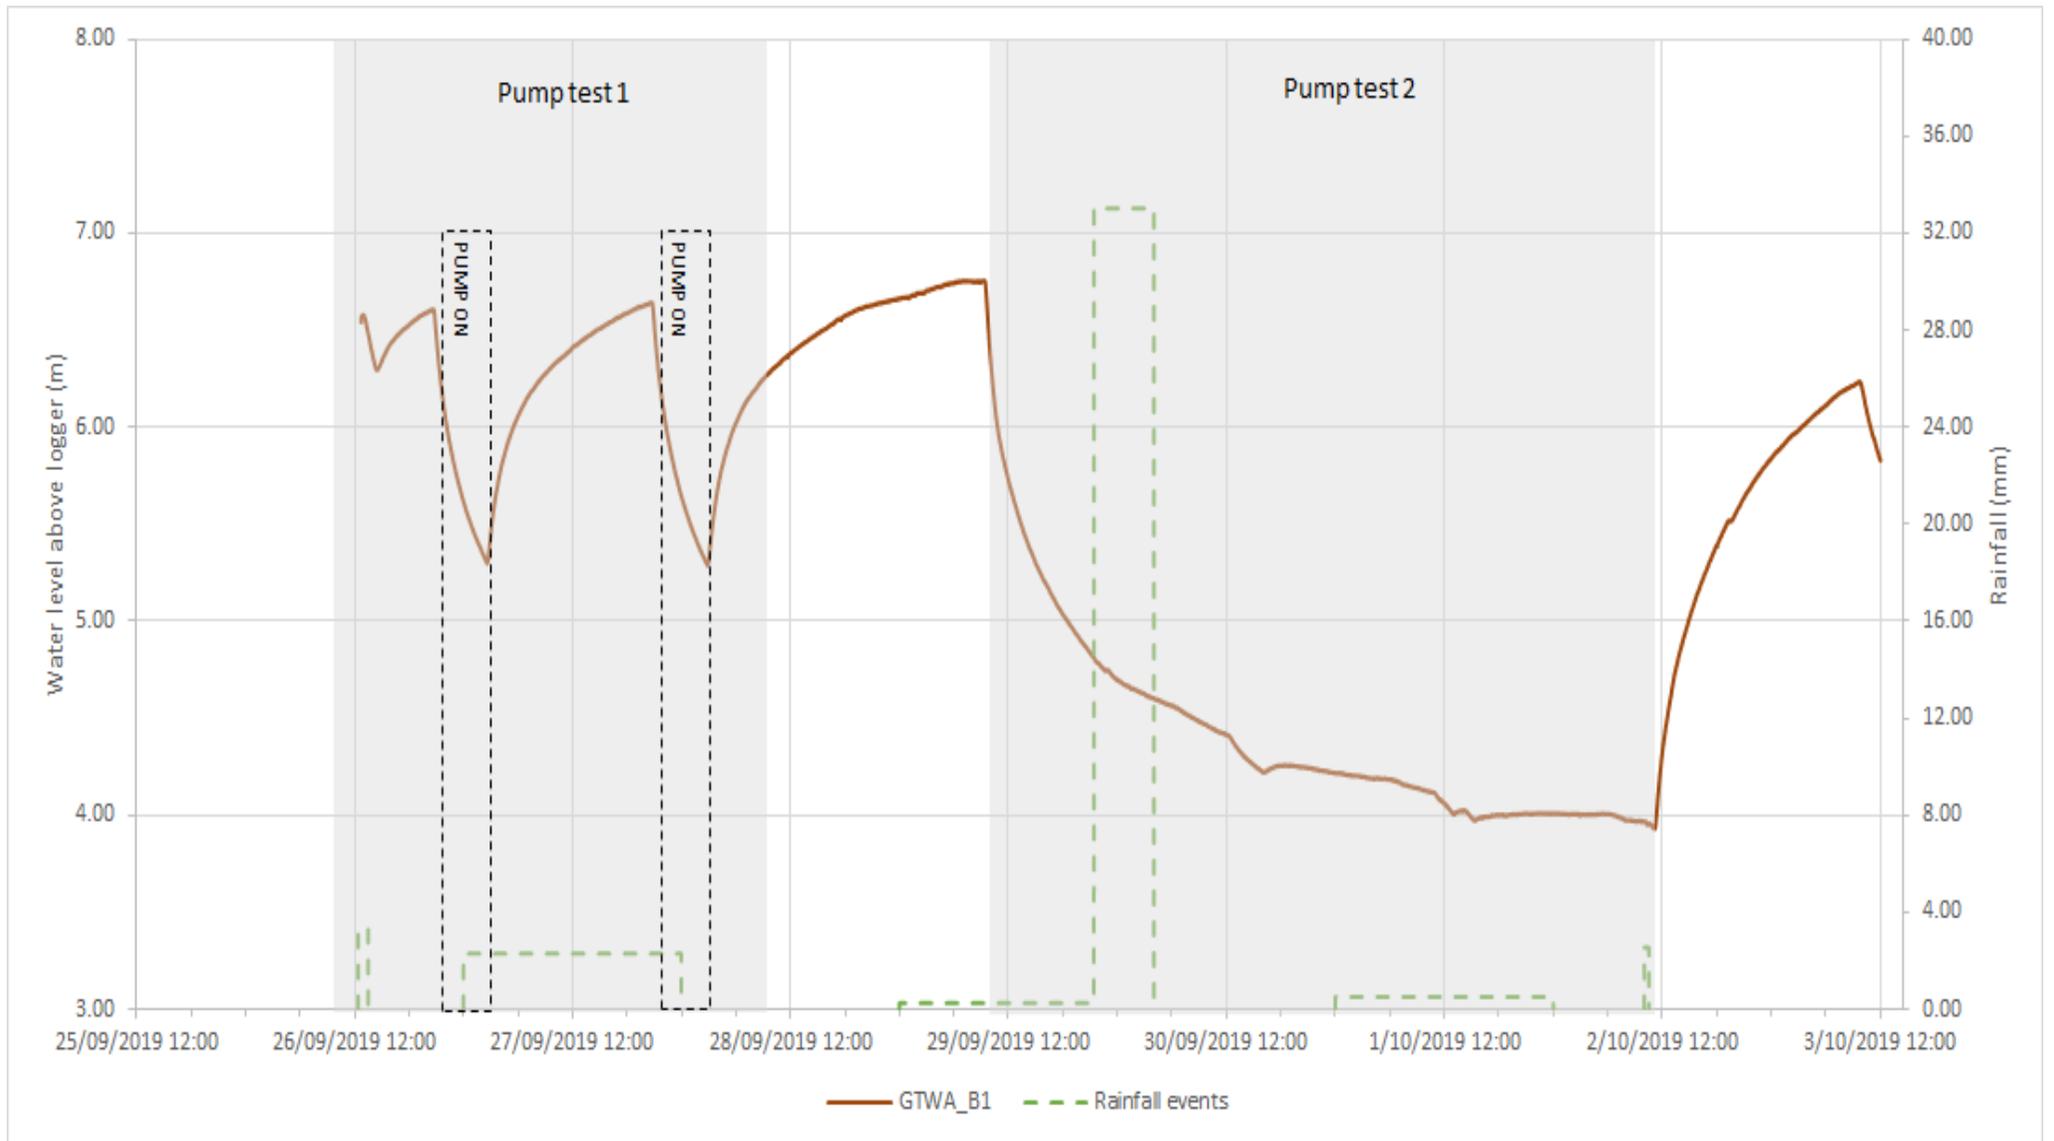
Figure 20. GTWA B1 water level response during pumping tests. B1 is non-operational and responds to pumping from B2 and B3.

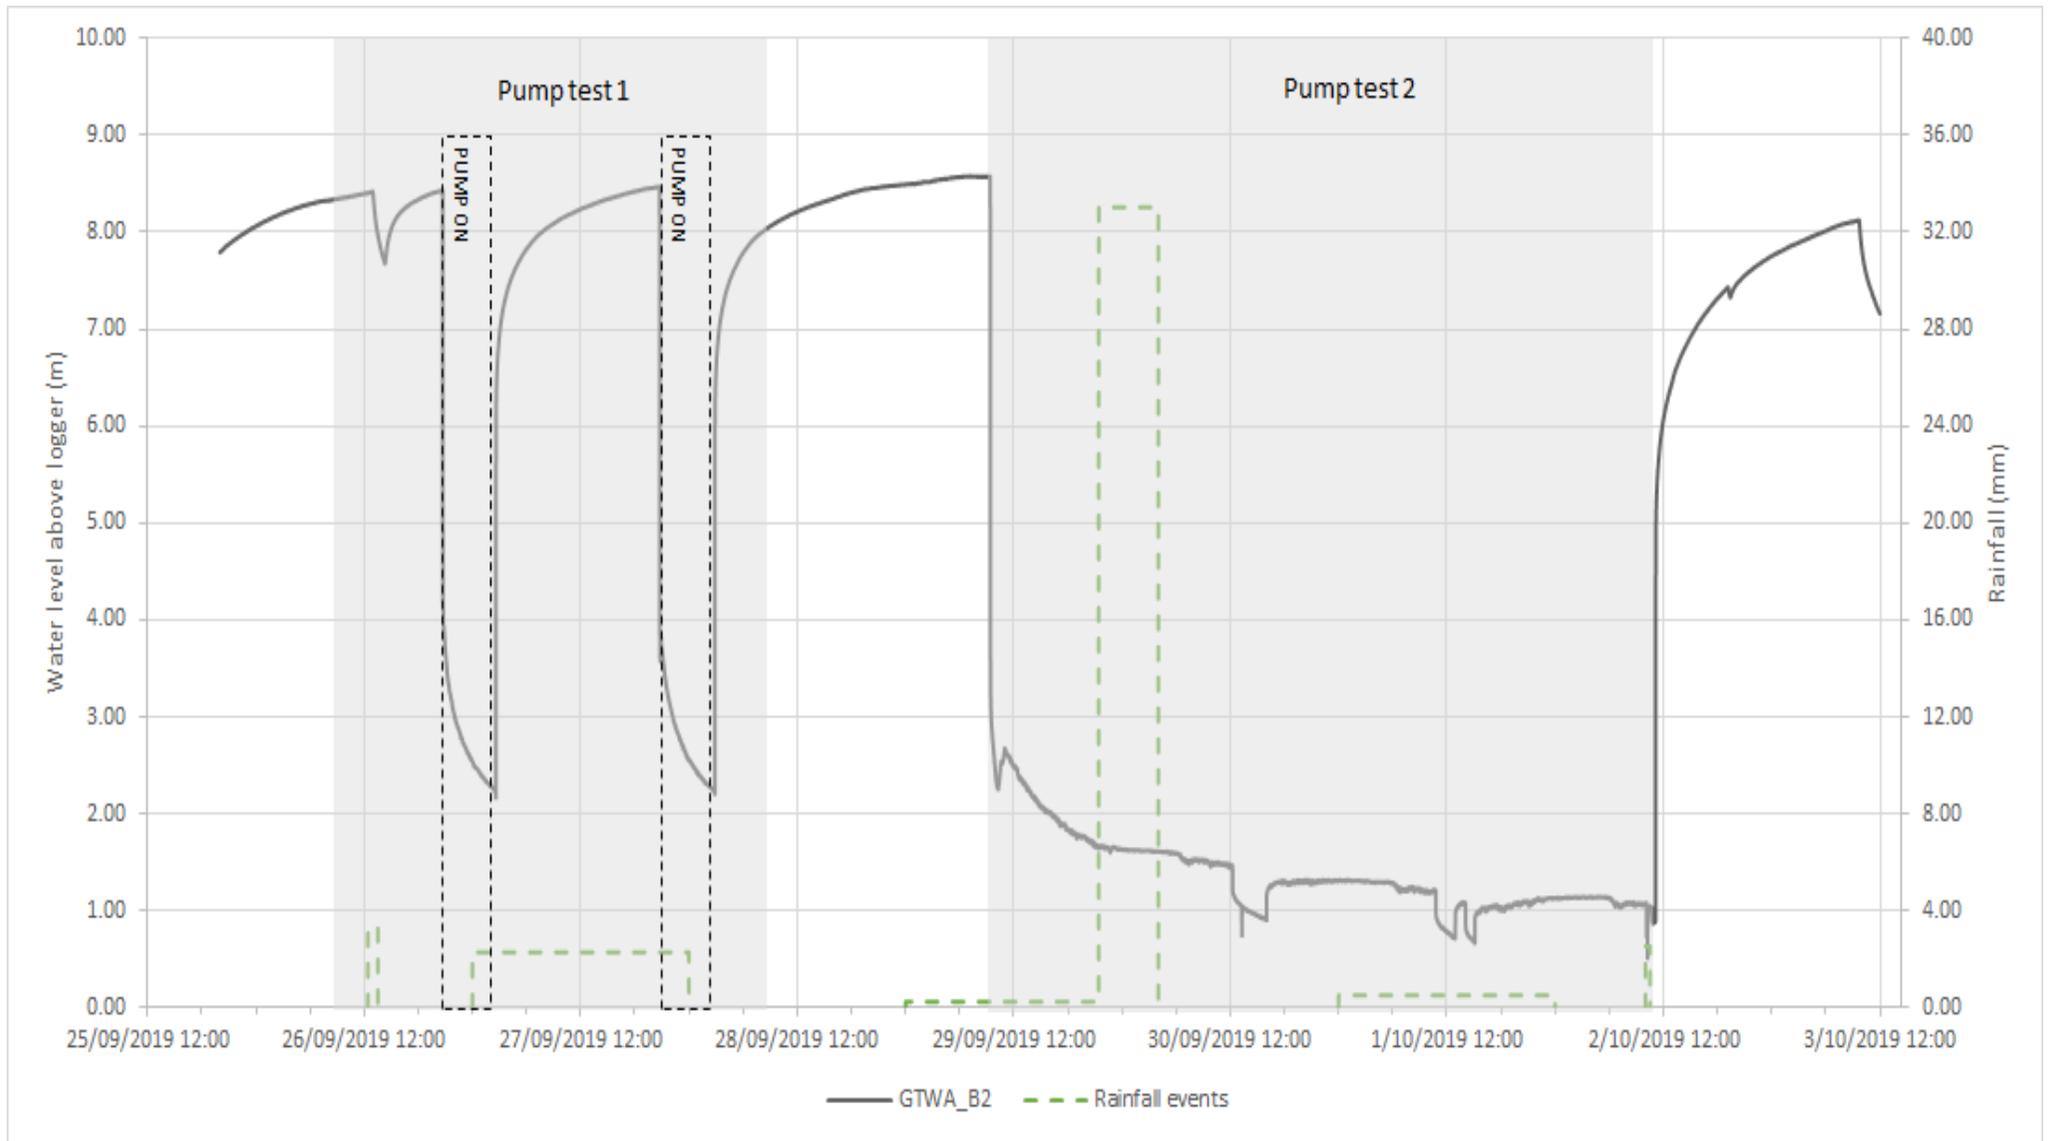
Figure 21. GTWA B2 water level response during pumping tests.

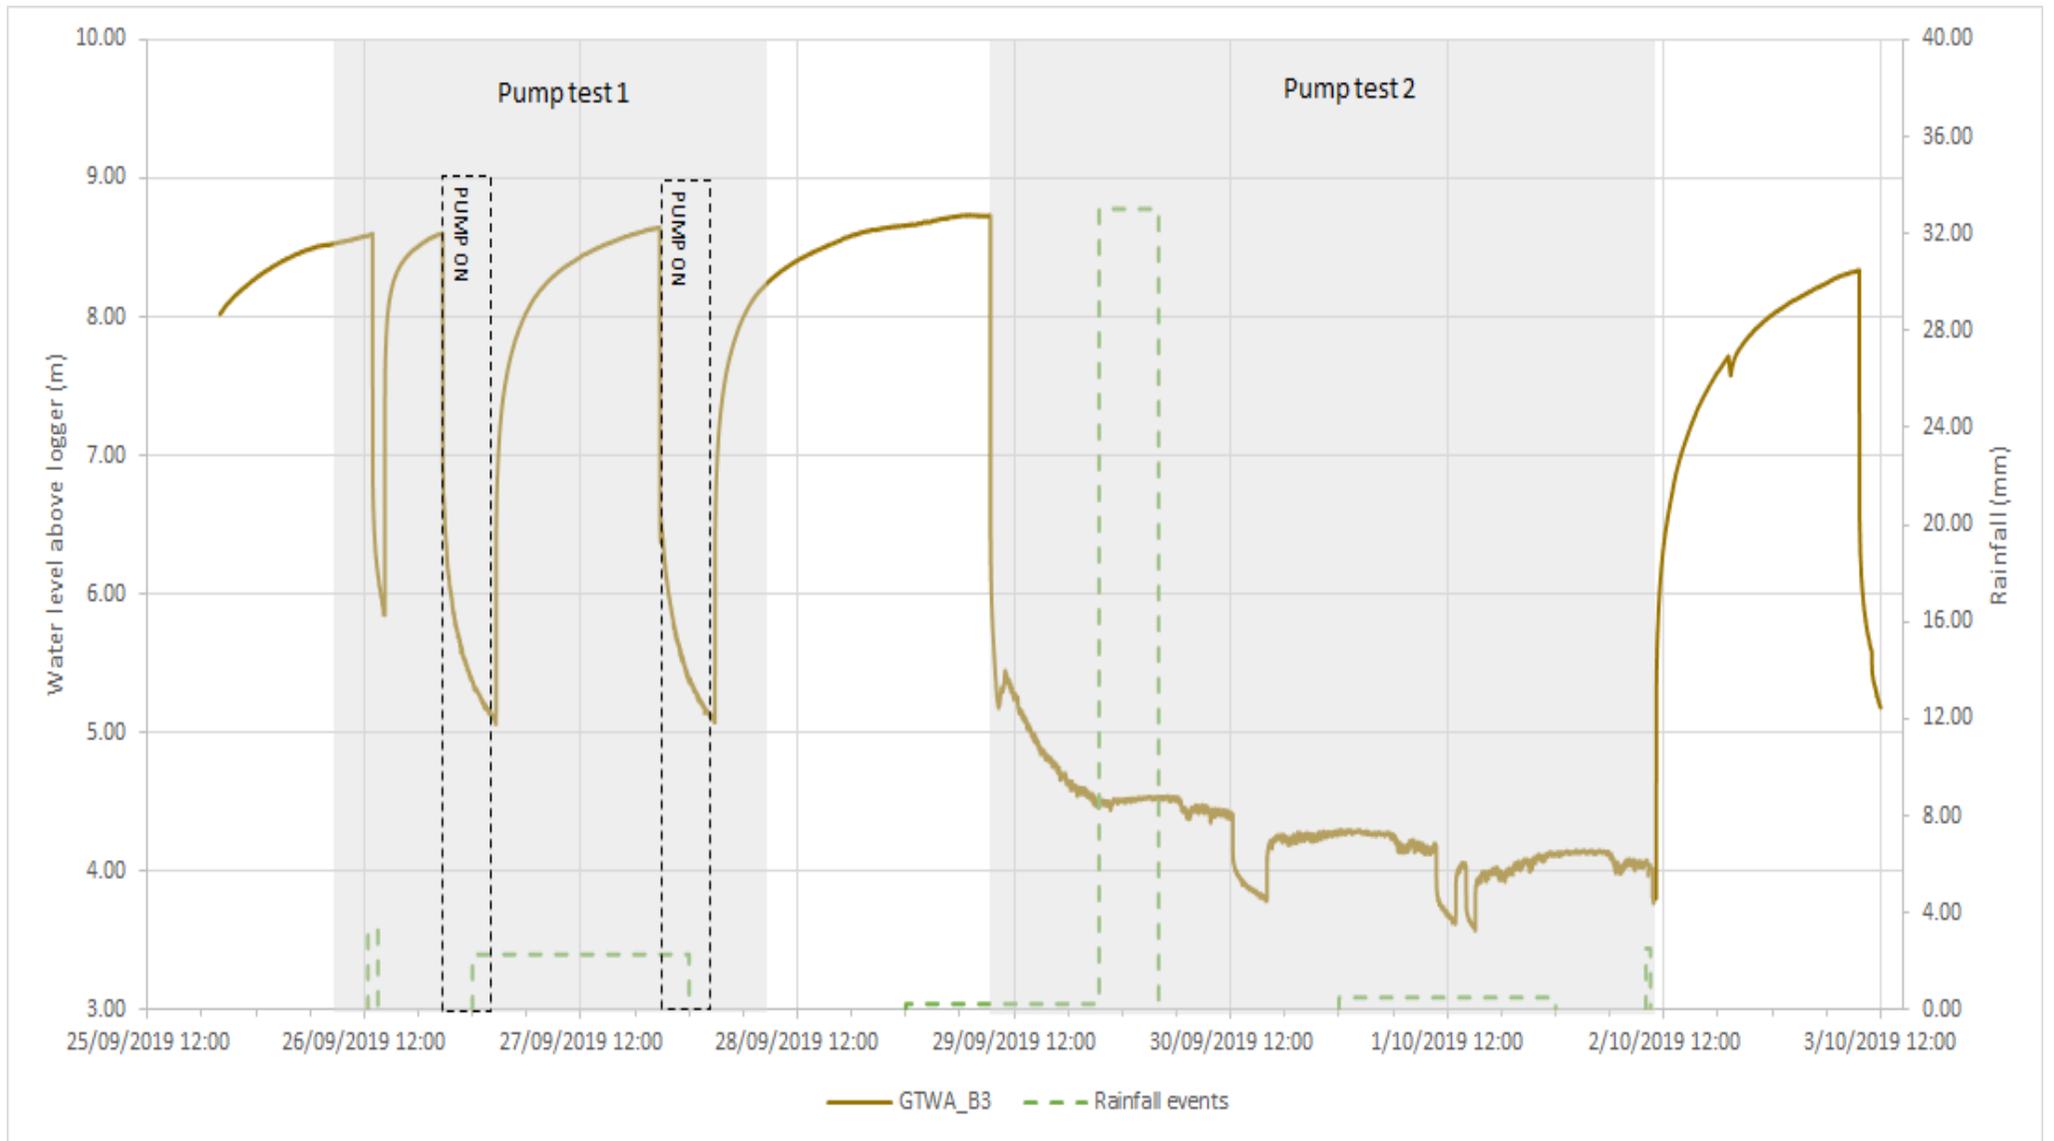
Figure 22. GTWA B3 water level response during pumping tests.

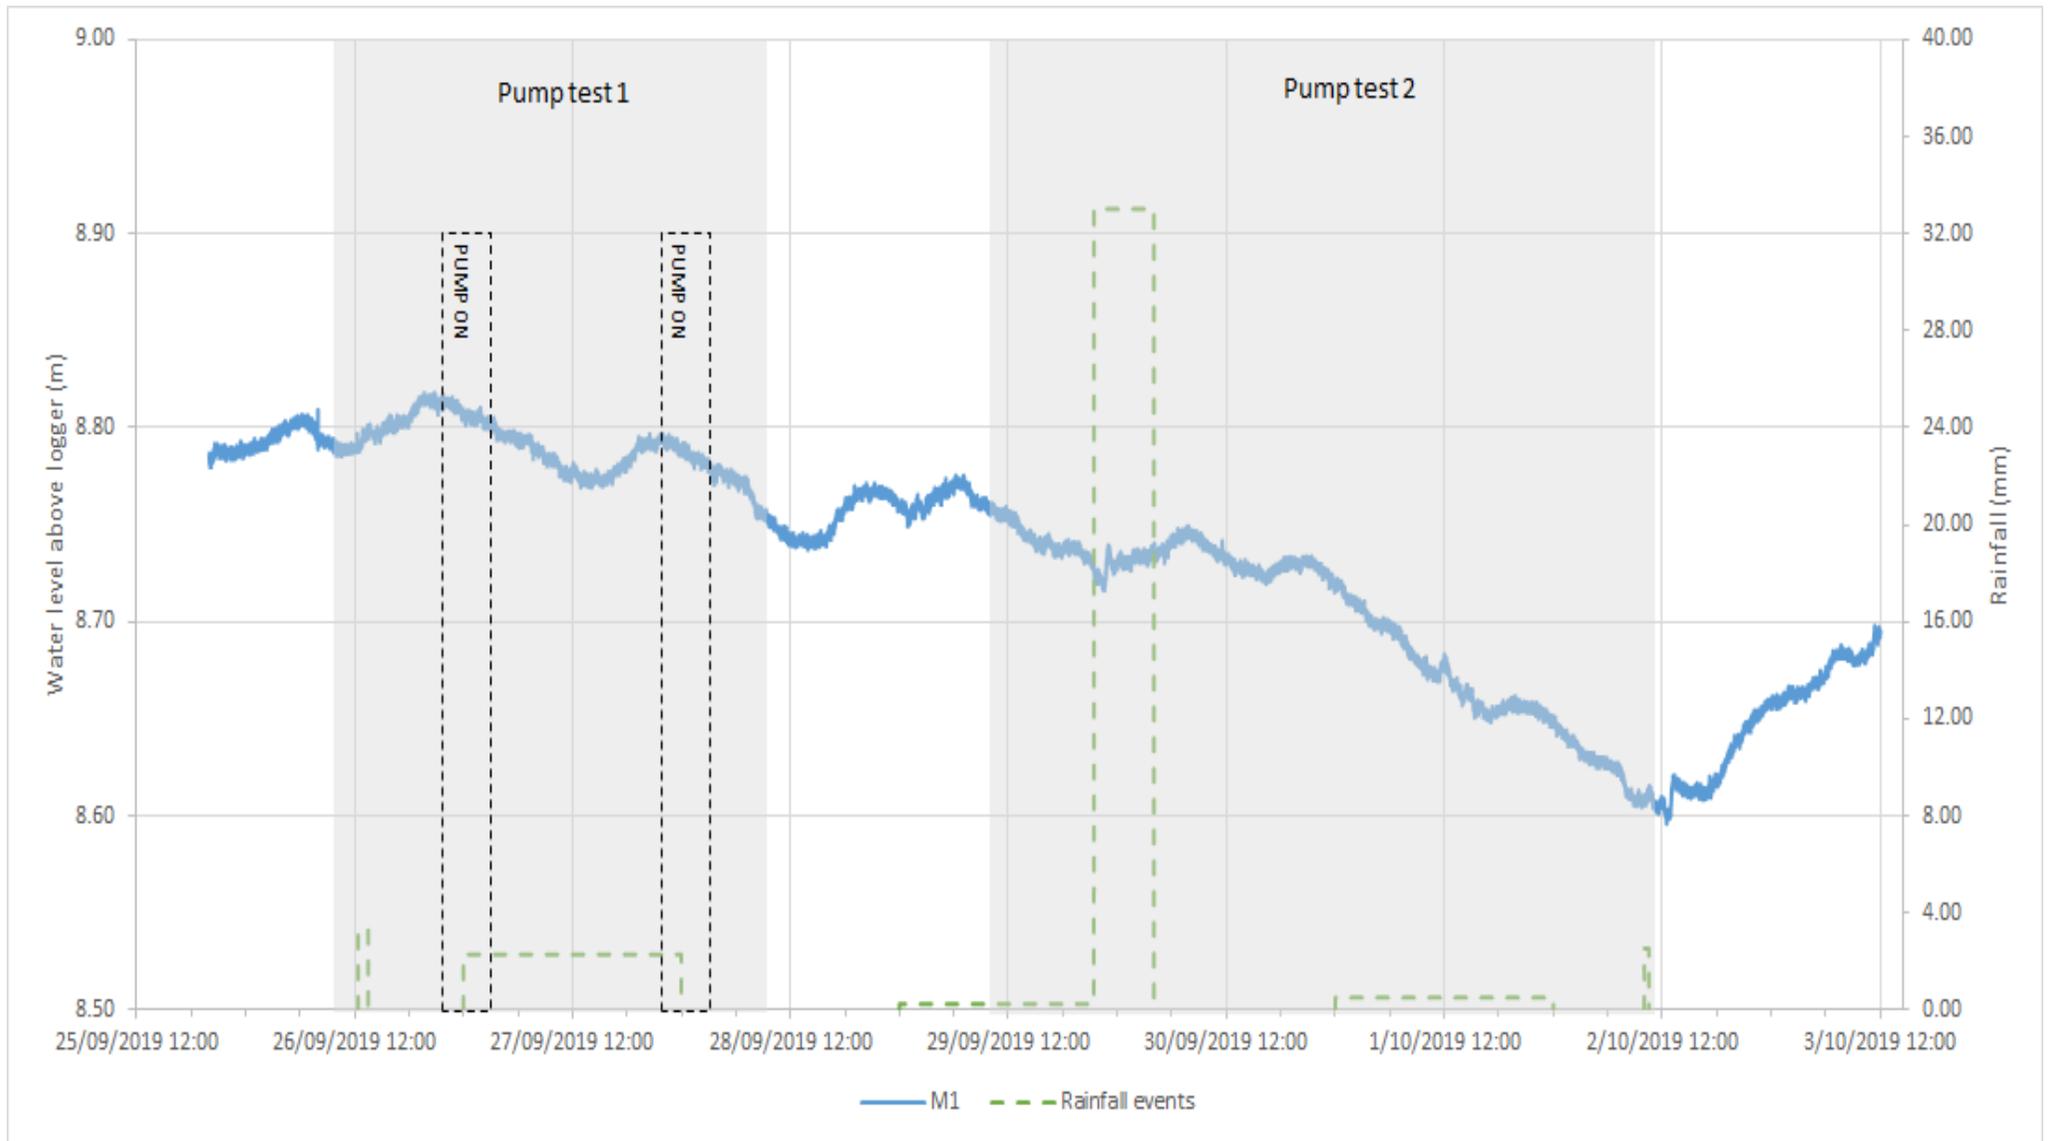
Figure 23. YSPSC M1 water level response during pumping tests.

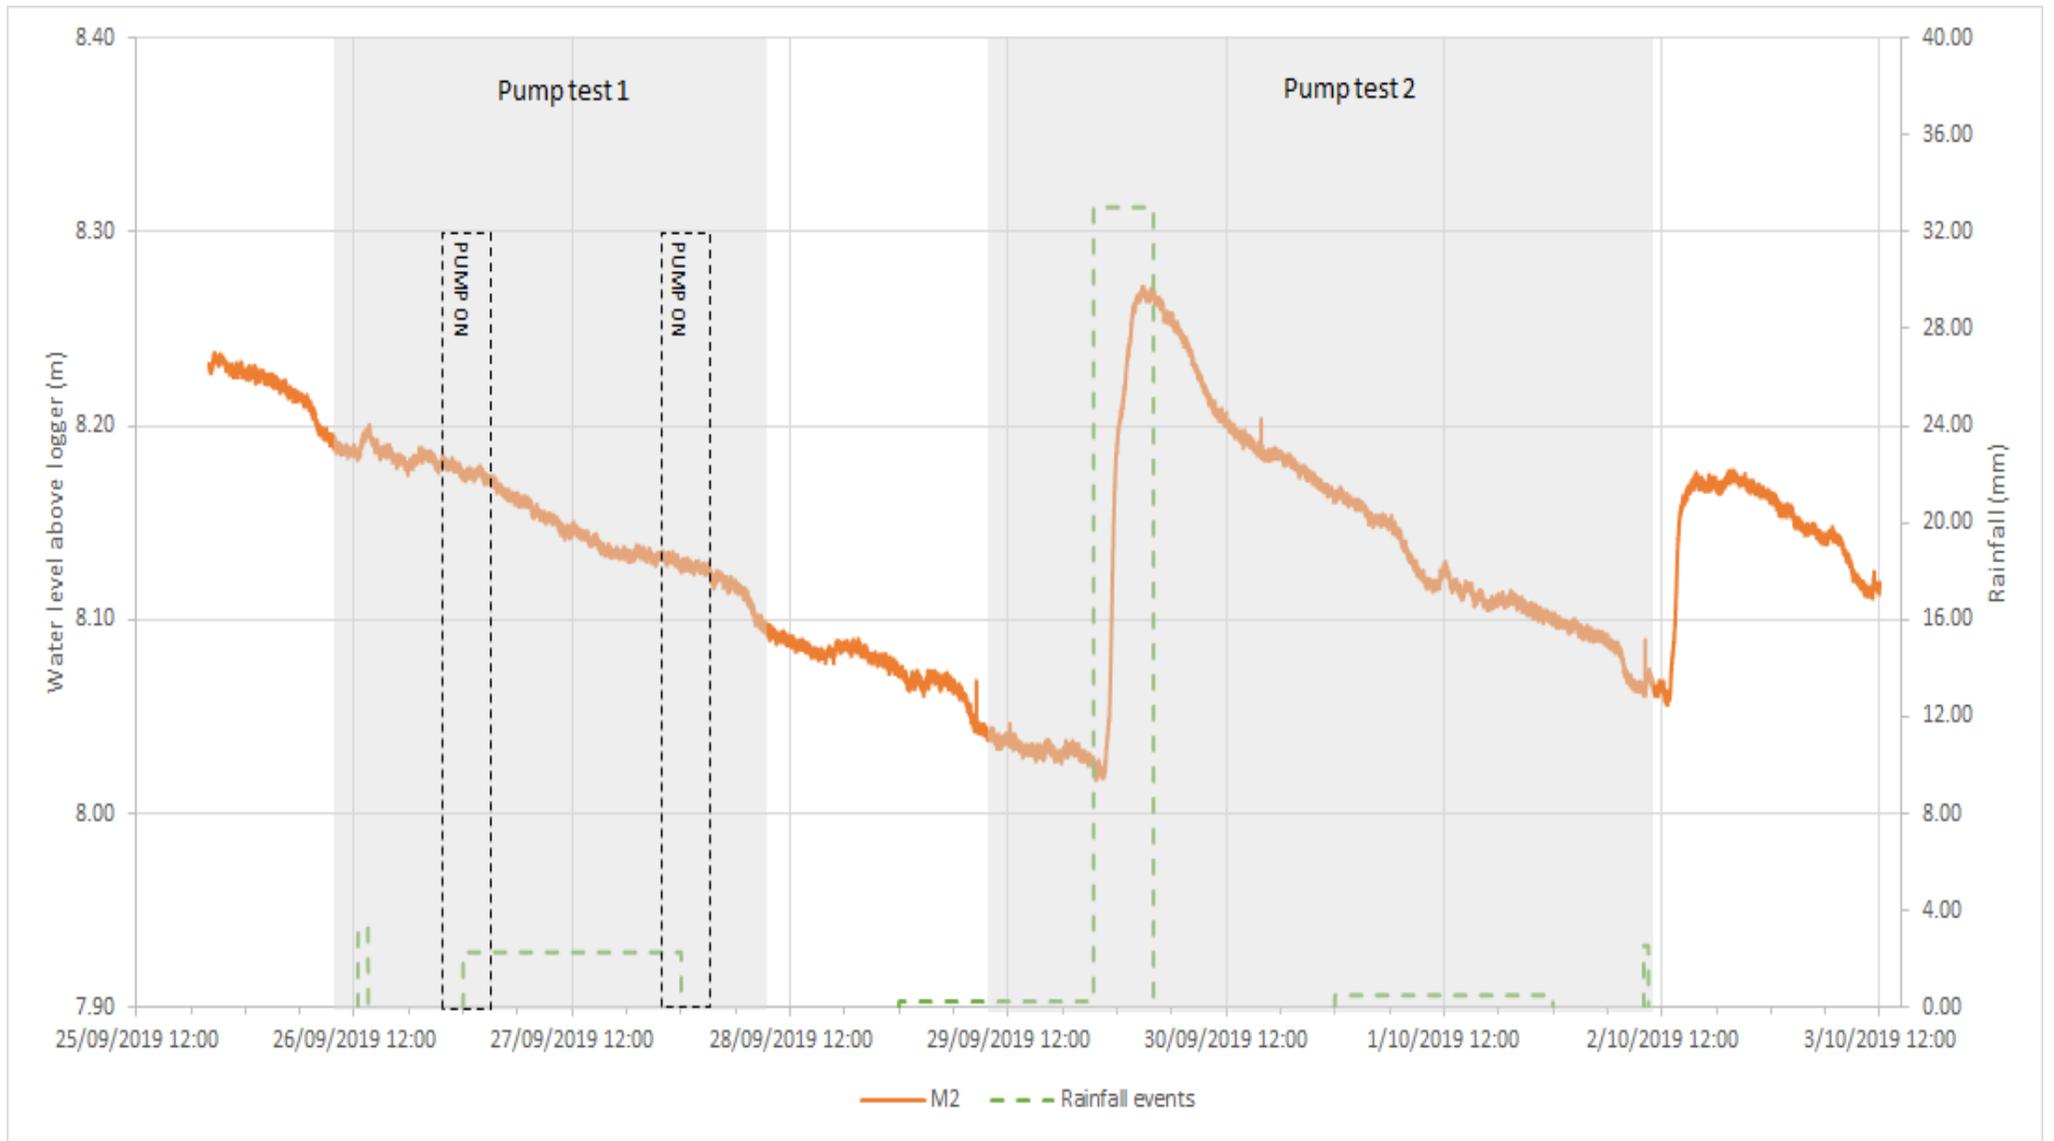
Figure 24. YSPSC M2 water level response during pumping tests.

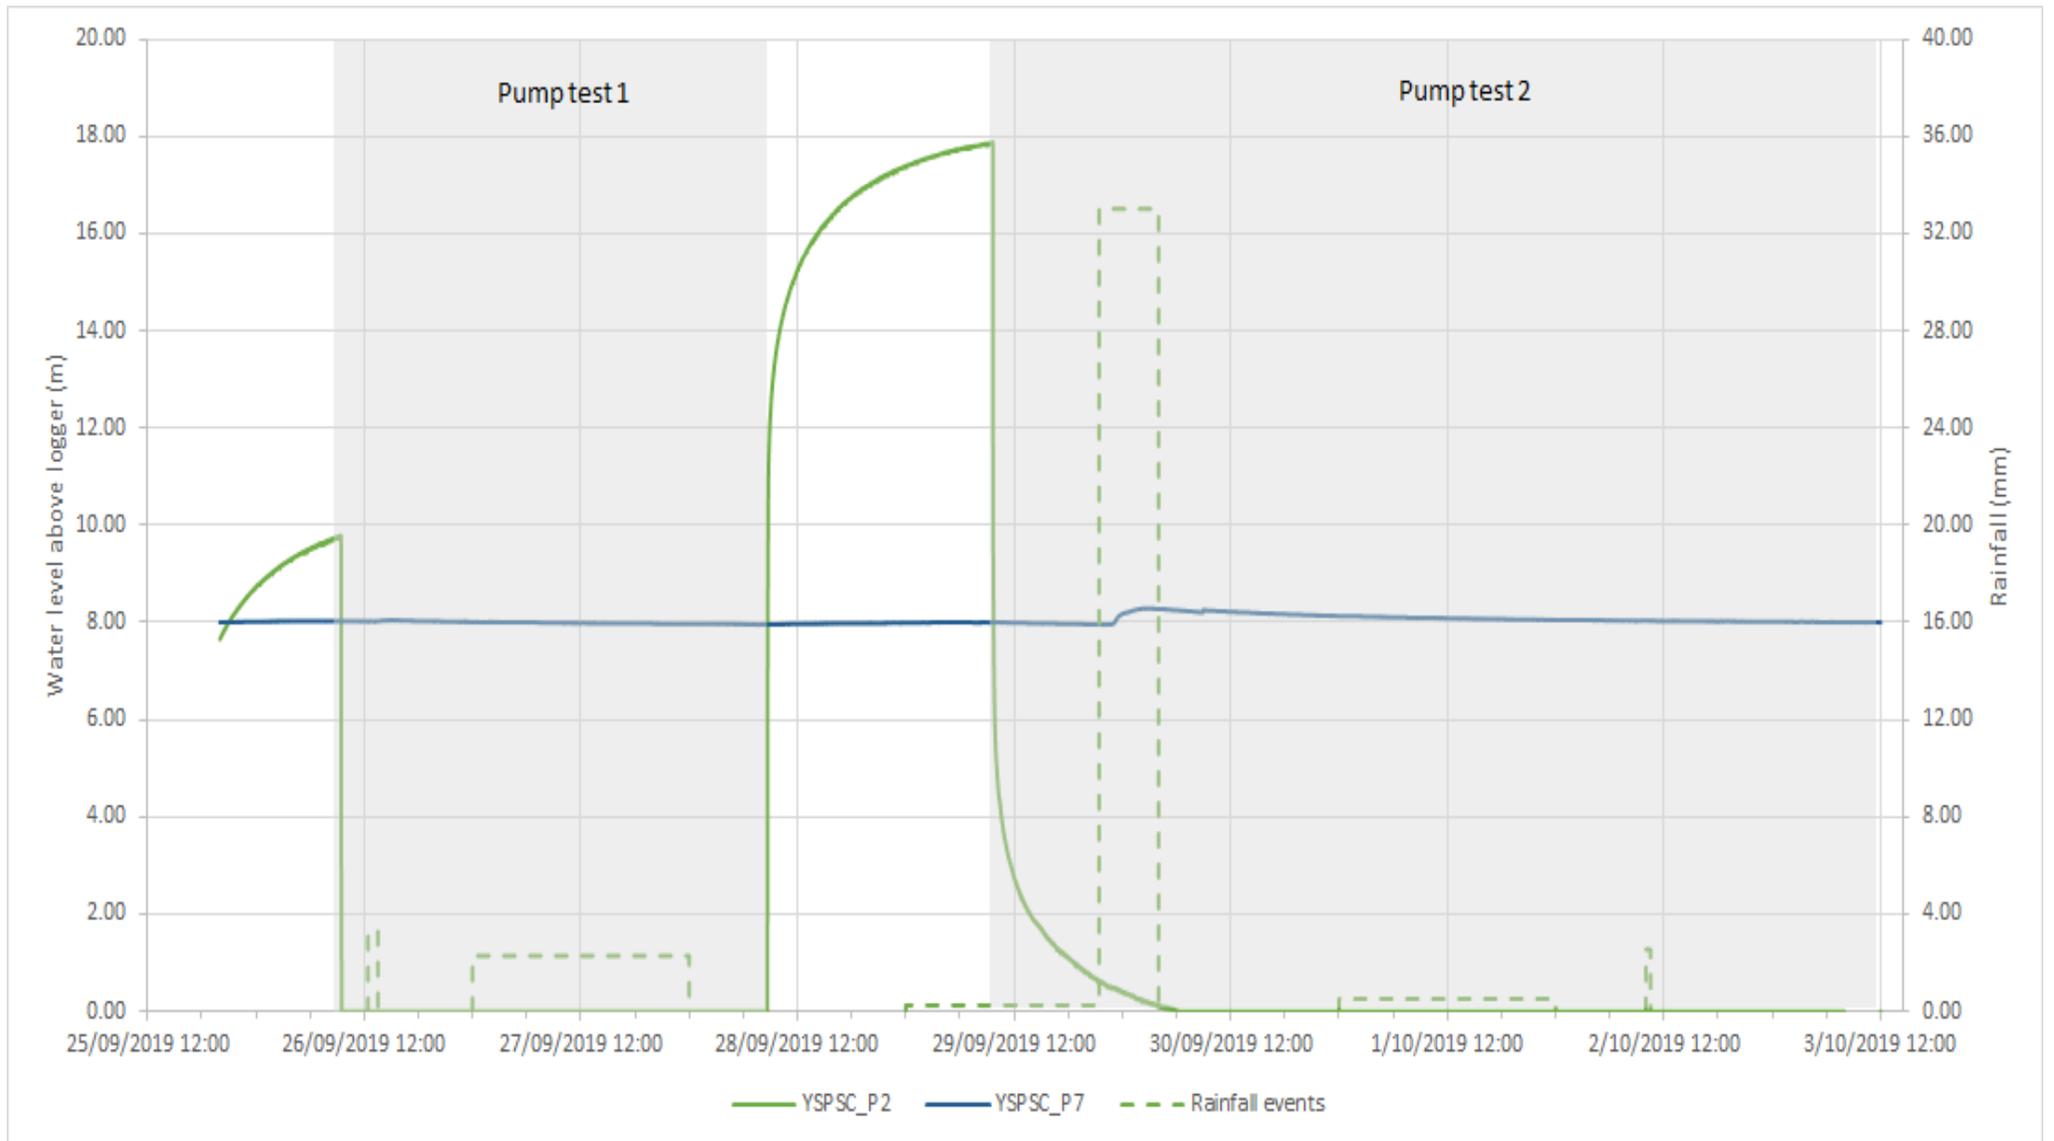
Figure 25. YSPSC P2 and P7 water level response during pumping tests.

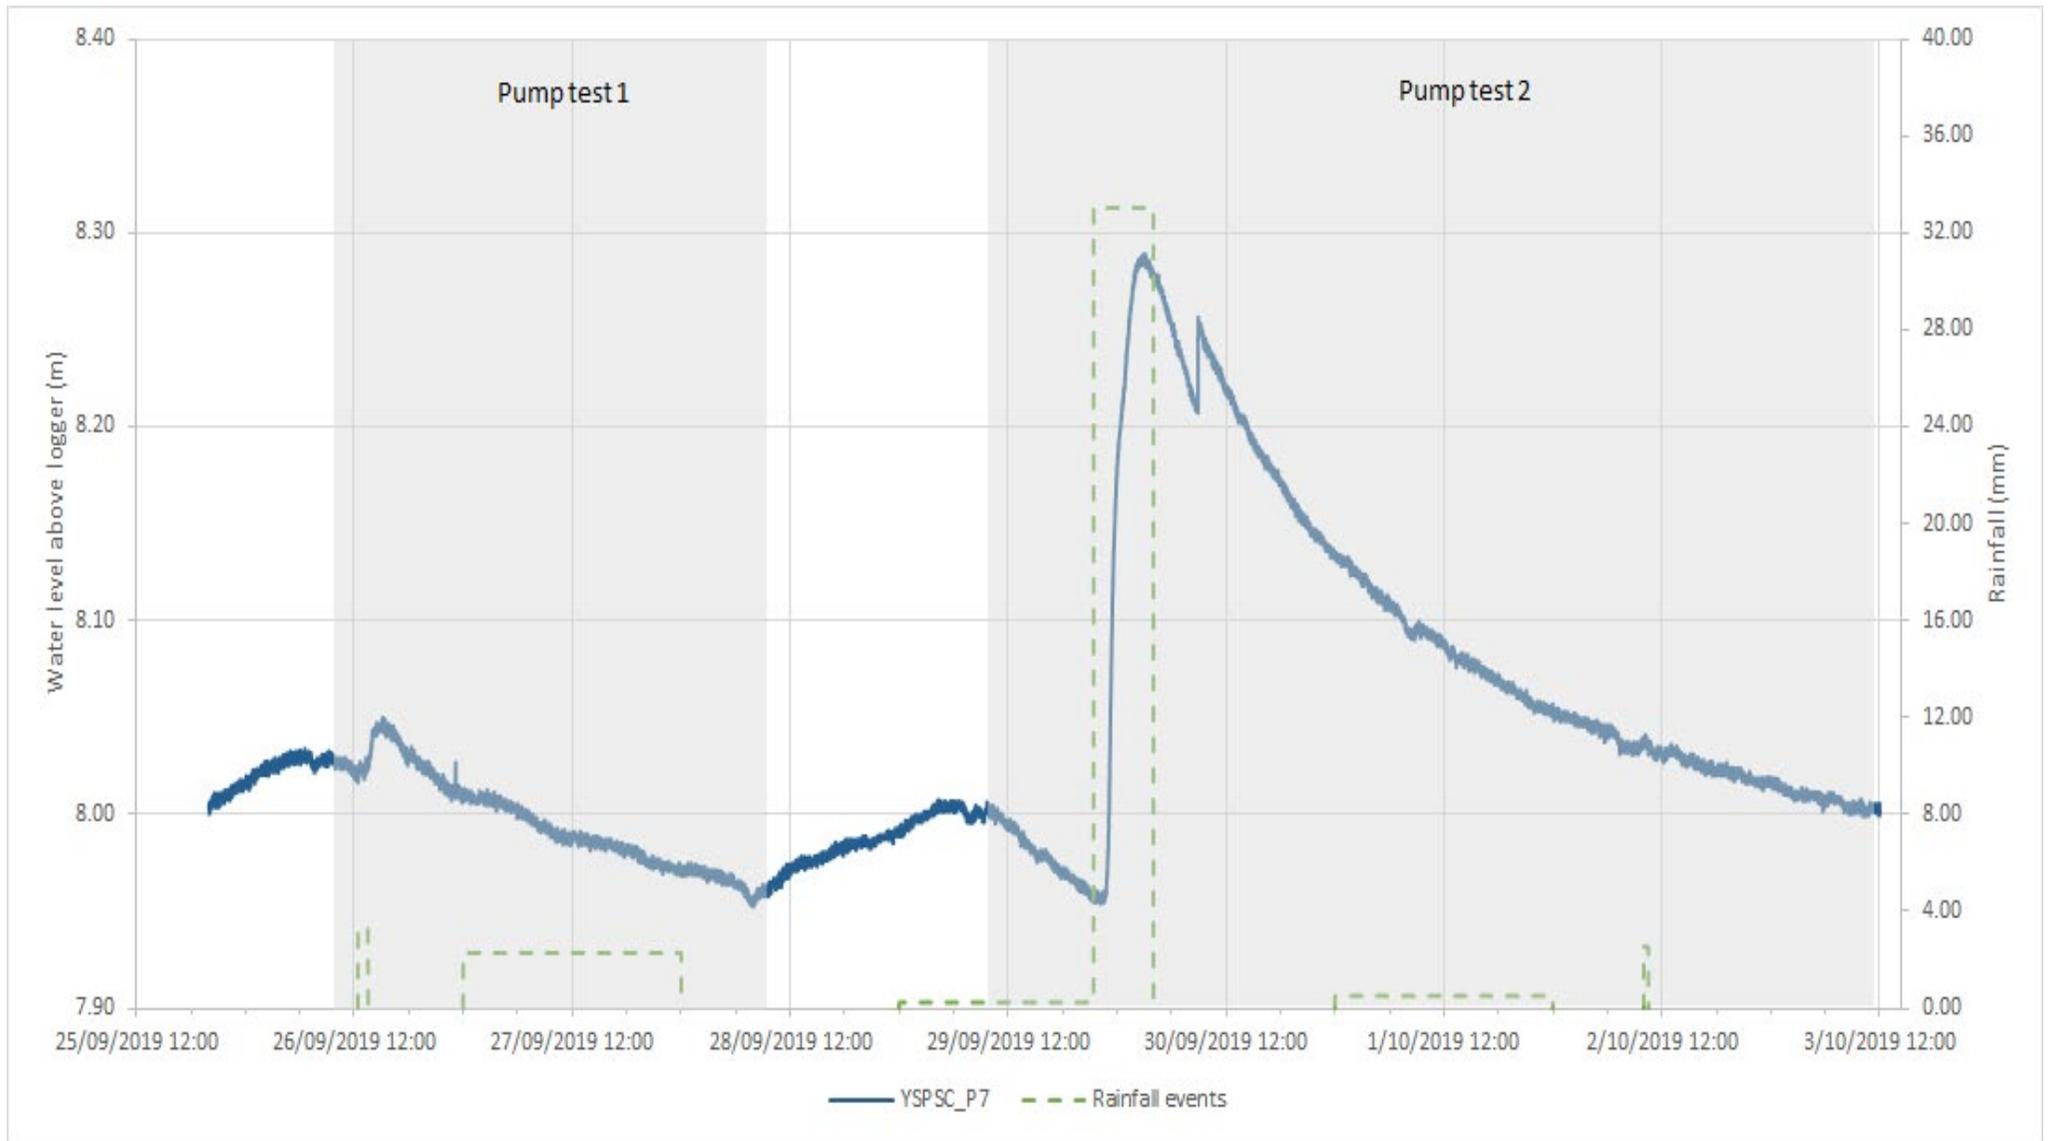
Figure 26. YSPSC P7 water level response during pumping tests.

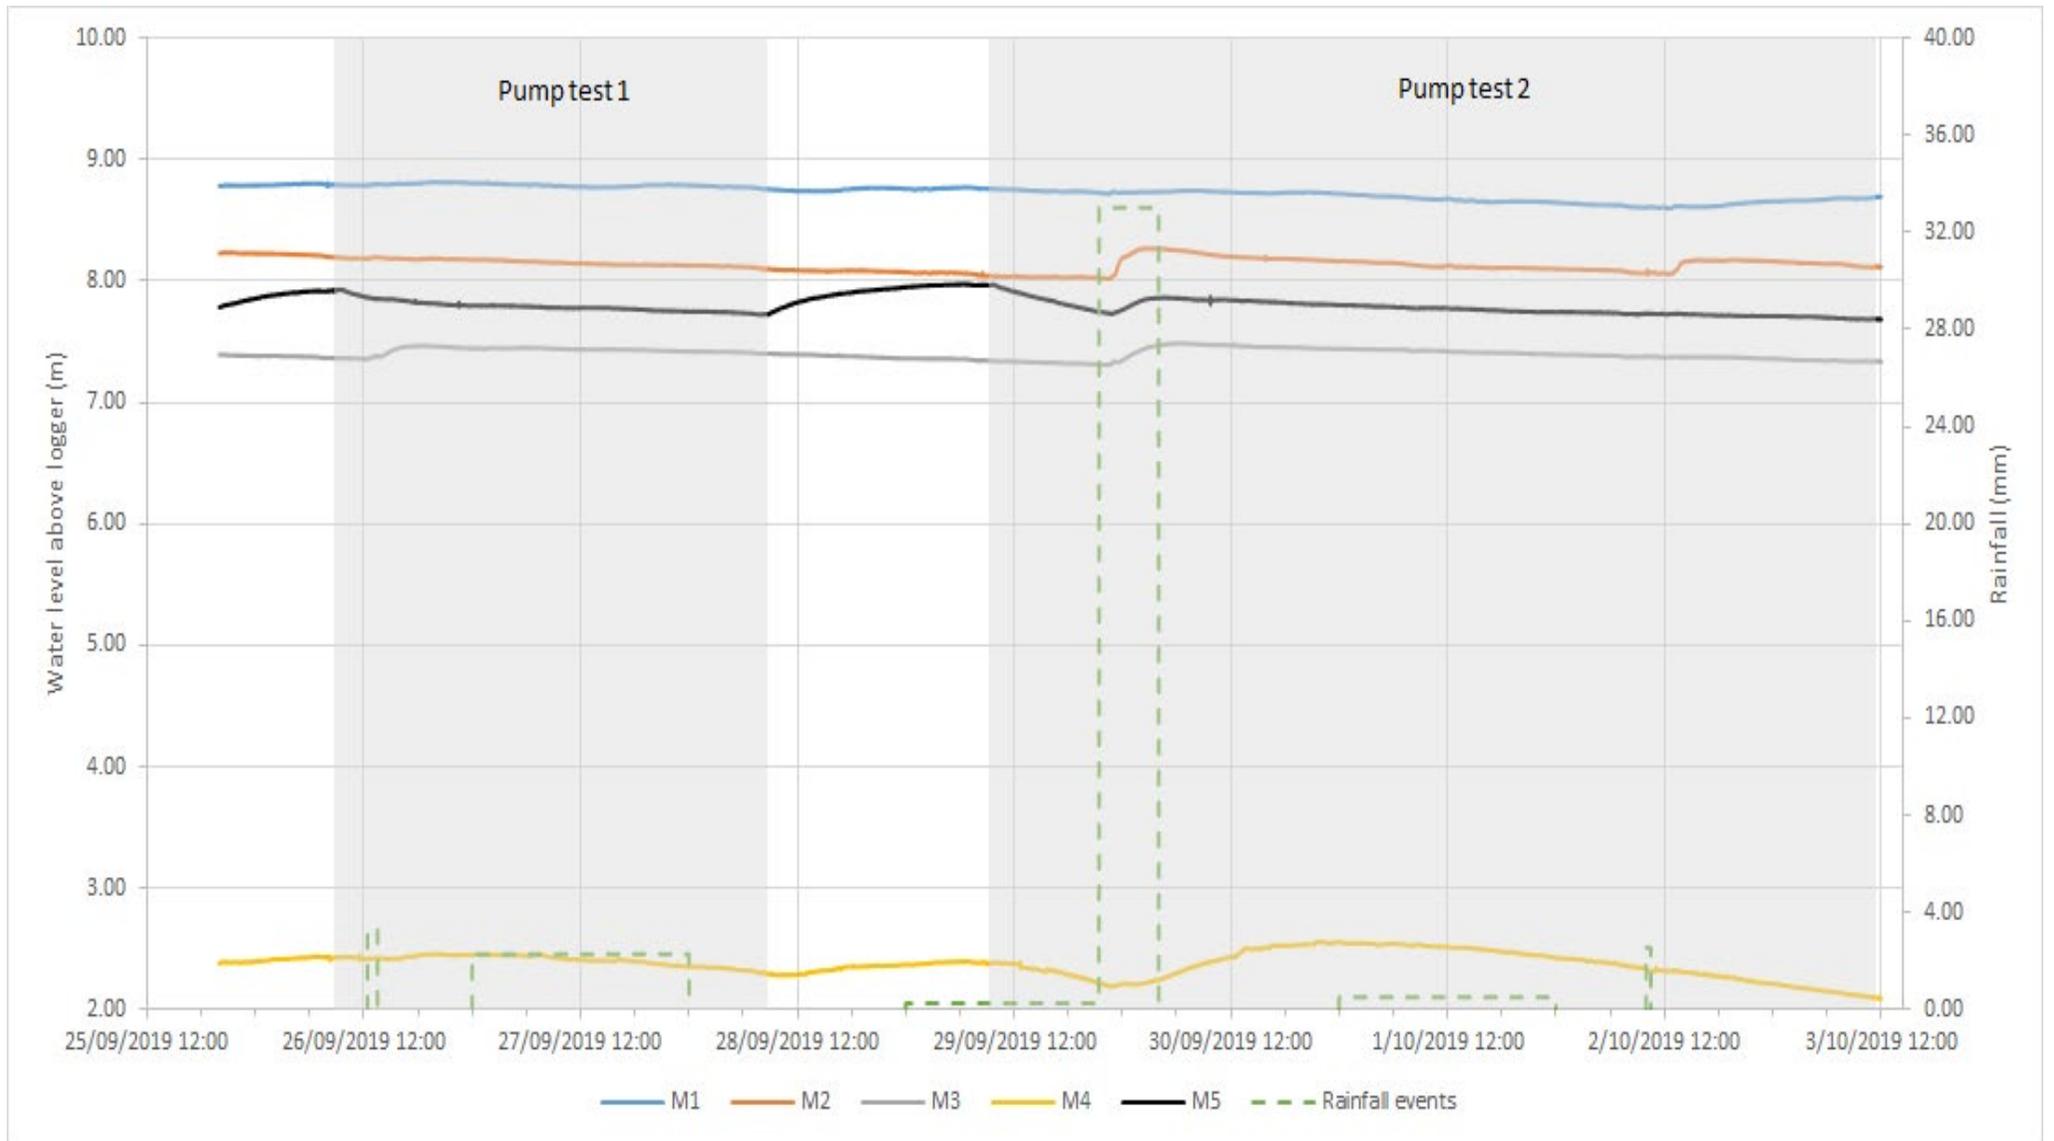
Figure 27. YSPSC monitoring bores M1, M2, M3, M4 and M5 water level response during pumping tests.
