Groundwater Resources Assessment: Gagil-Tomil, Yap State, Federated States of Micronesia

Aminisitai Loco, Andreas Antoniou, Anesh Kumar, Nicholas Metherall,
Peter Sinclair

North Pacific – Readiness for El Niño (RENI) project

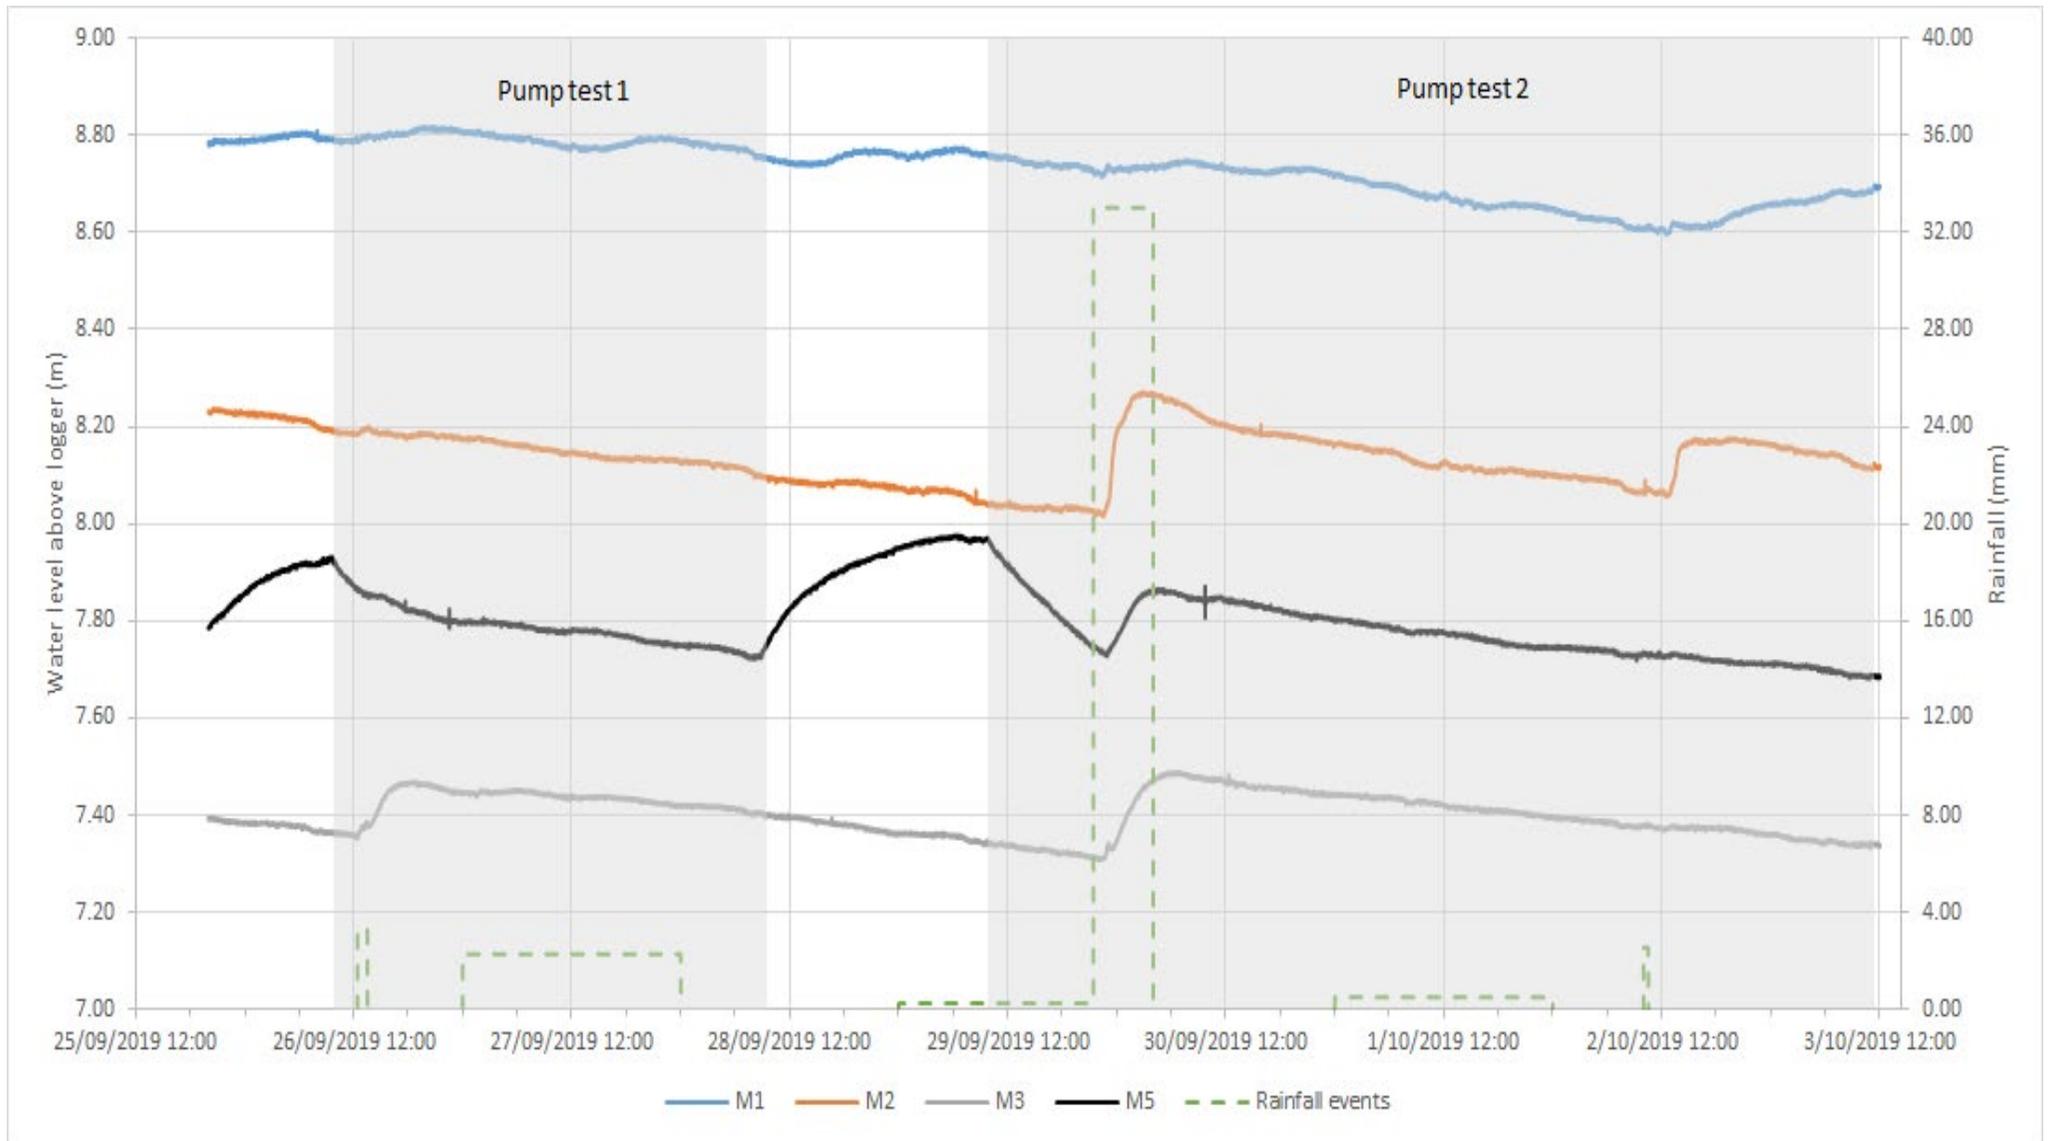
Figure 28. YSPSC monitoring bores M1, M2, M3 and M5 water level response during pumping tests.

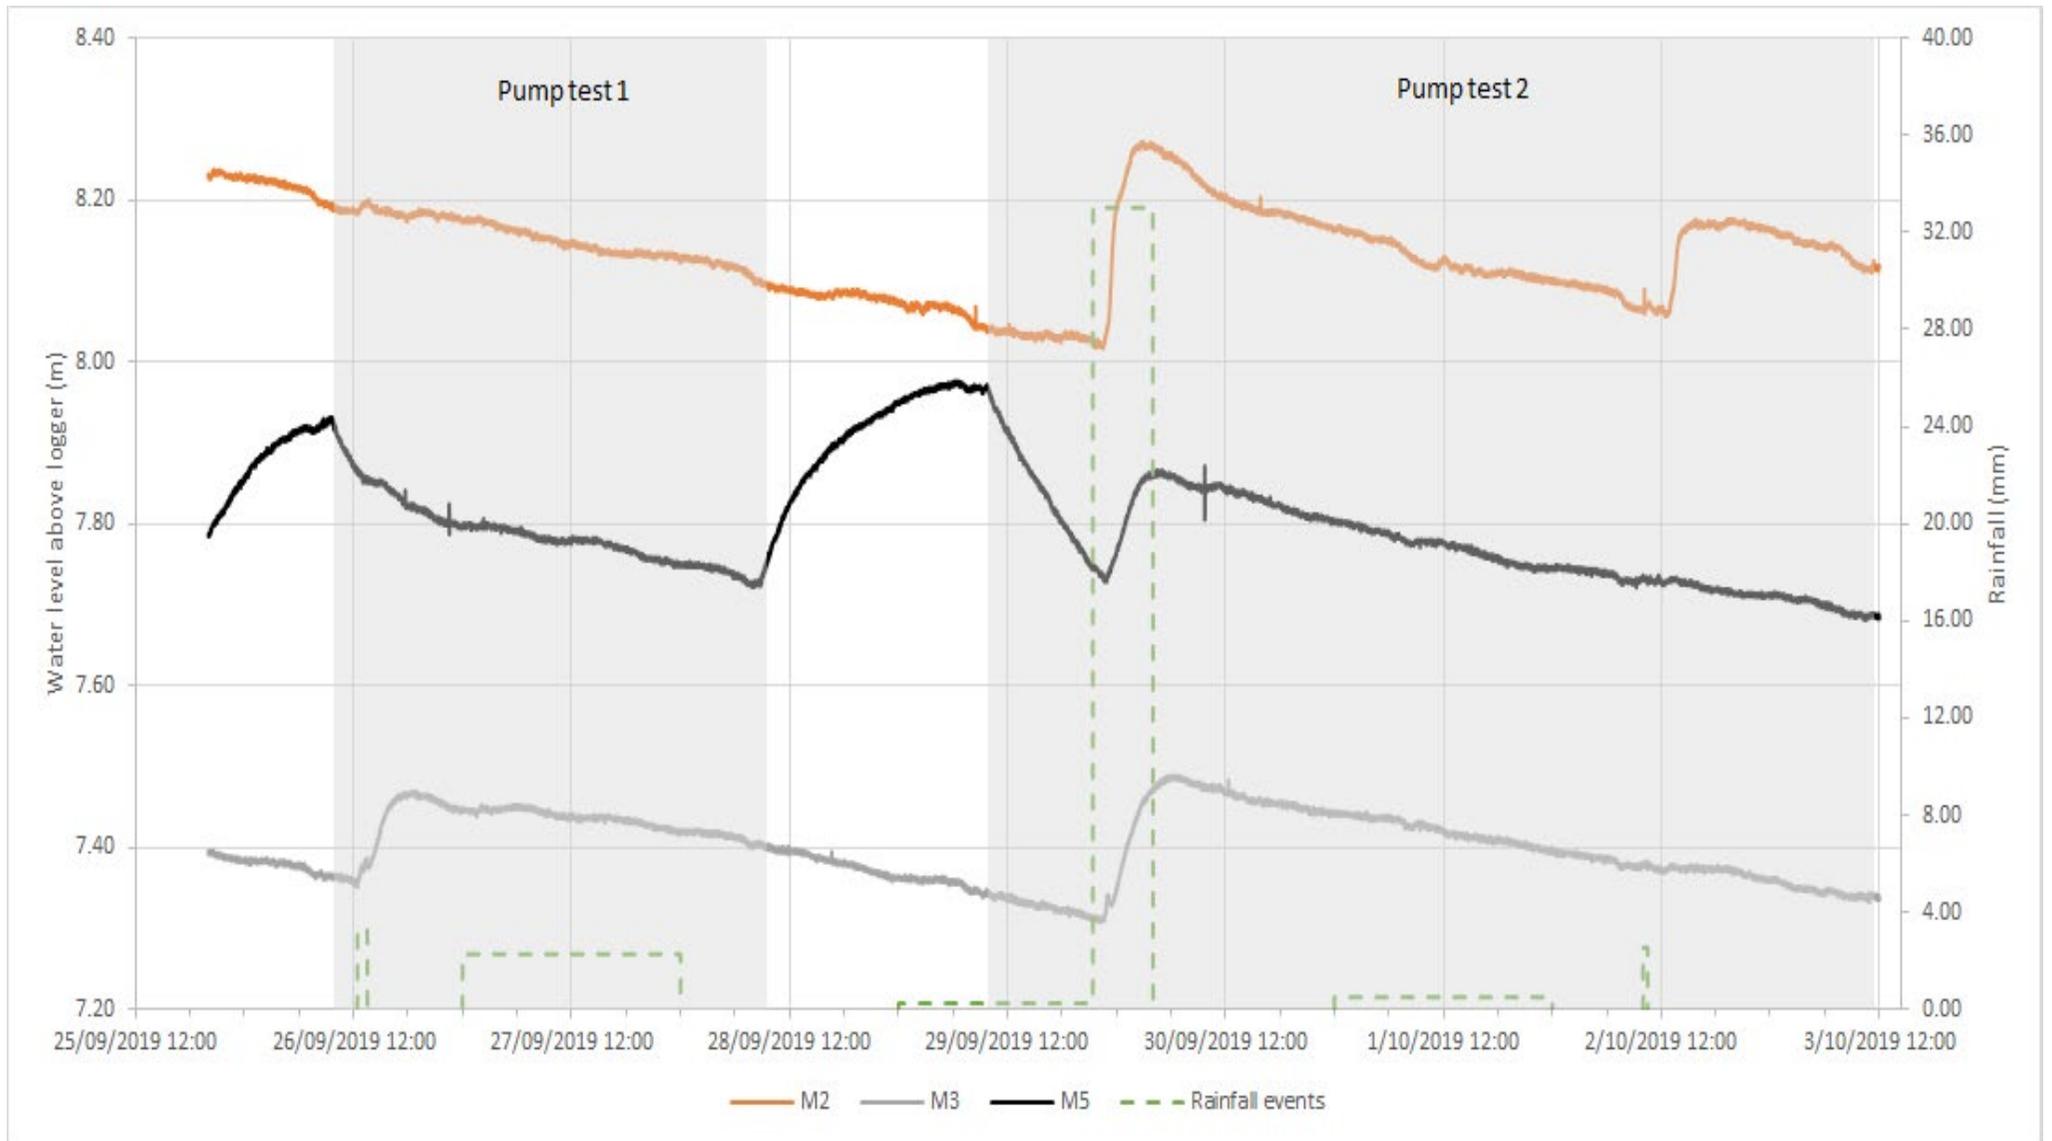
Figure 29. YSPSC monitoring bores M2, M3 and M5 water level response during pumping tests.

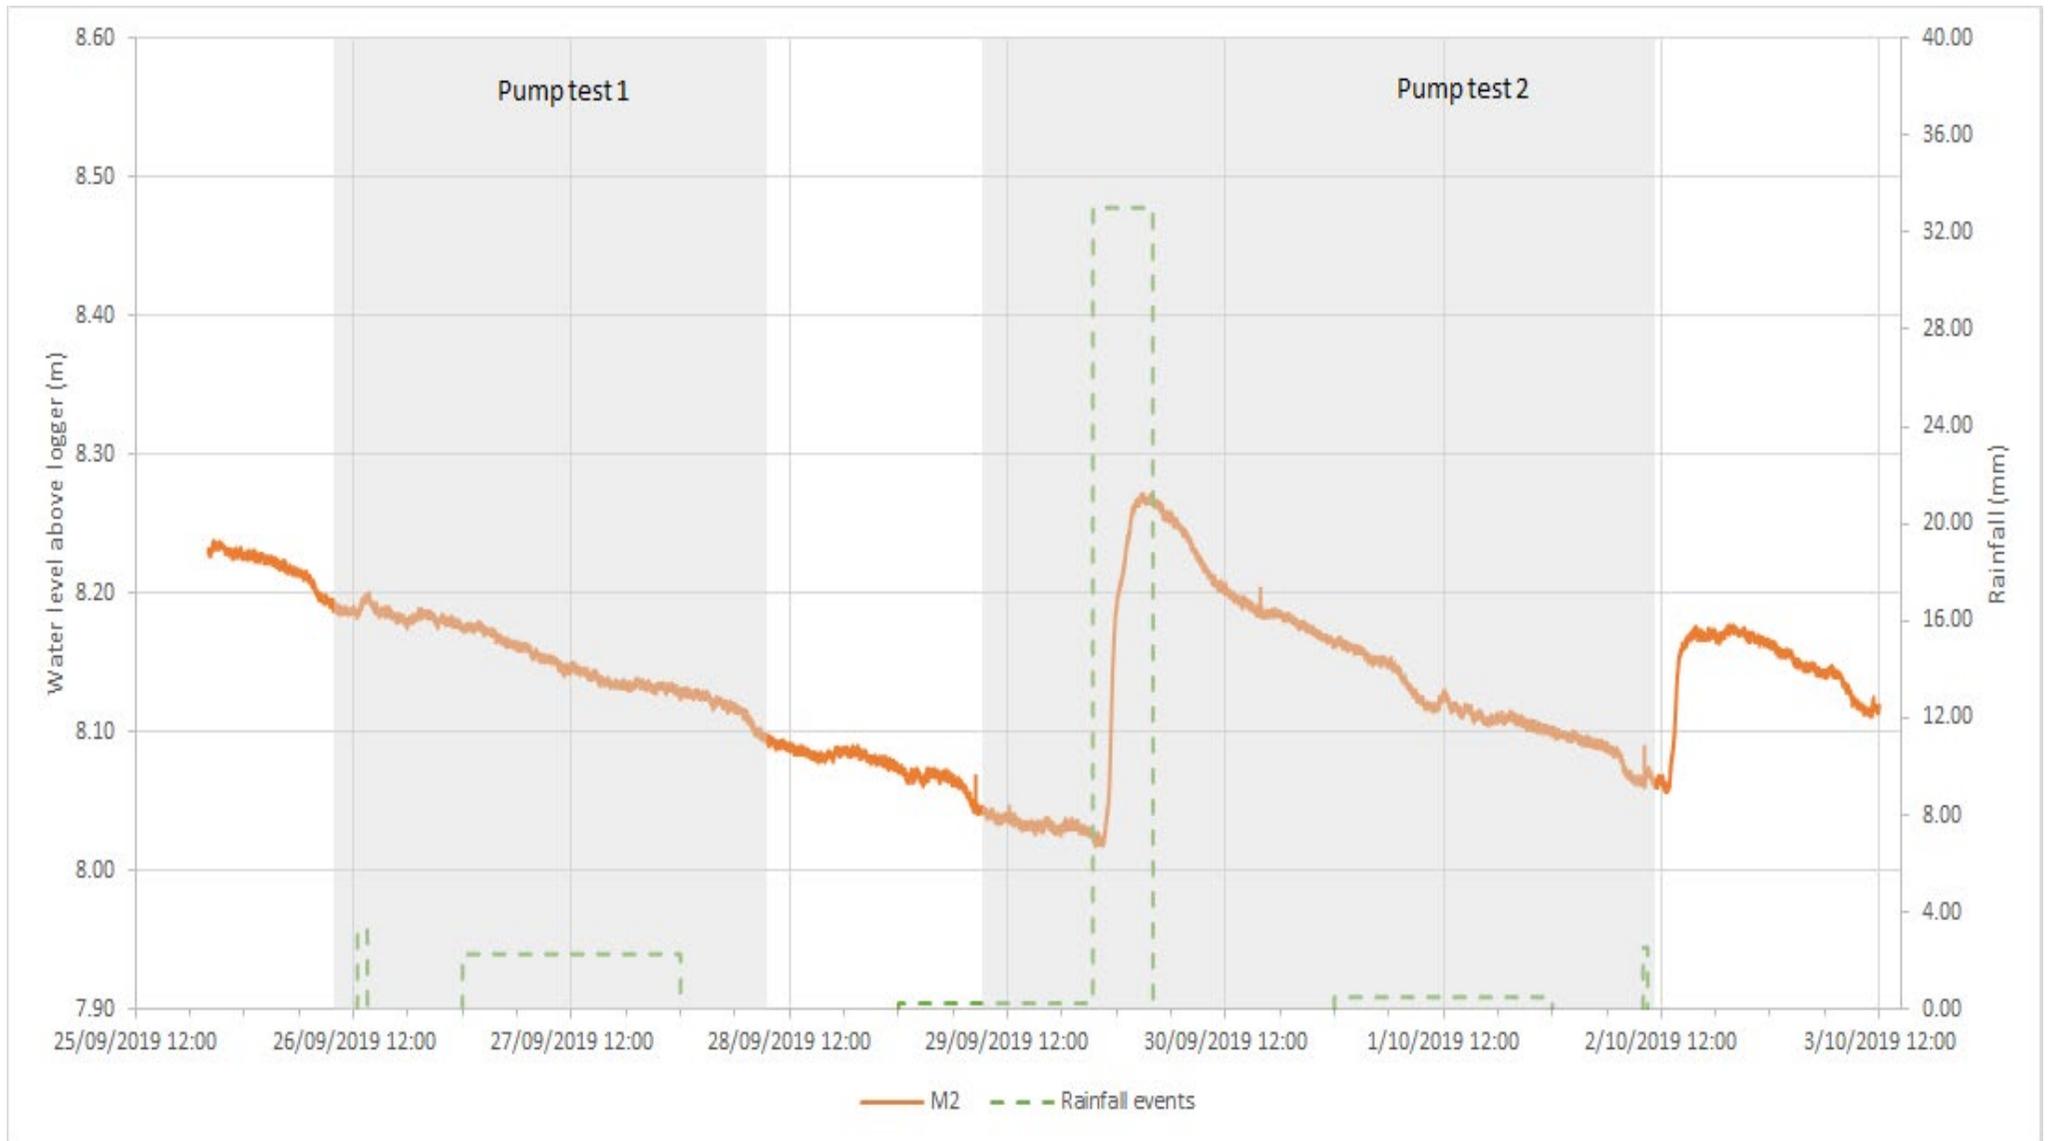
Figure 30. YSPSC monitoring bore M2 water level response during pumping tests.

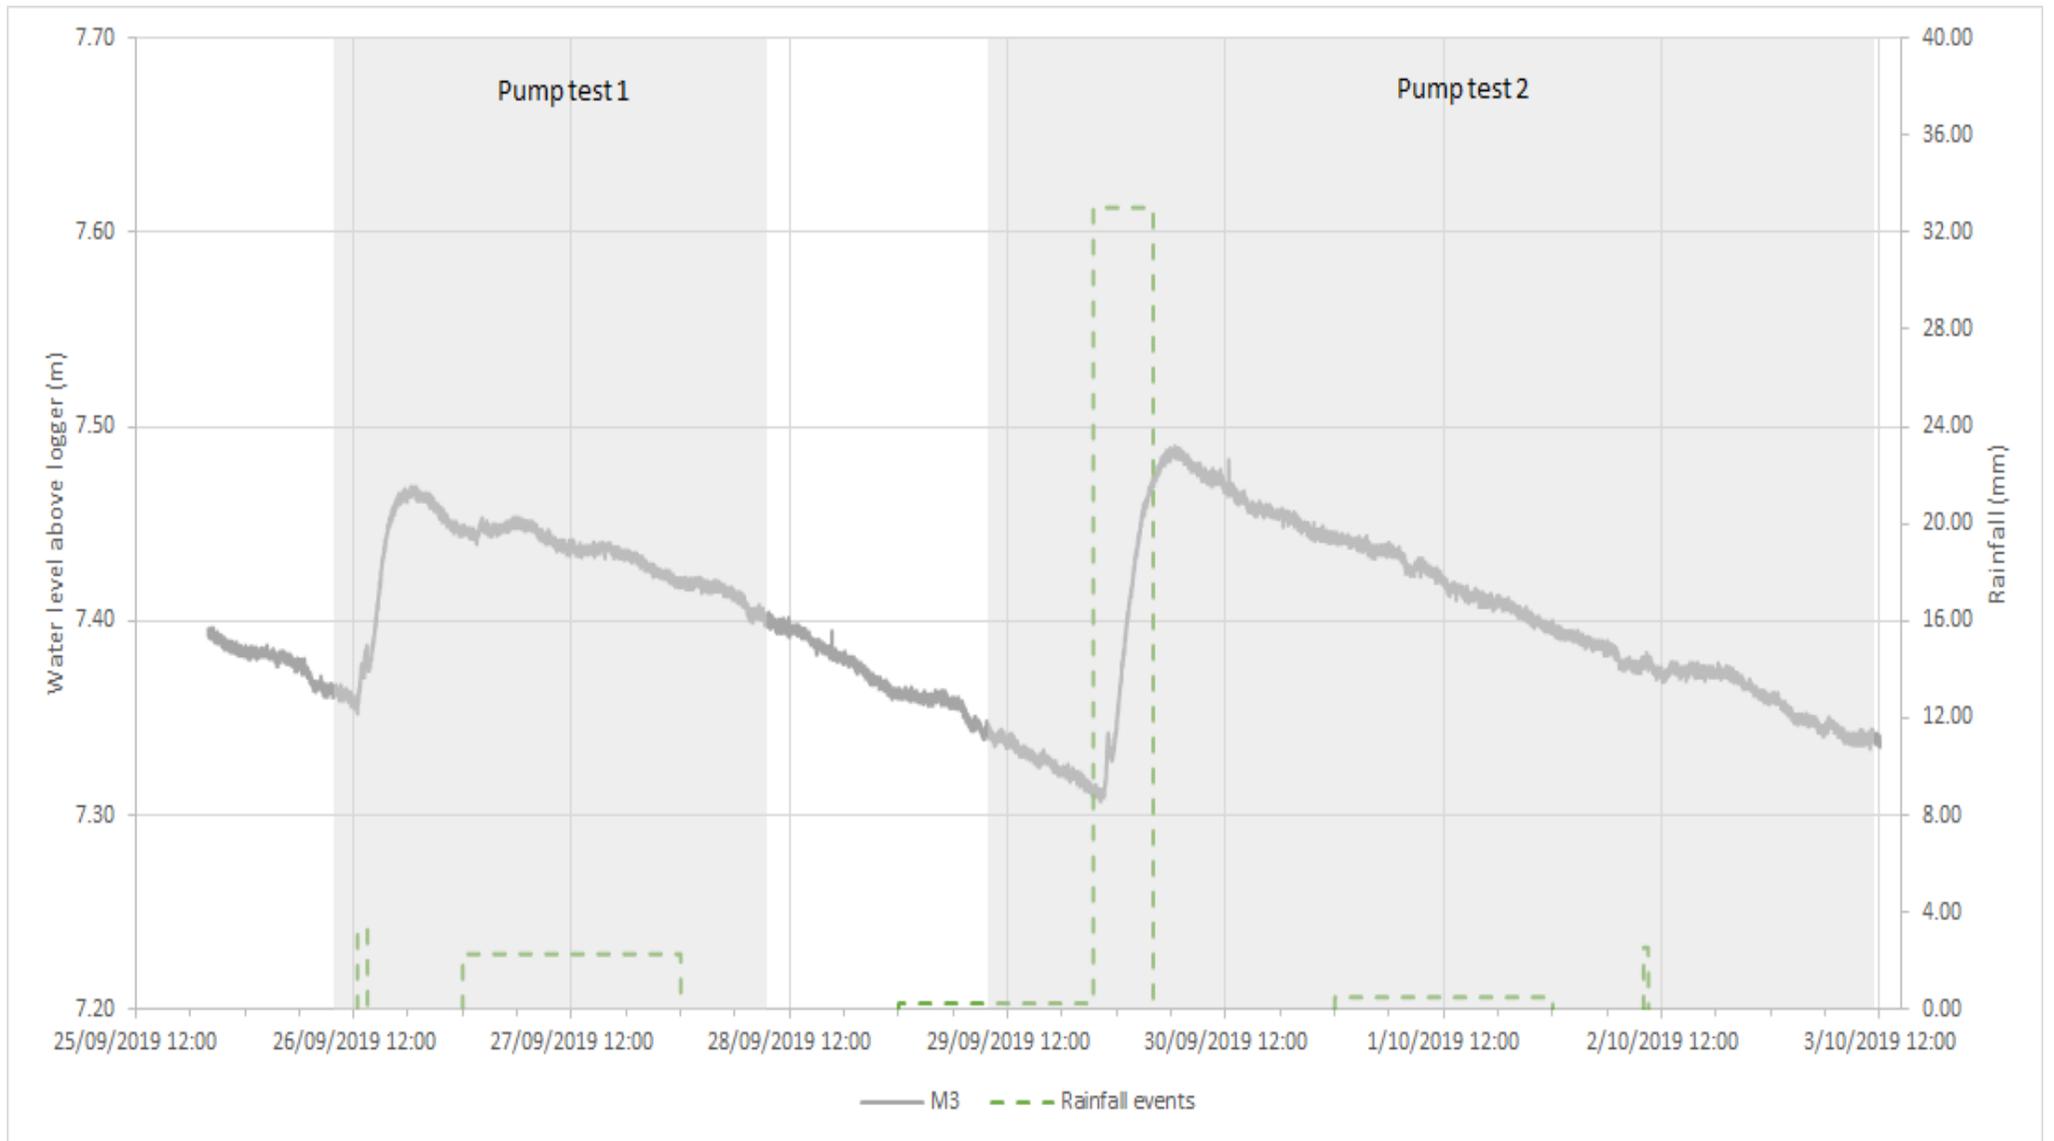
Figure 31. YSPSC monitoring bore M3 water level response during pumping tests.

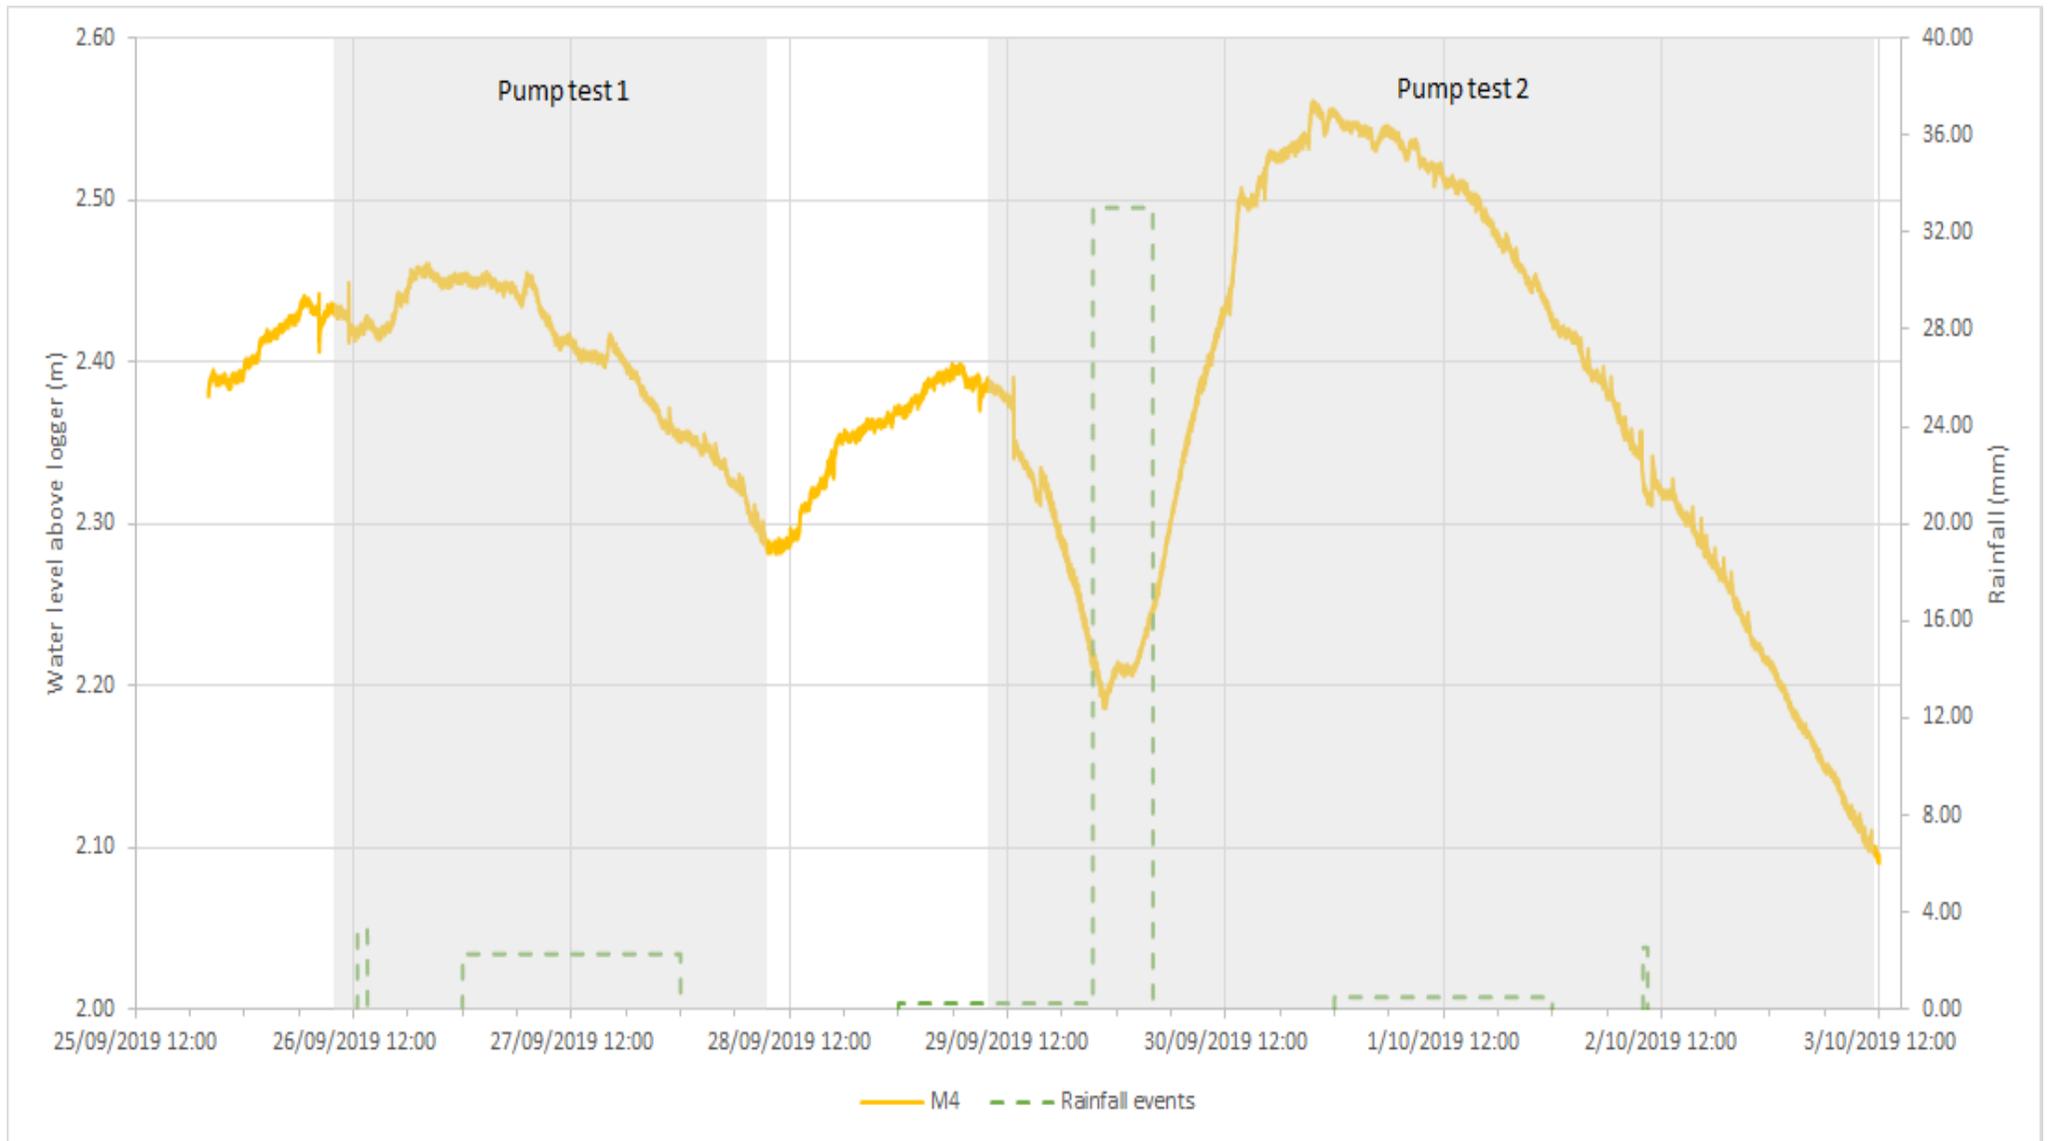
Figure 32. YSPSC monitoring bore M4 water level response during pumping tests.

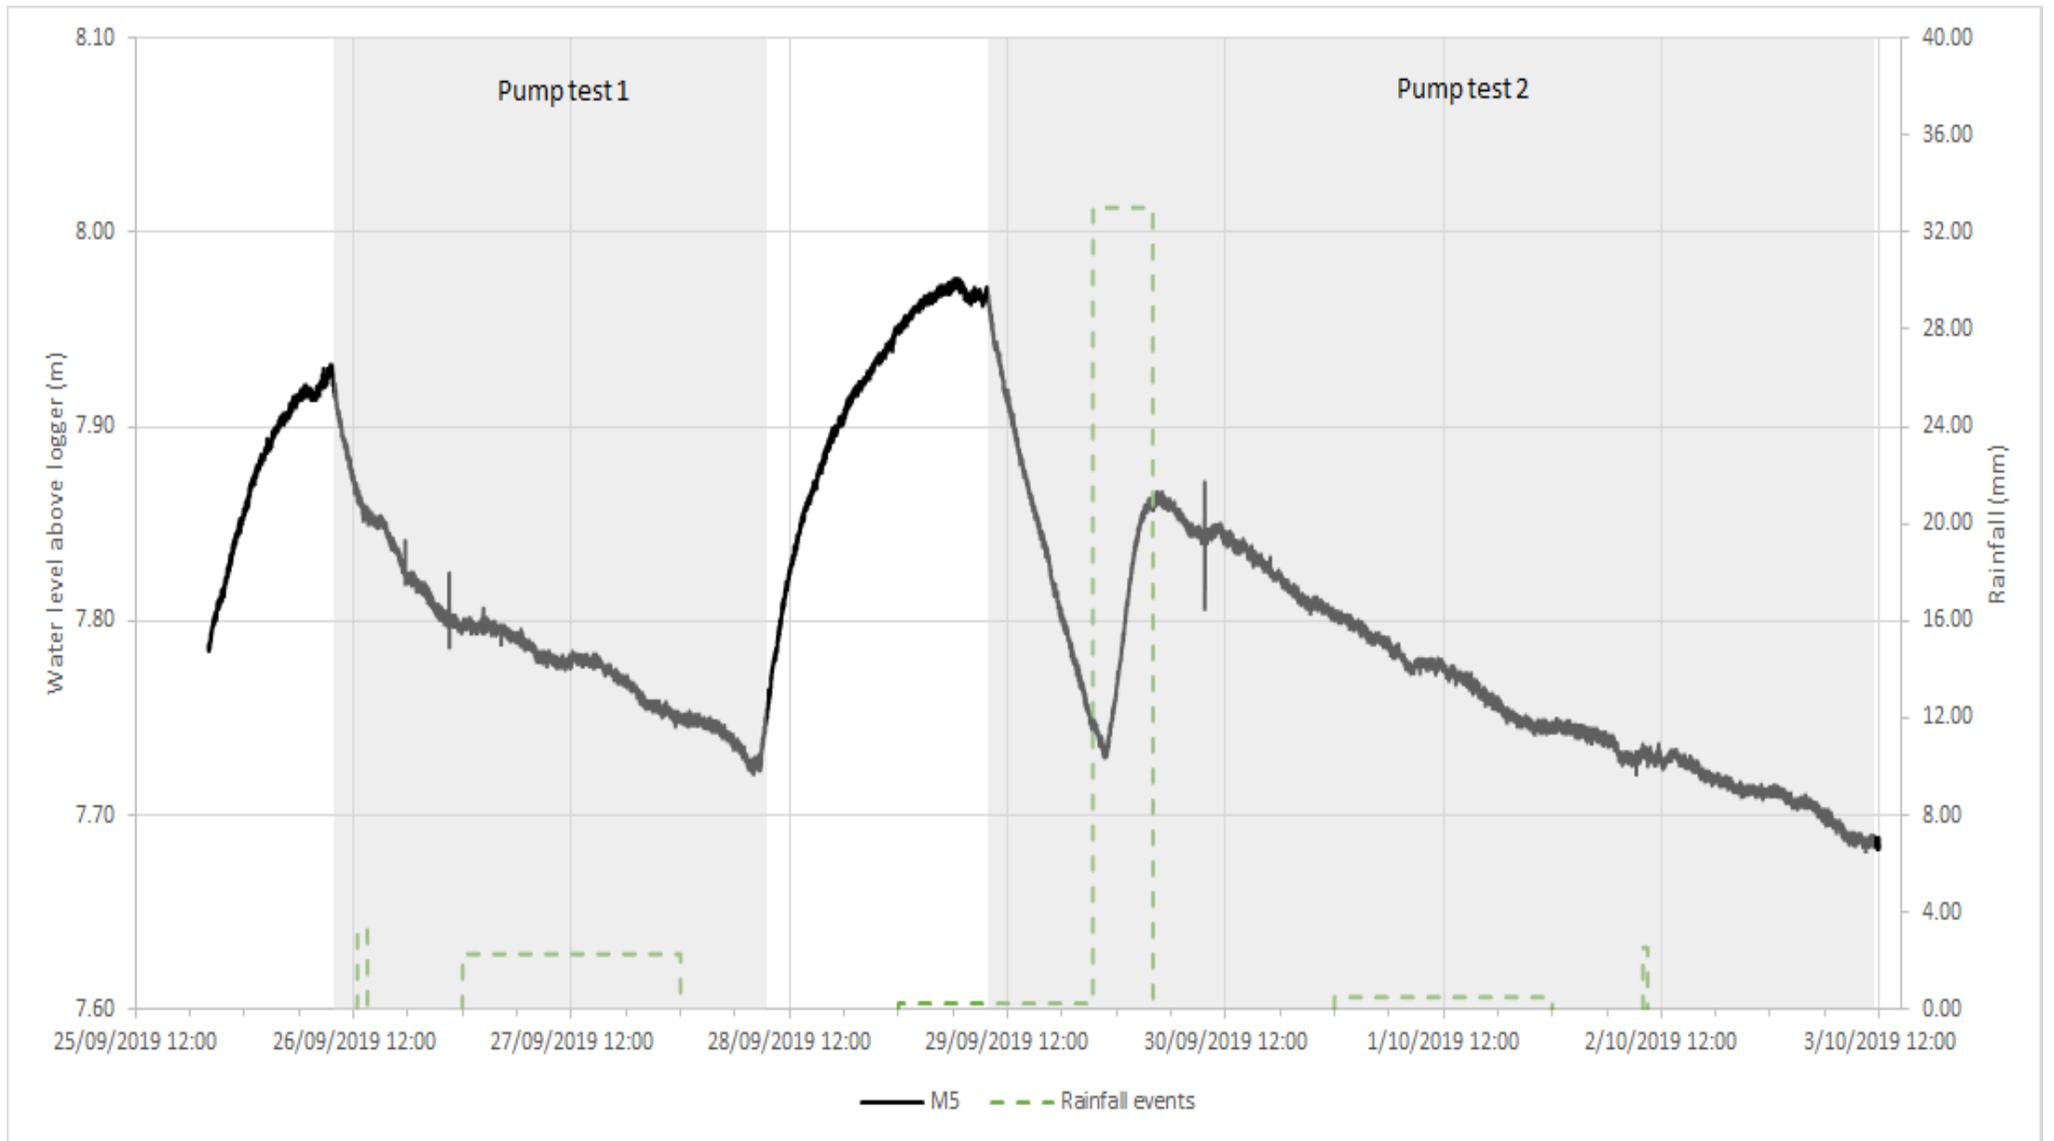
Figure 33. YSPSC monitoring bore M5 water level response during pumping tests.

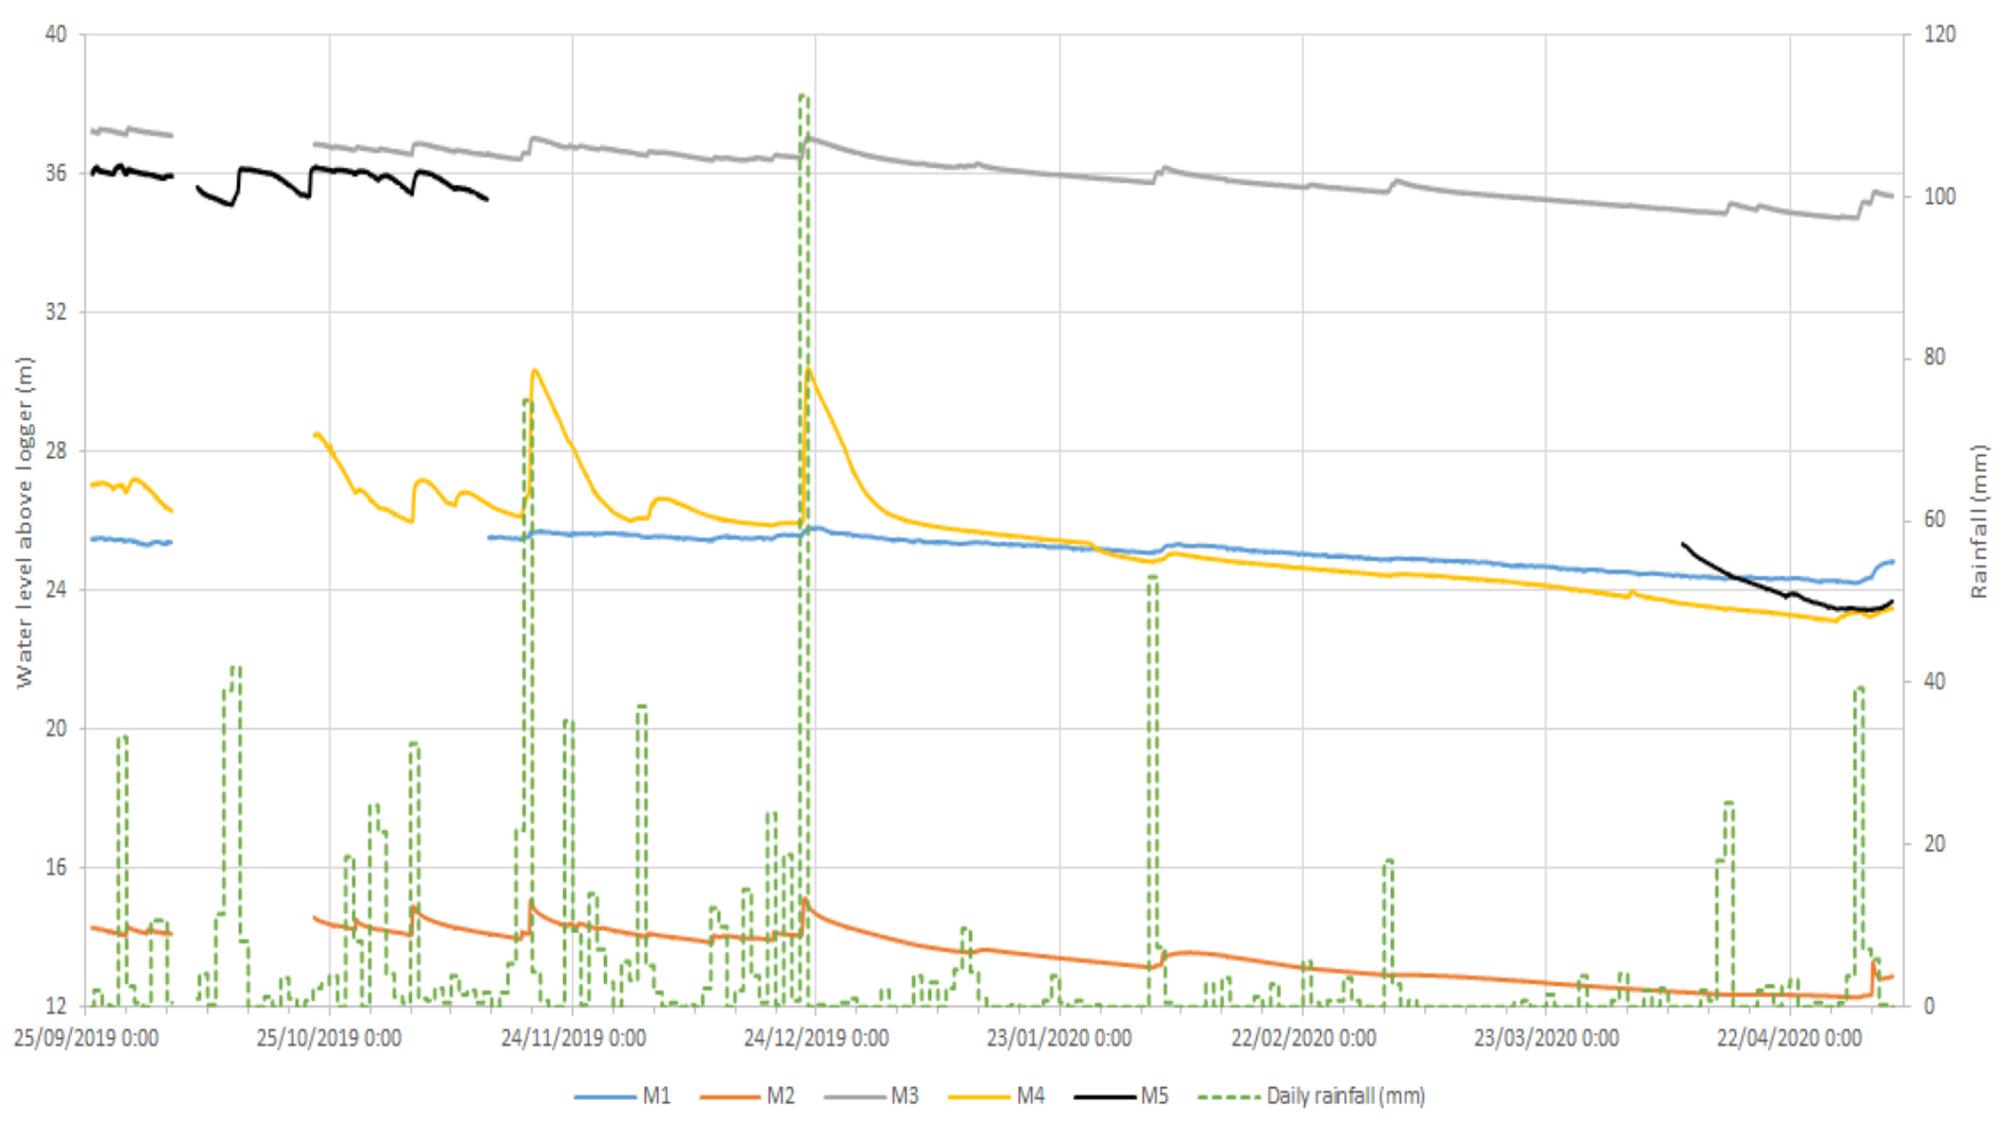
Figure 34. YSPSC monitoring bores M1, M2, M3, M4 and M5 water level response during long-term monitoring period.

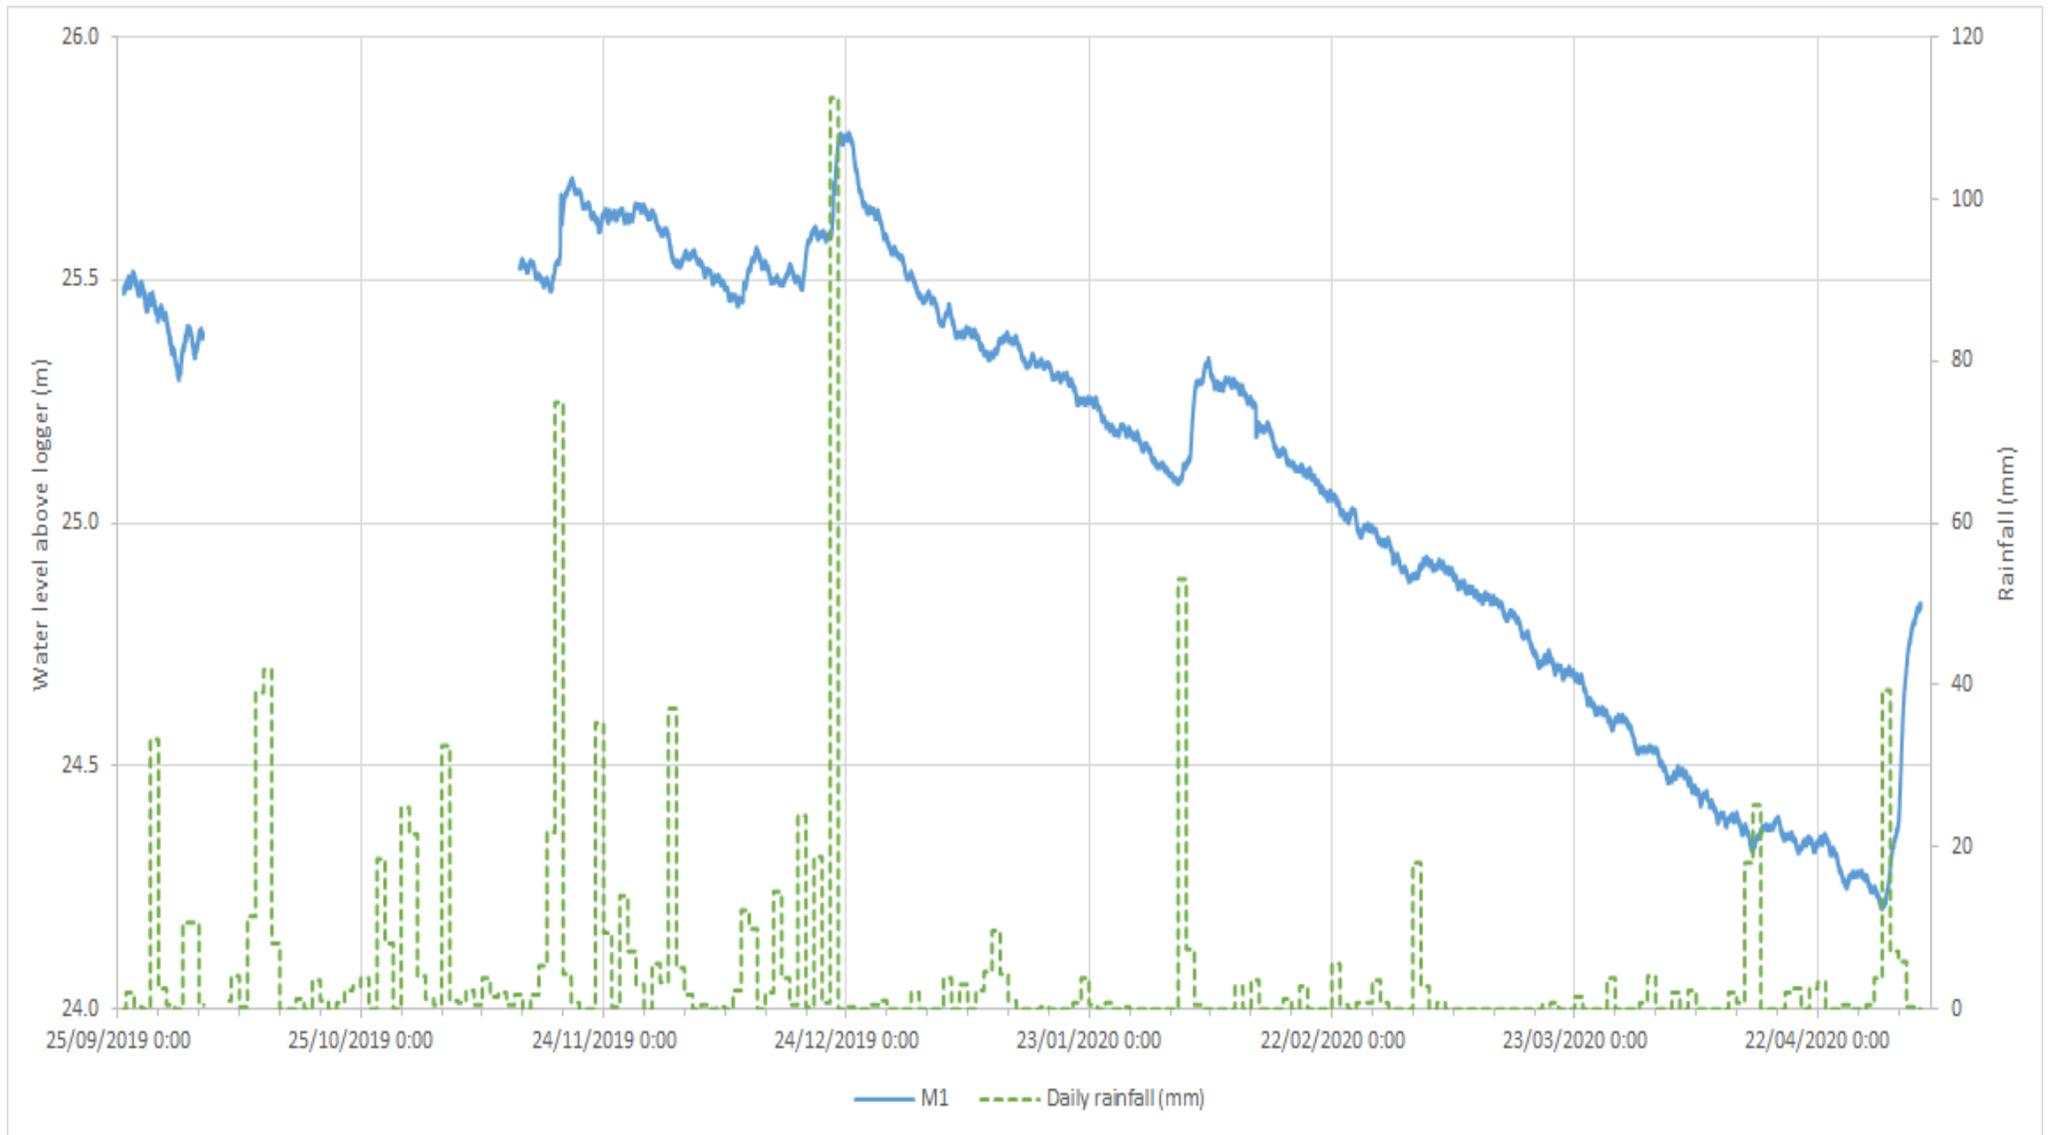
Figure 35. YSPSC monitoring bore M1 water level response during long-term monitoring period.

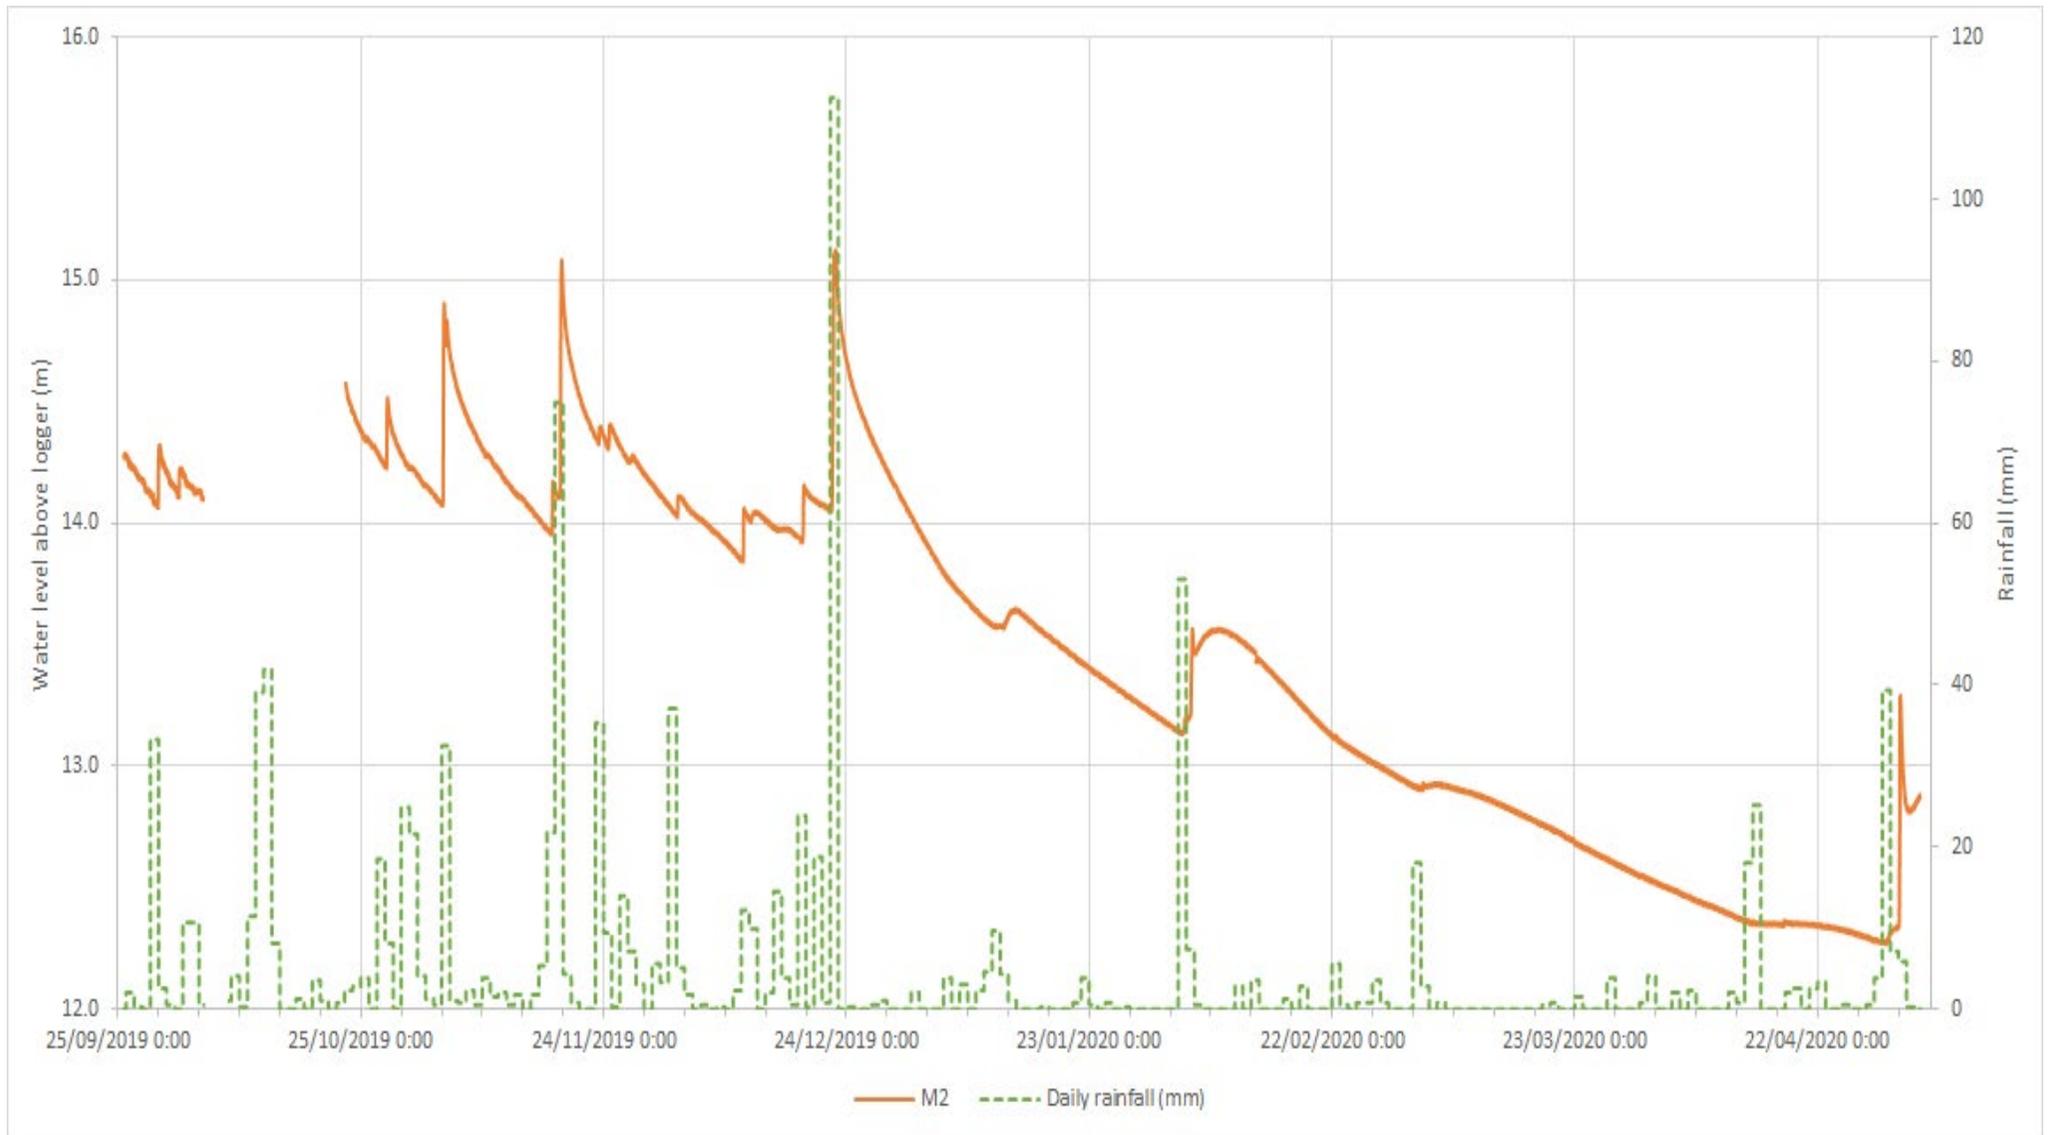
Figure 36. YSPSC monitoring bore M2 water level response during long-term monitoring period.
