Groundwater Resources Assessment: Gagil-Tomil, Yap State, Federated States of Micronesia

Aminisitai Loco, Andreas Antoniou, Anesh Kumar, Nicholas Metherall,
Peter Sinclair

North Pacific – Readiness for El Niño (RENI) project

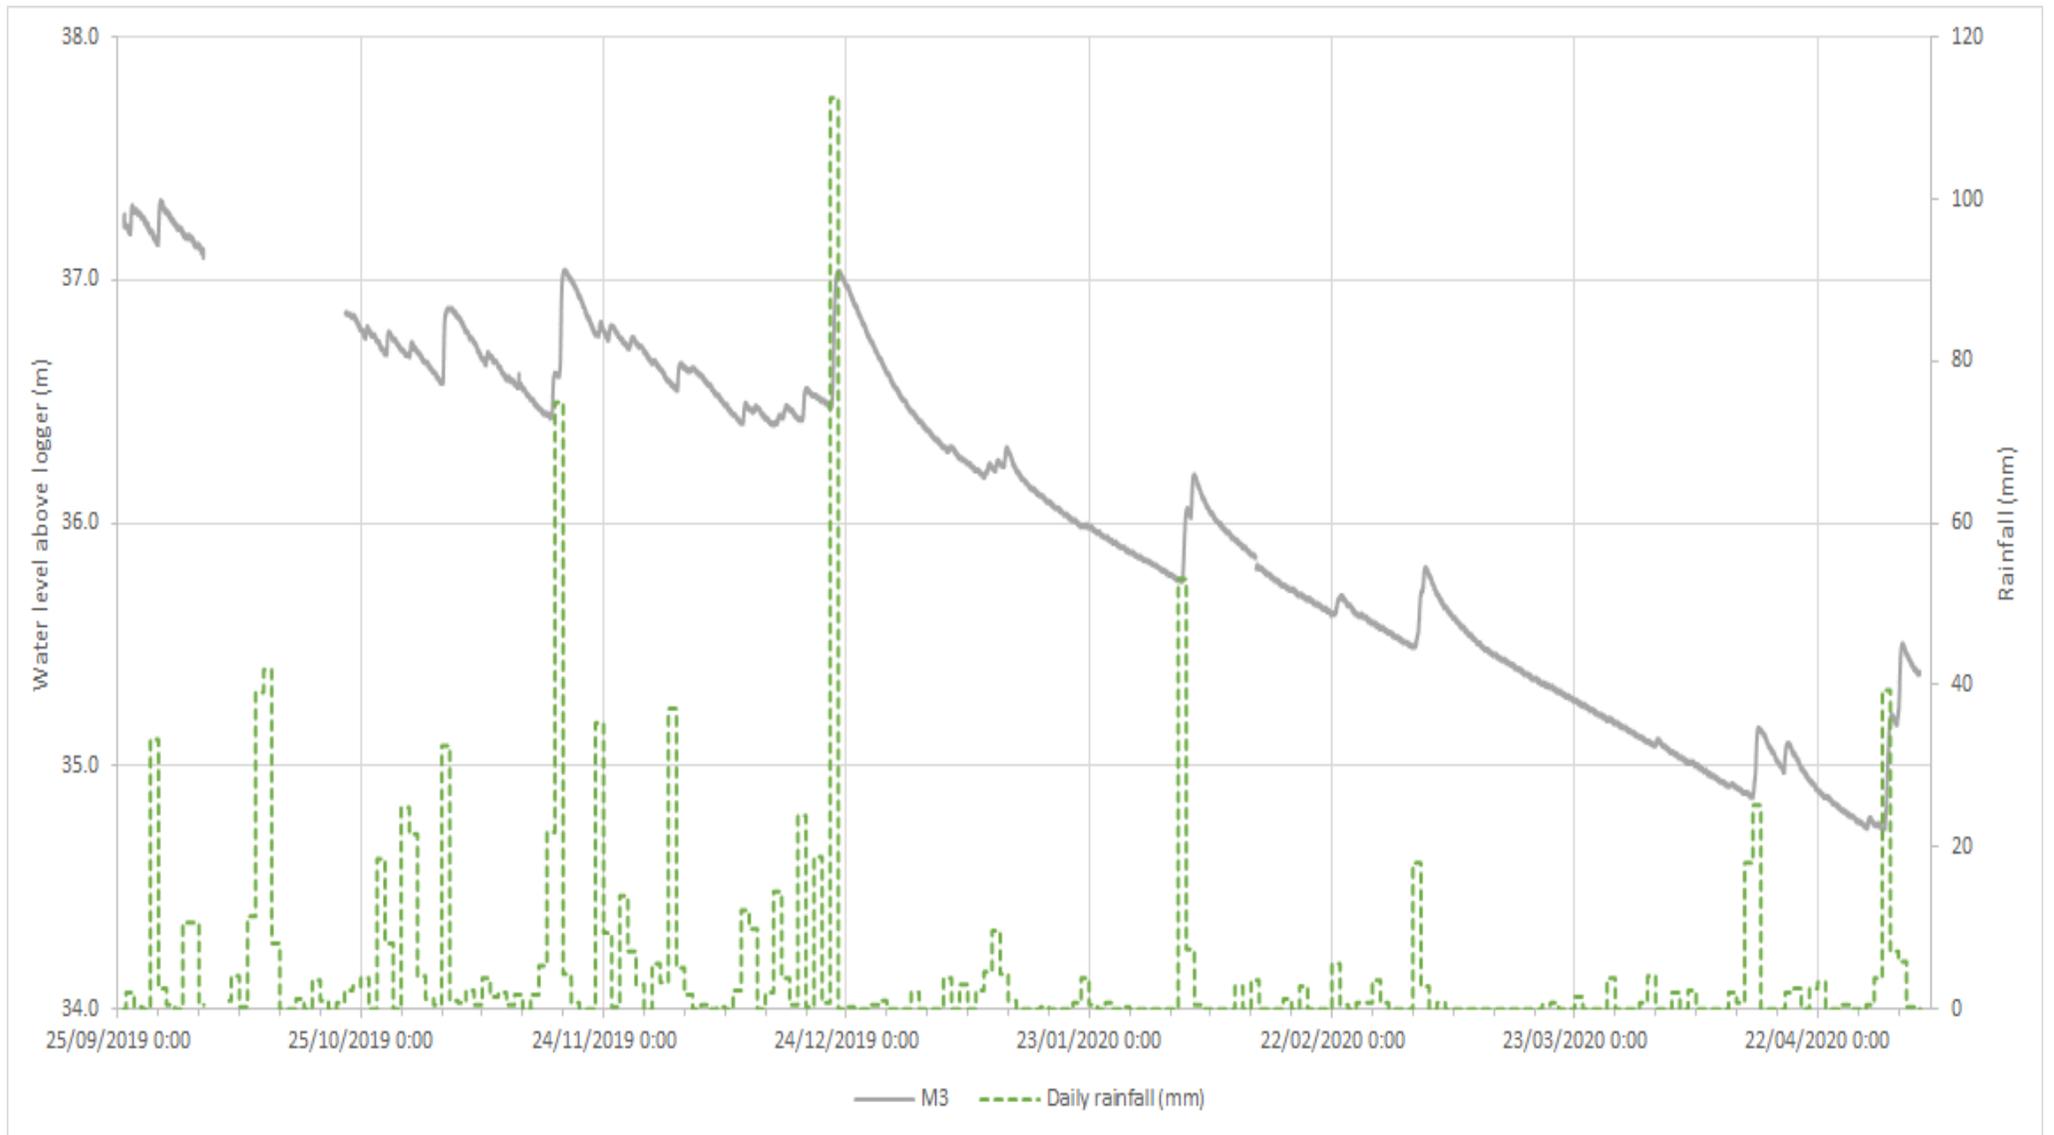
Figure 37. YSPSC monitoring bore M3 water level response during long-term monitoring period.

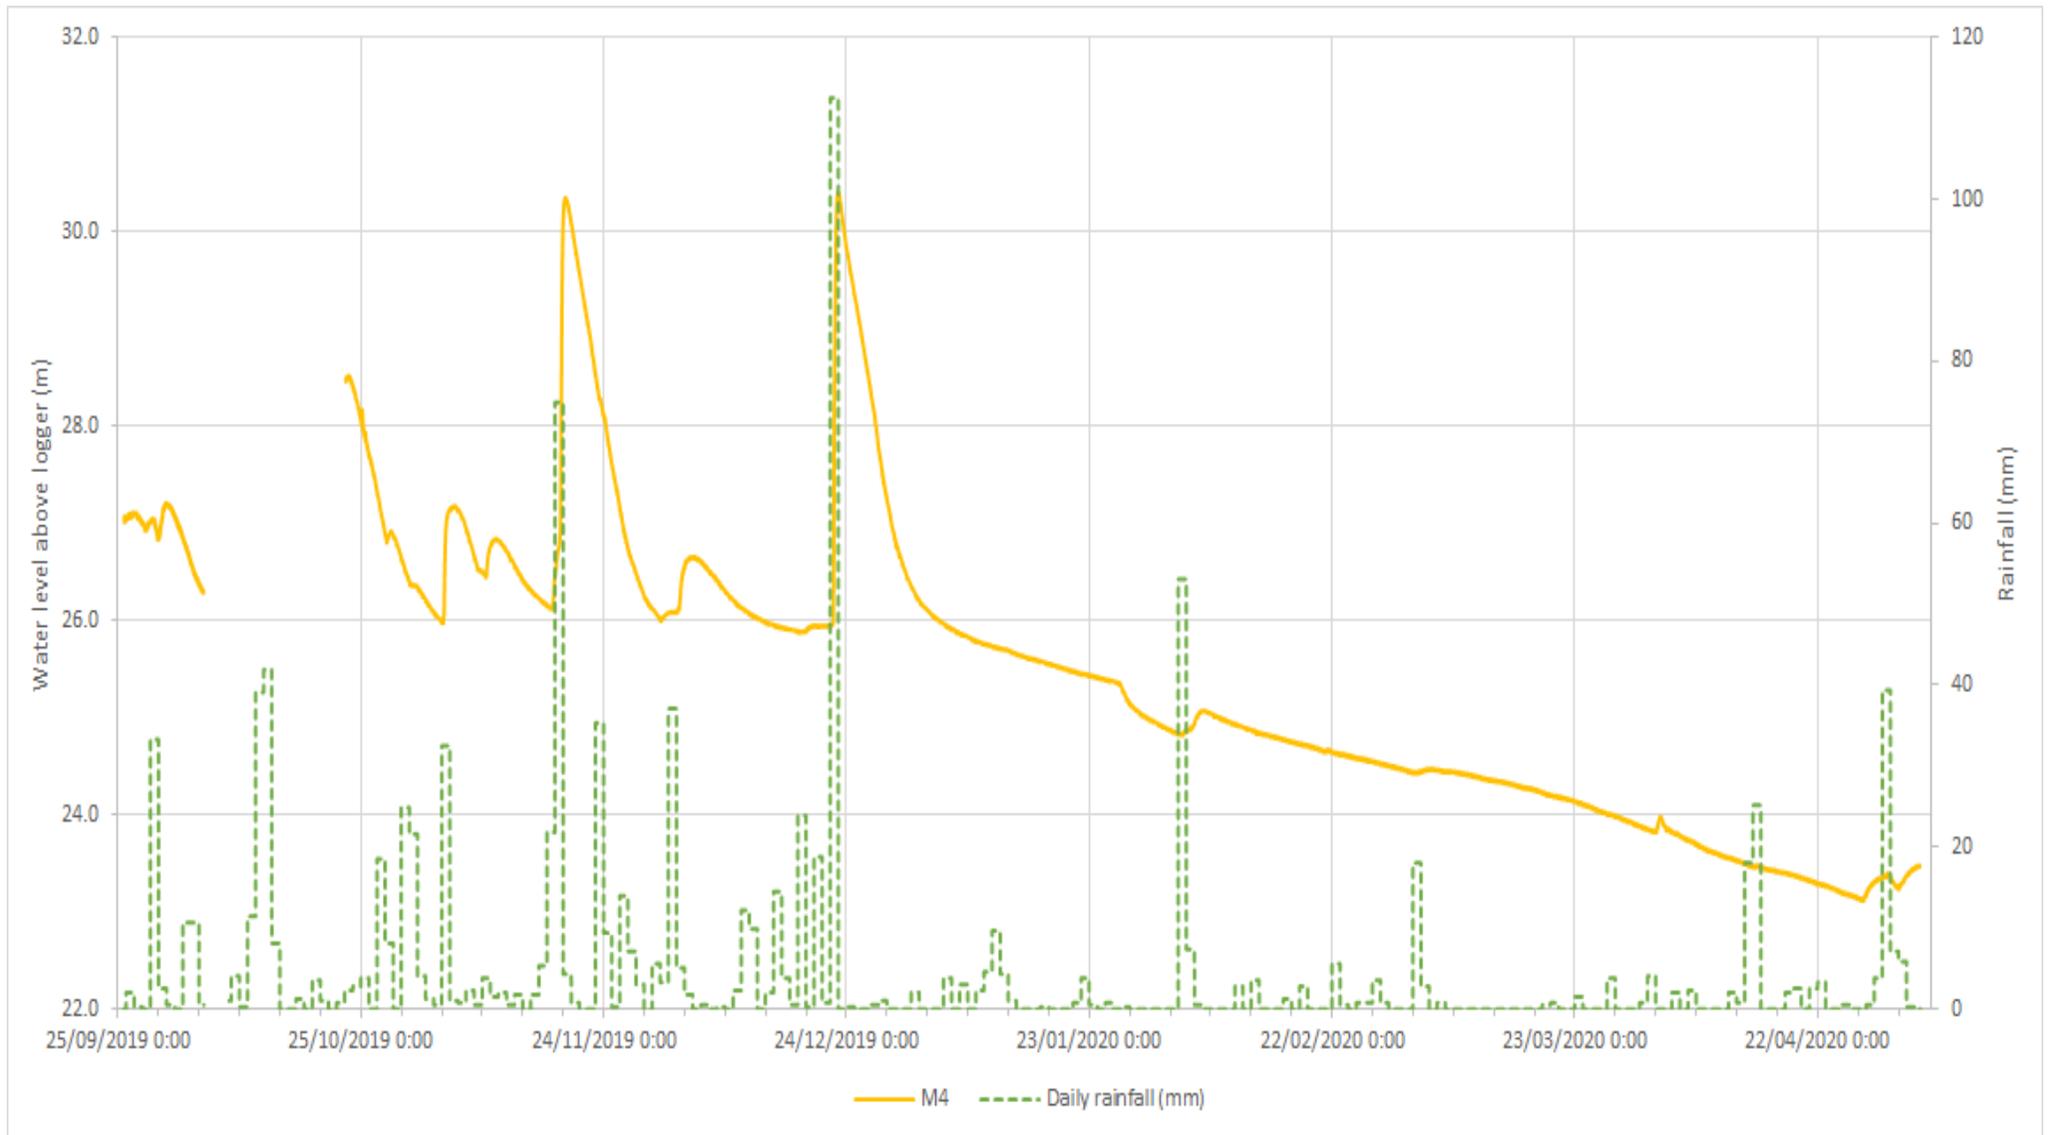
Figure 38. YSPSC monitoring bore M4 water level response during long-term monitoring period.

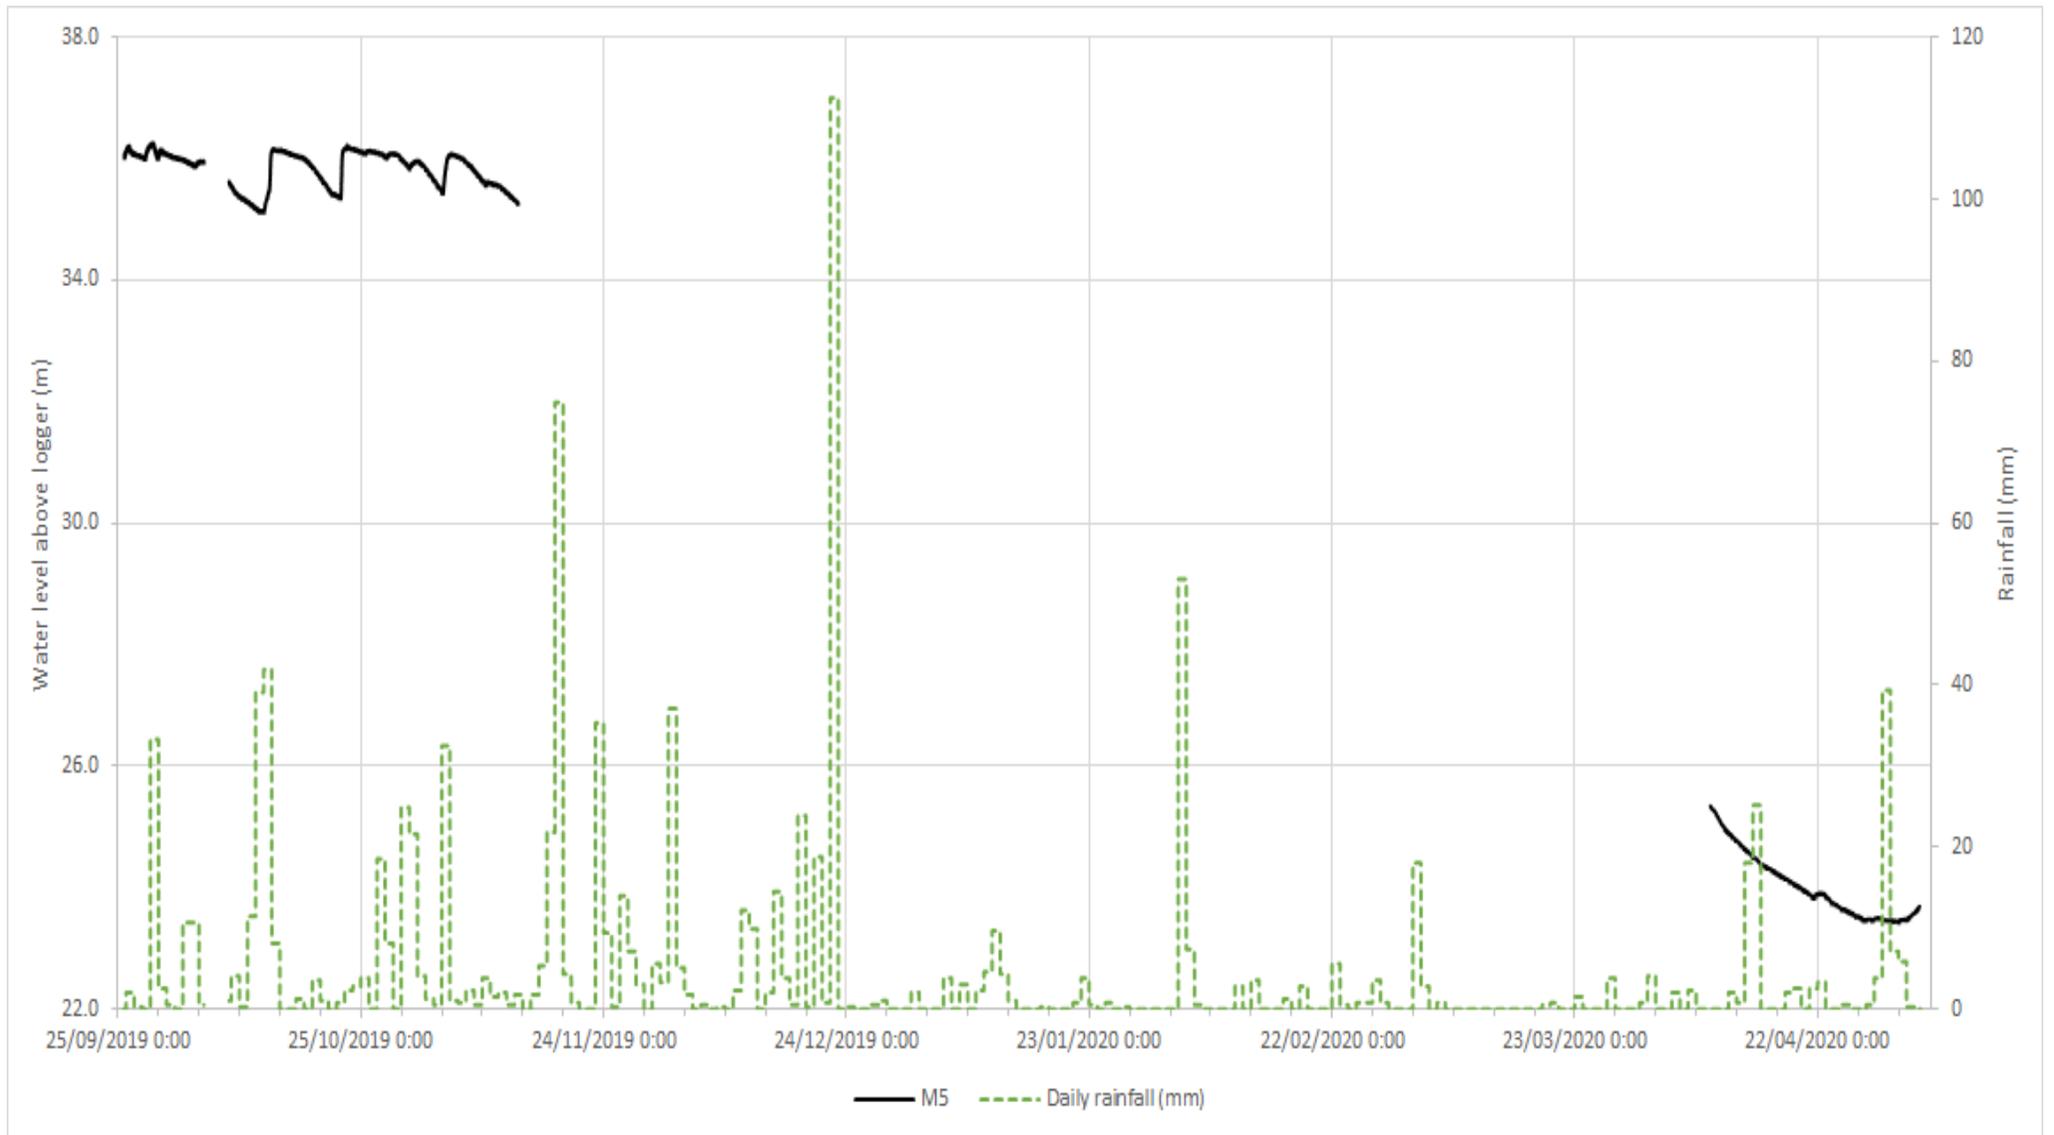
Figure 39. YSPSC monitoring bore M5 water level response during long-term monitoring period.

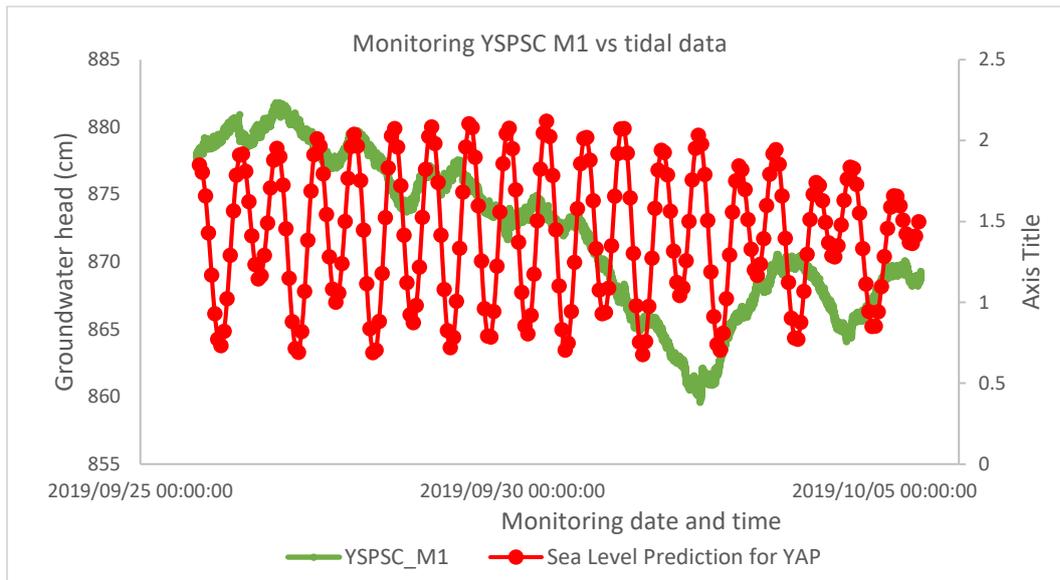
Figure 40. Groundwater level in monitoring well M1 during the GTWA pumping test from 29 September to 2 October against the predicted hourly tidal data for Yap.

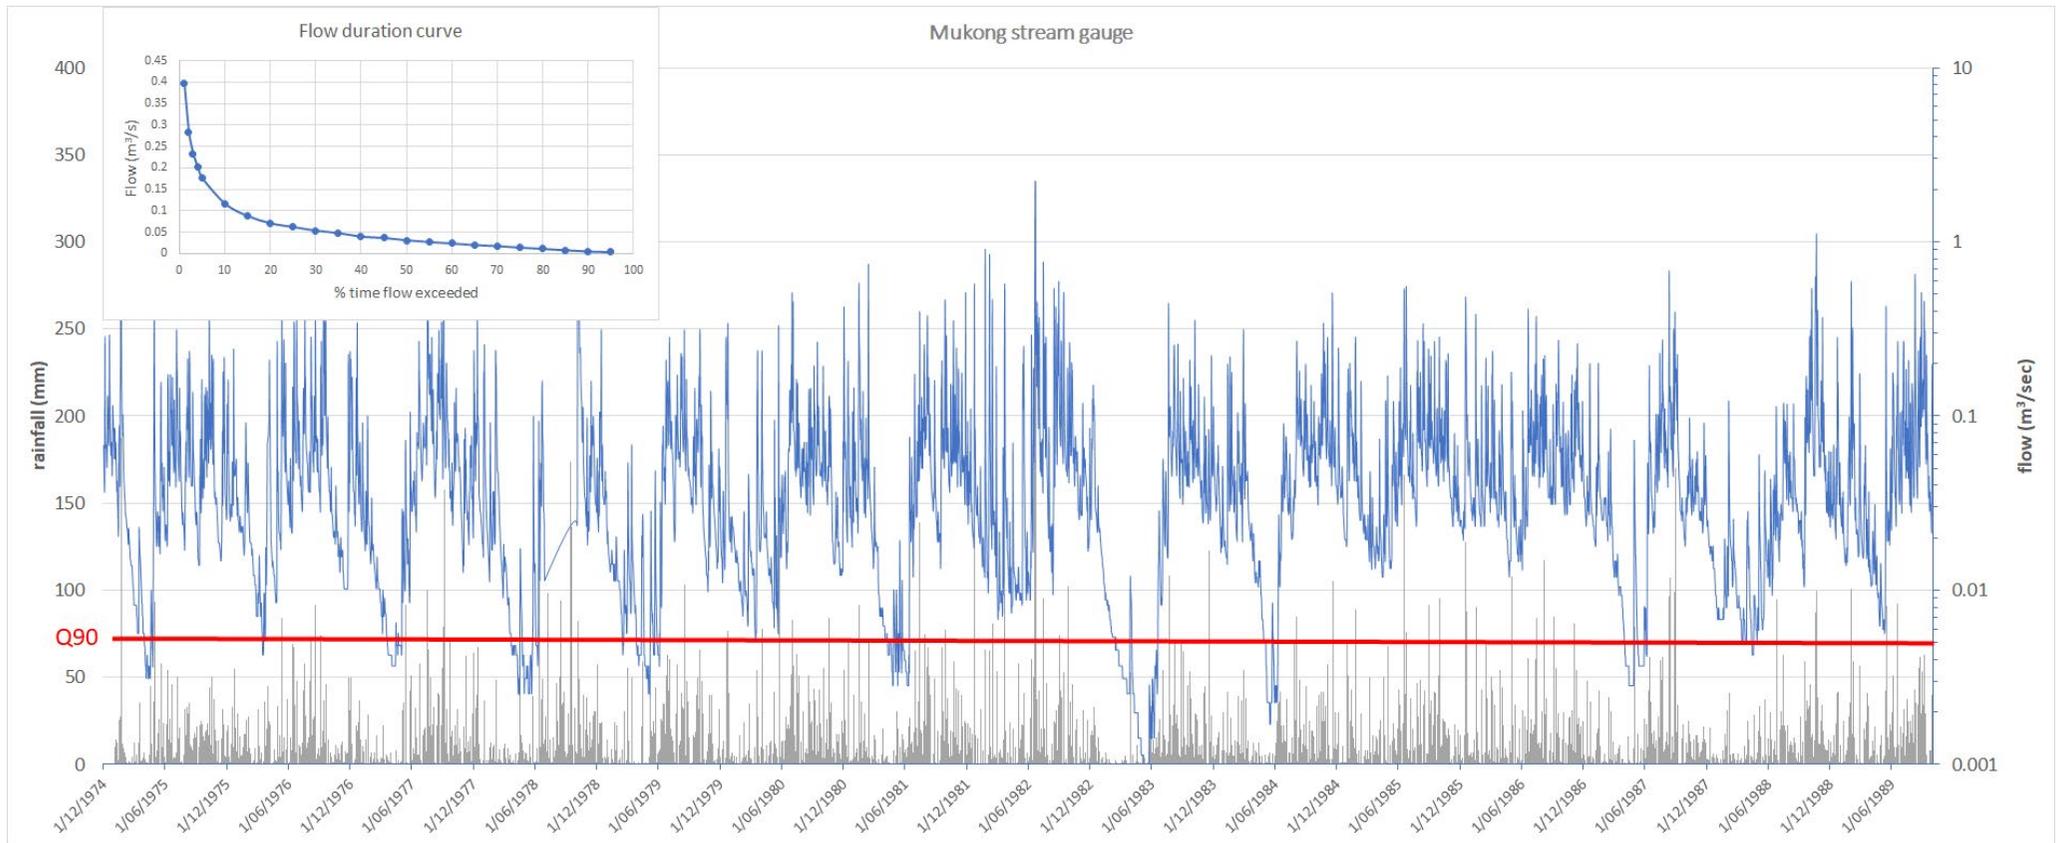
Figure 41. Mukong stream hydrograph for the complete series of records (USGS 16893180, 16/9/1980 – 21/3/1984), including flow duration curve identifying 10% lowest flow levels.

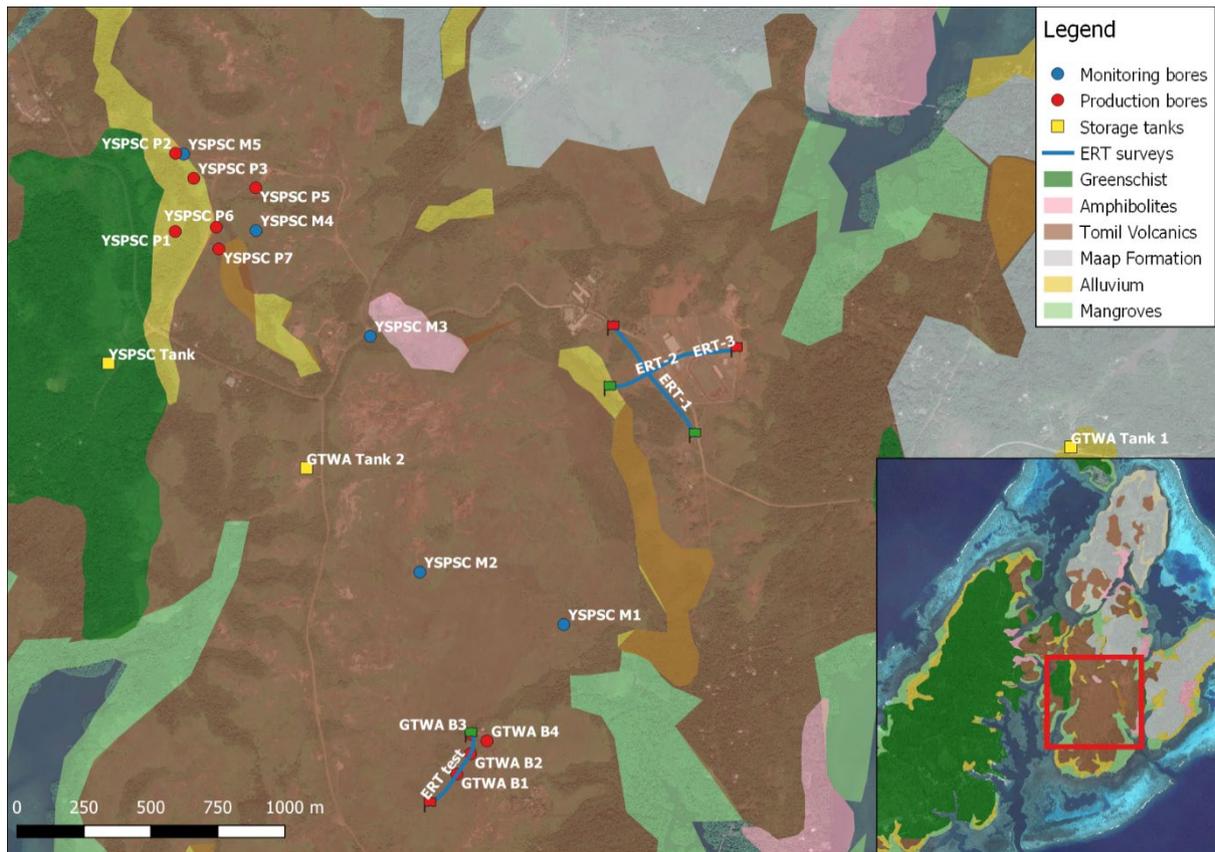
Figure 42. Location of the groundwater infrastructures and the ERT survey lines superimposed onto the geological framework.

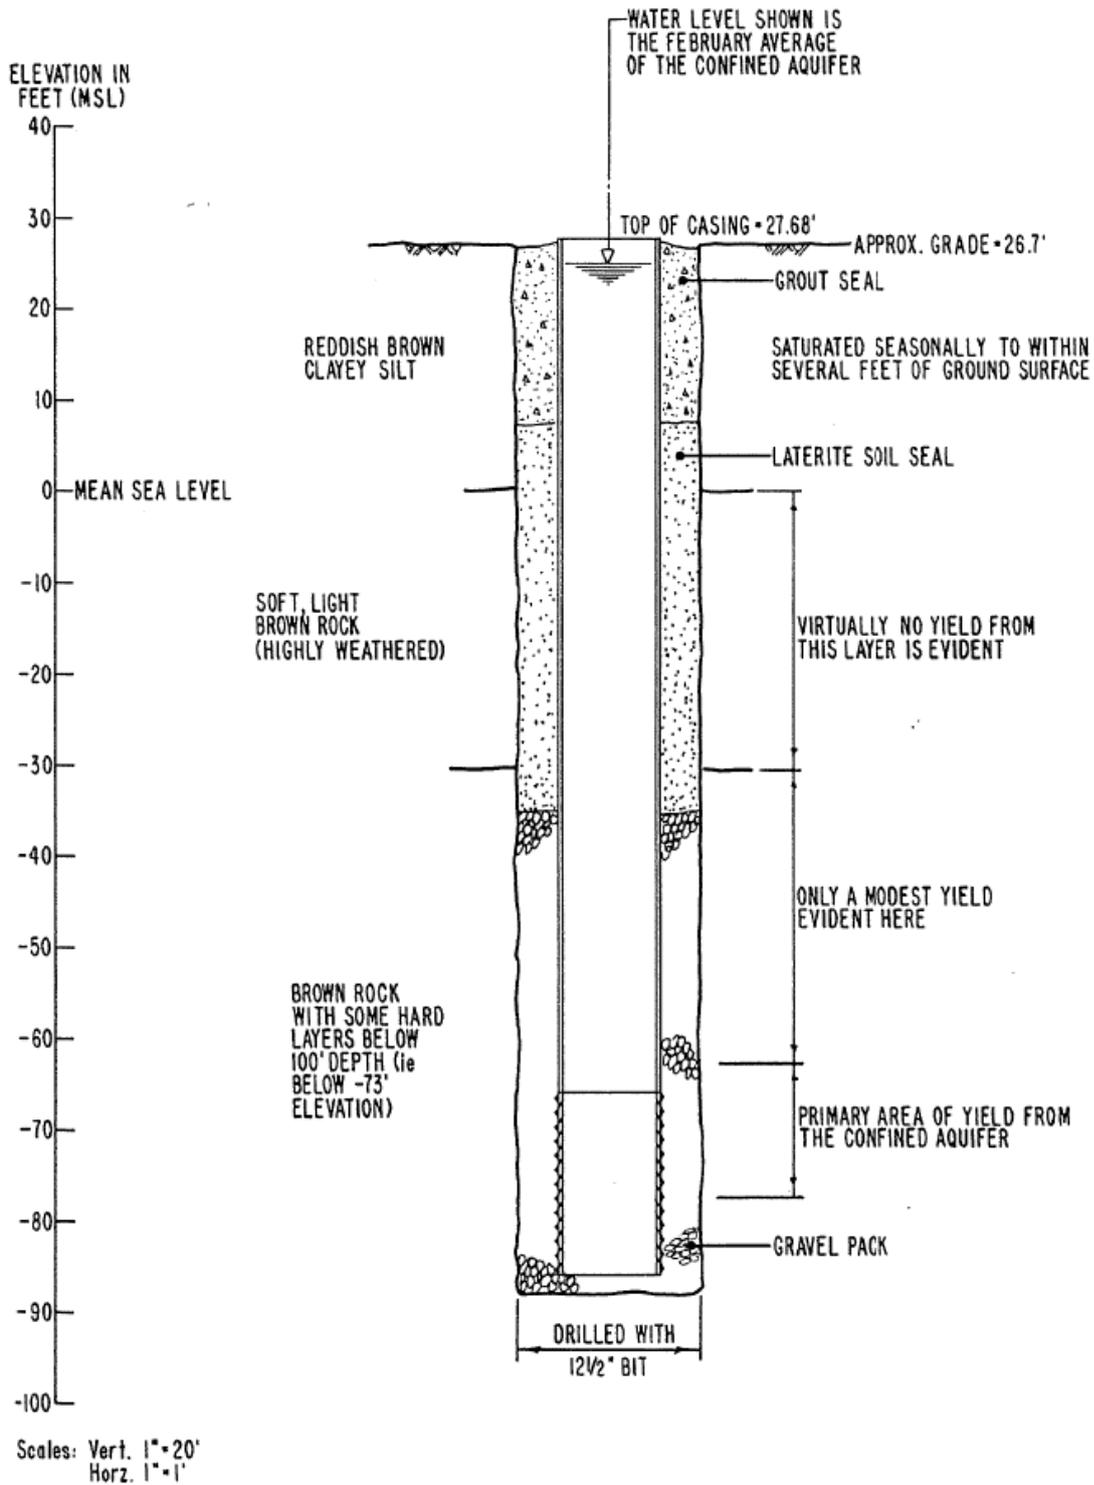
- Drilling and Driller's Log by Ted Lund
- Well Dimensions and Comments on Yield by Tom Nance

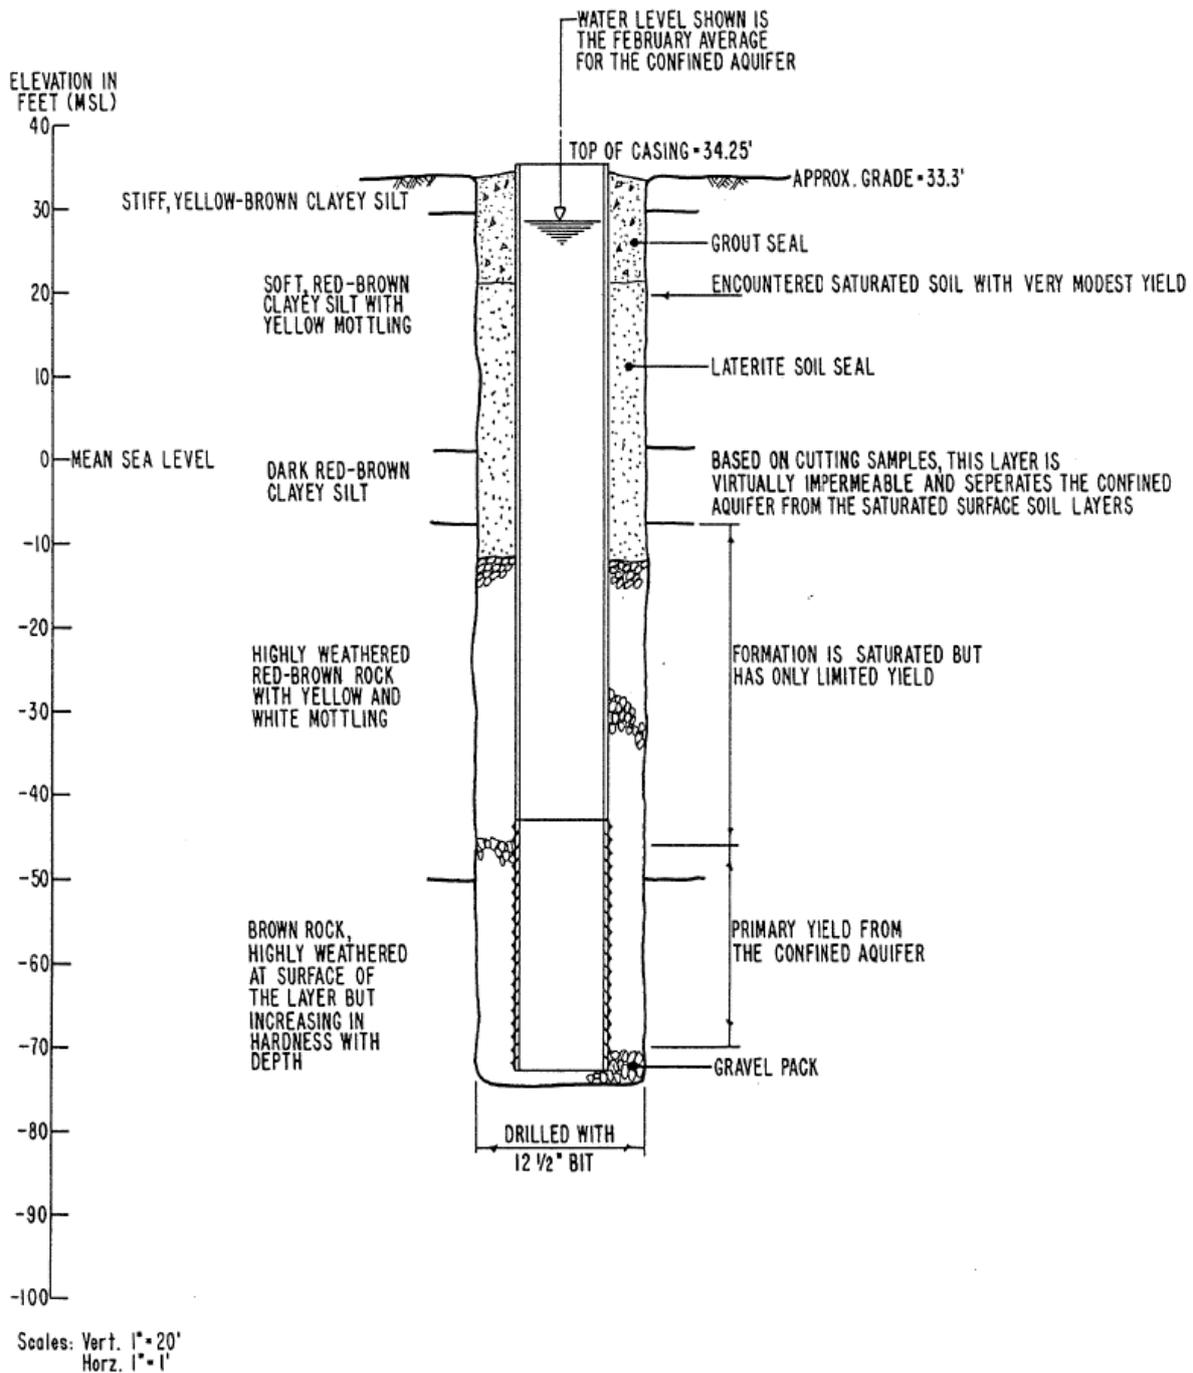
- Drilled by Ted Lund
- Drilling Log, Well Dimensions, and Comments on Yield by Tom Nance

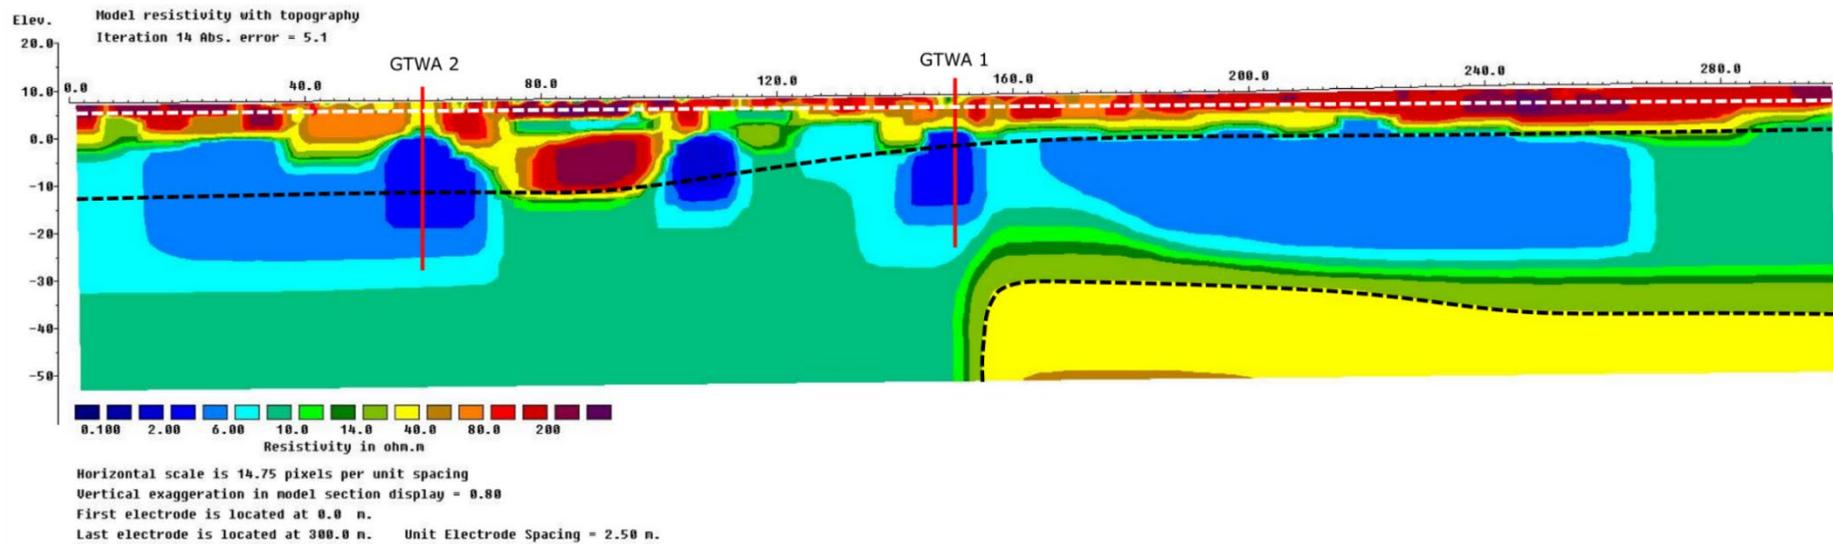
Figure 45. Field calibration line using Multiple Gradient array.

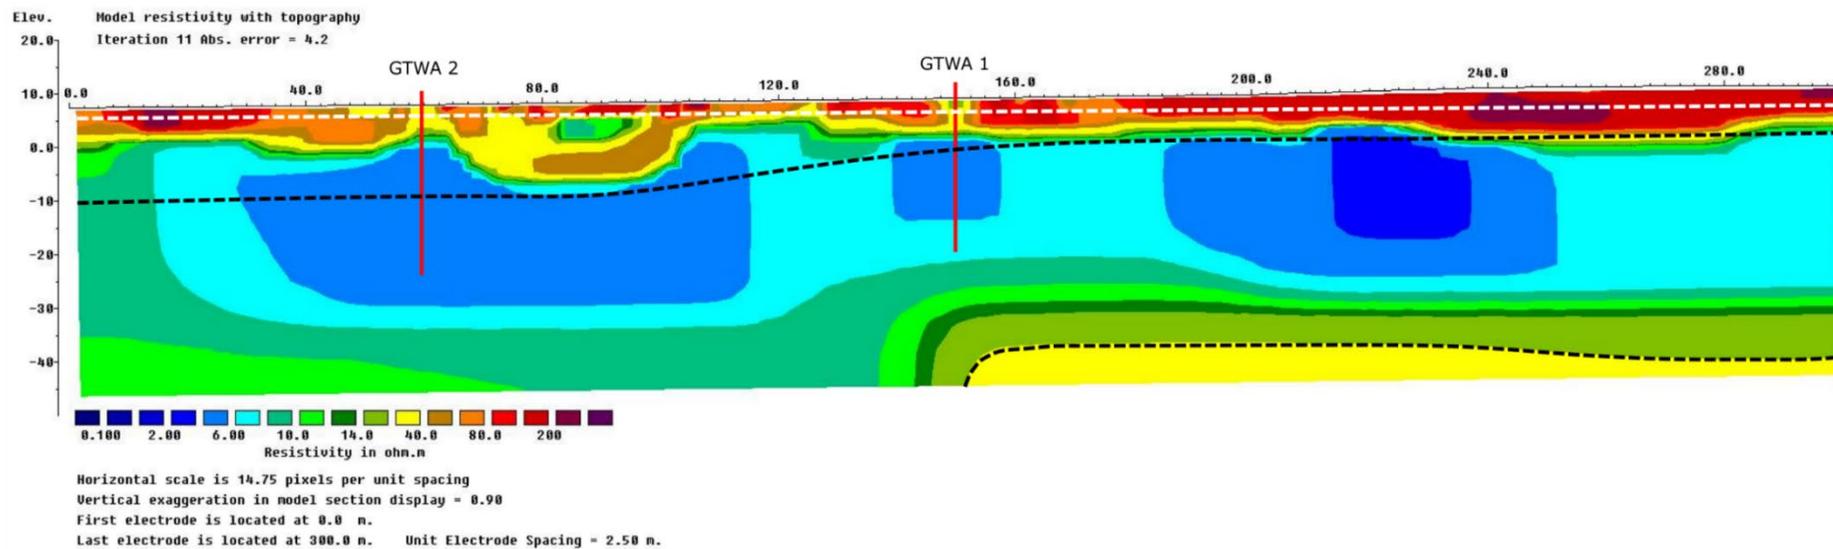
Figure 46. Field calibration line using Wenner array.

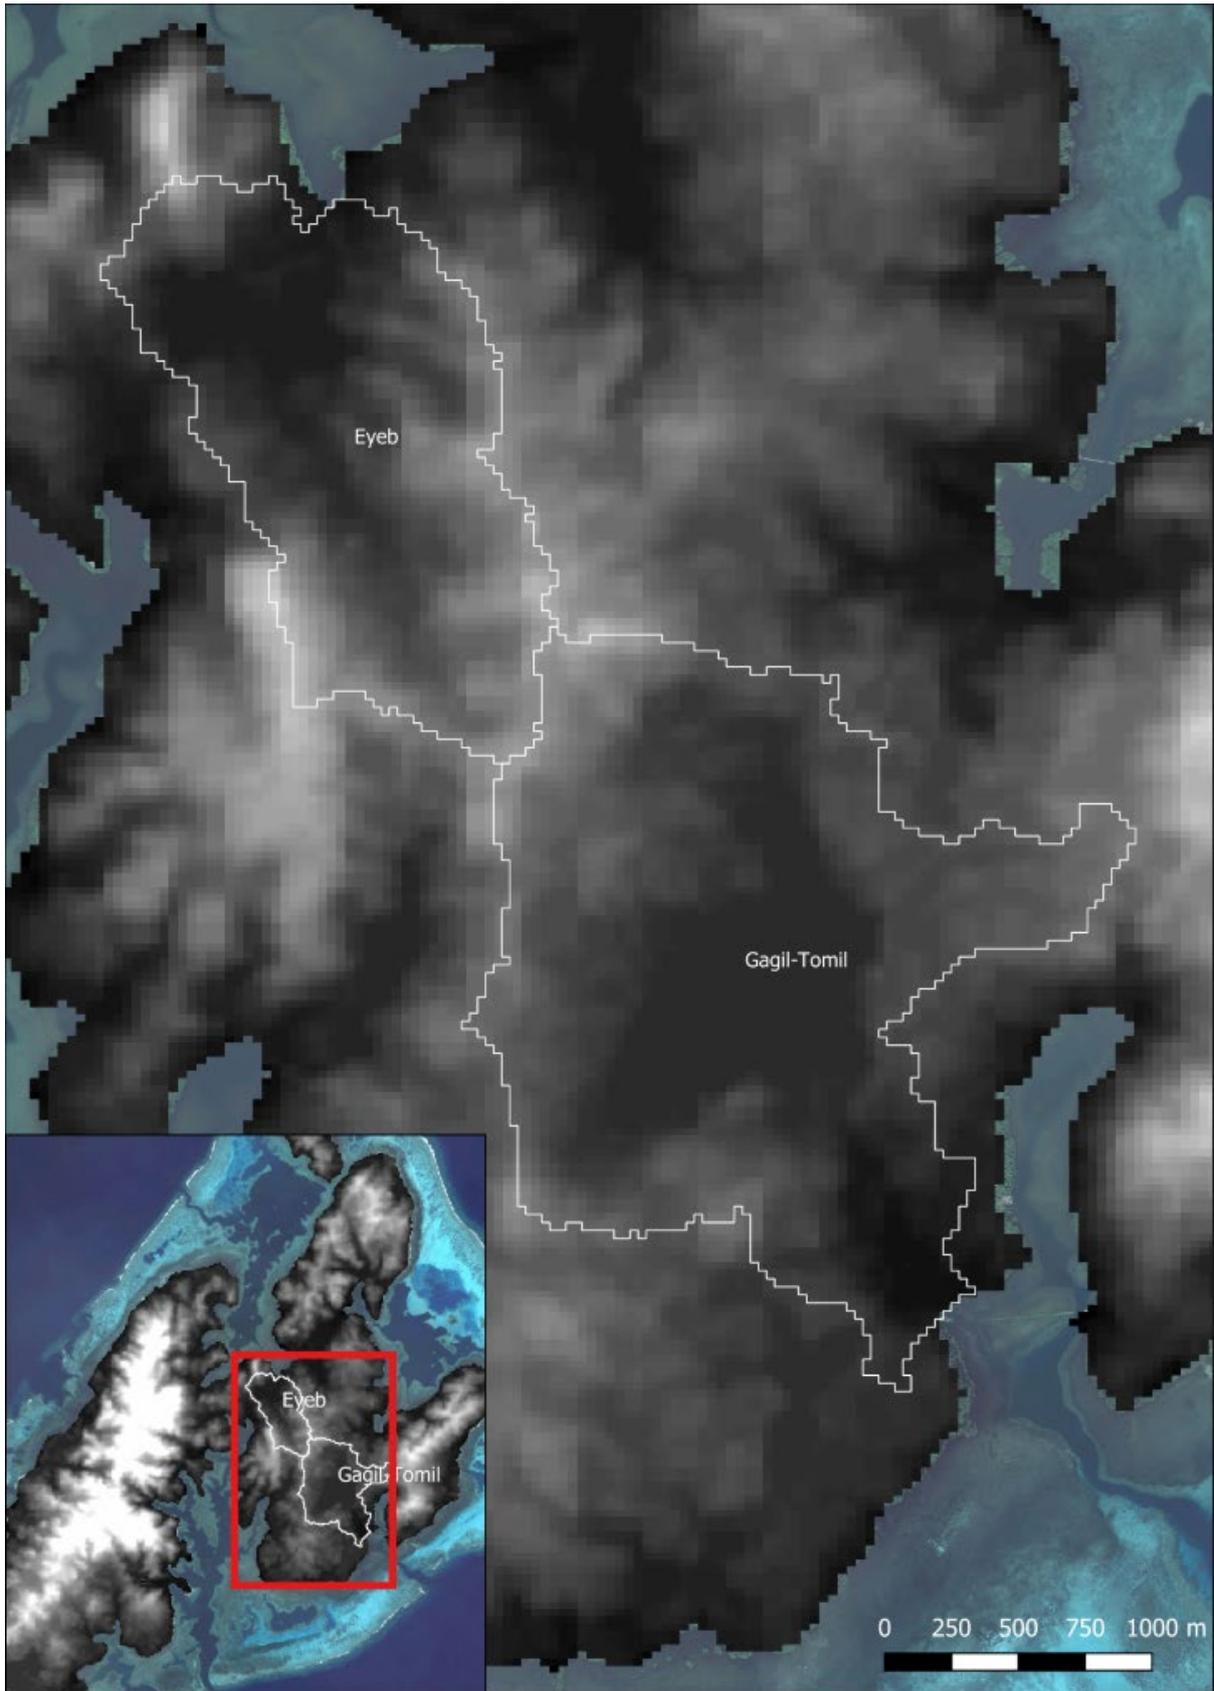
Figure 50. Digital elevation model of Yap used to derive the catchment delineation.
